Subject: Elyria Midway Mall Inspection
Store by Store Envelope Inspections
R.E. Warner Project 37422

LORAIN COUNTY PORT AUTHORITY
ELYRIA MIDWAY MALL

R.E. Warner Project No. 37422

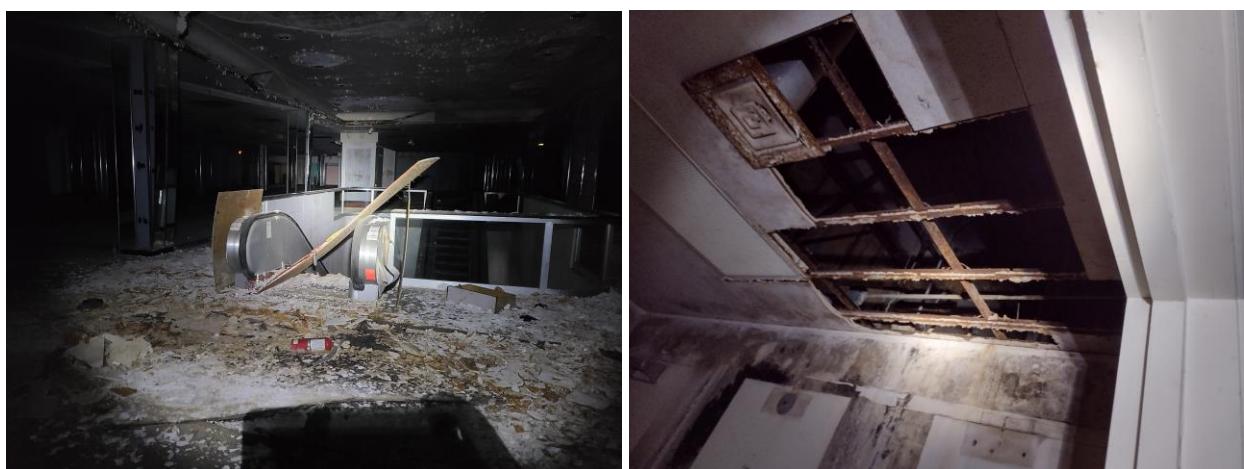
- Building is in very poor condition: water damage, mold, and a large amount of structural damage were noted.

Refer to General Repair Recommendations #1 and #19

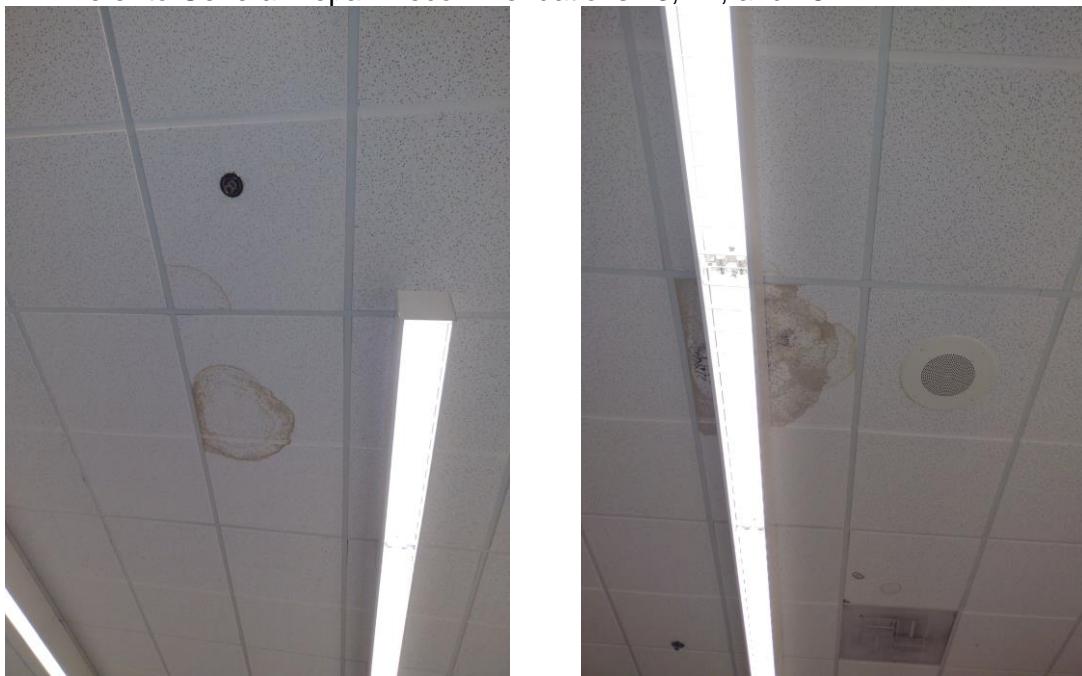
- There are (4) areas of ceiling tiles with stains continued
Refer to General Repair Recommendations #3, #4, and #8

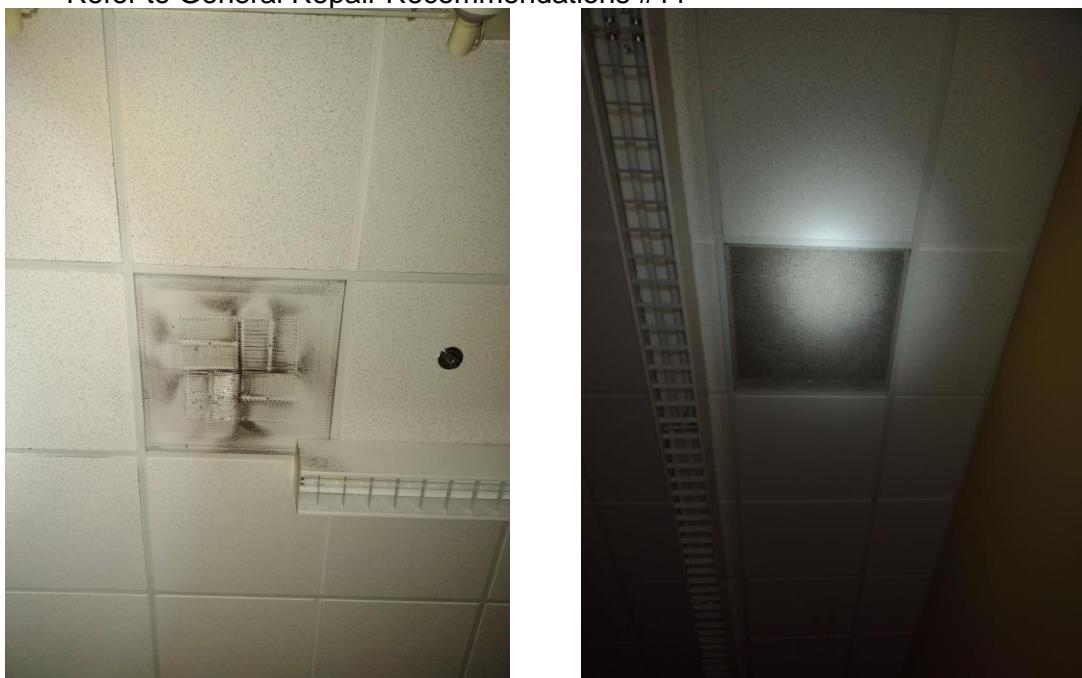
- Air Vent Covers are dirty
Refer to General Repair Recommendations #11

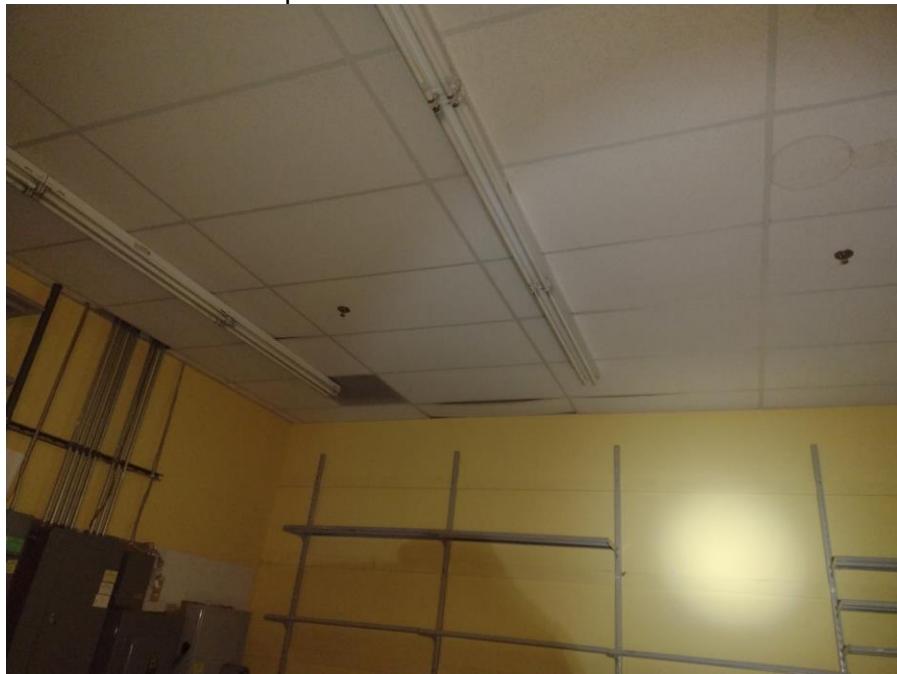
- Rear Storage has stained and warped ceiling tiles
Refer to General Repair Recommendations #10

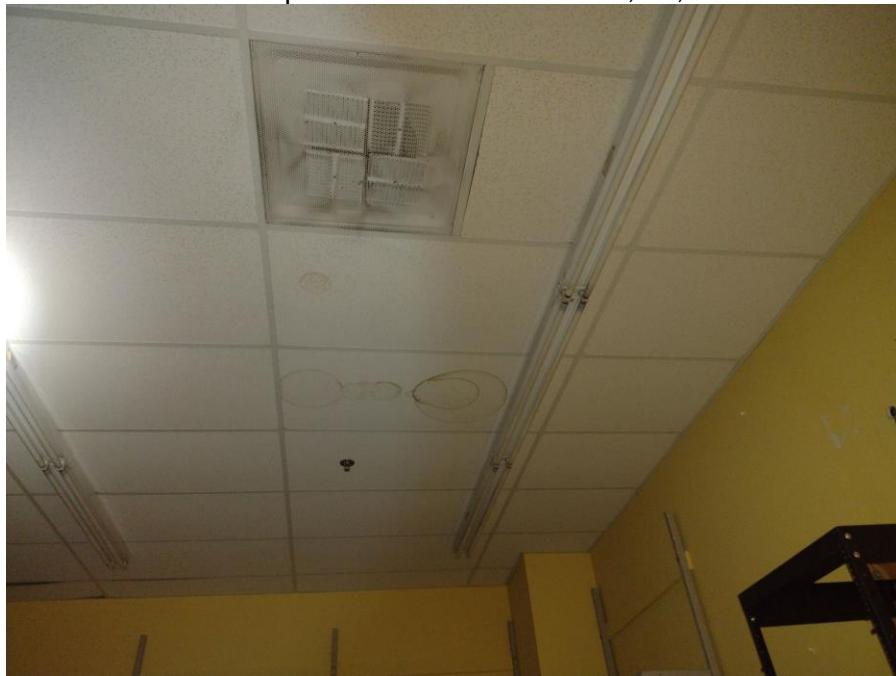
- Random minor Staining of Ceiling tiles
Refer to General Repair Recommendations #3, #4, and #8

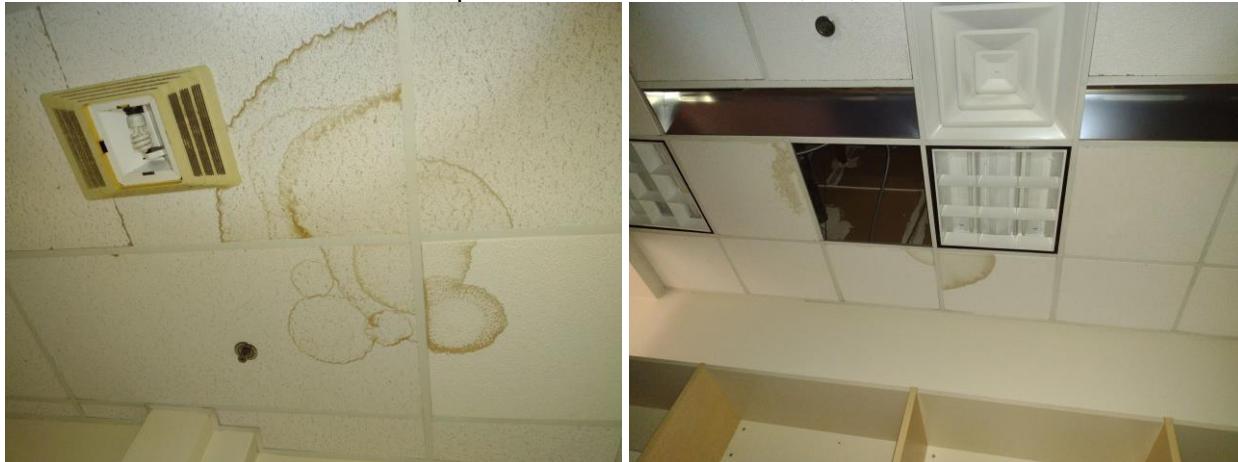
- Dirty, yellowed ceiling tiles
Refer to General Repair Recommendations #3, #4, #8, and #12

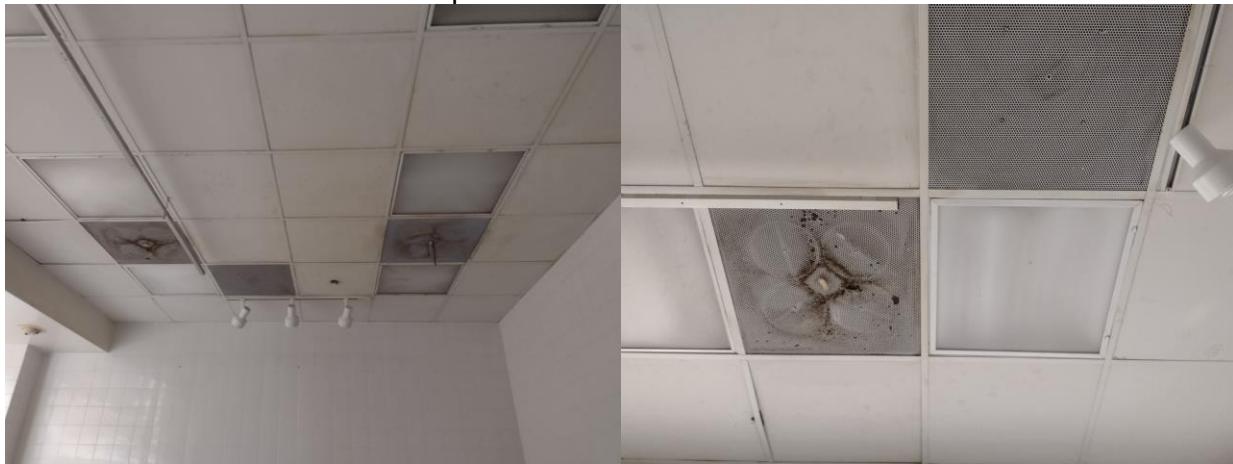
- Dirty vent
Refer to General Repair Recommendations #11

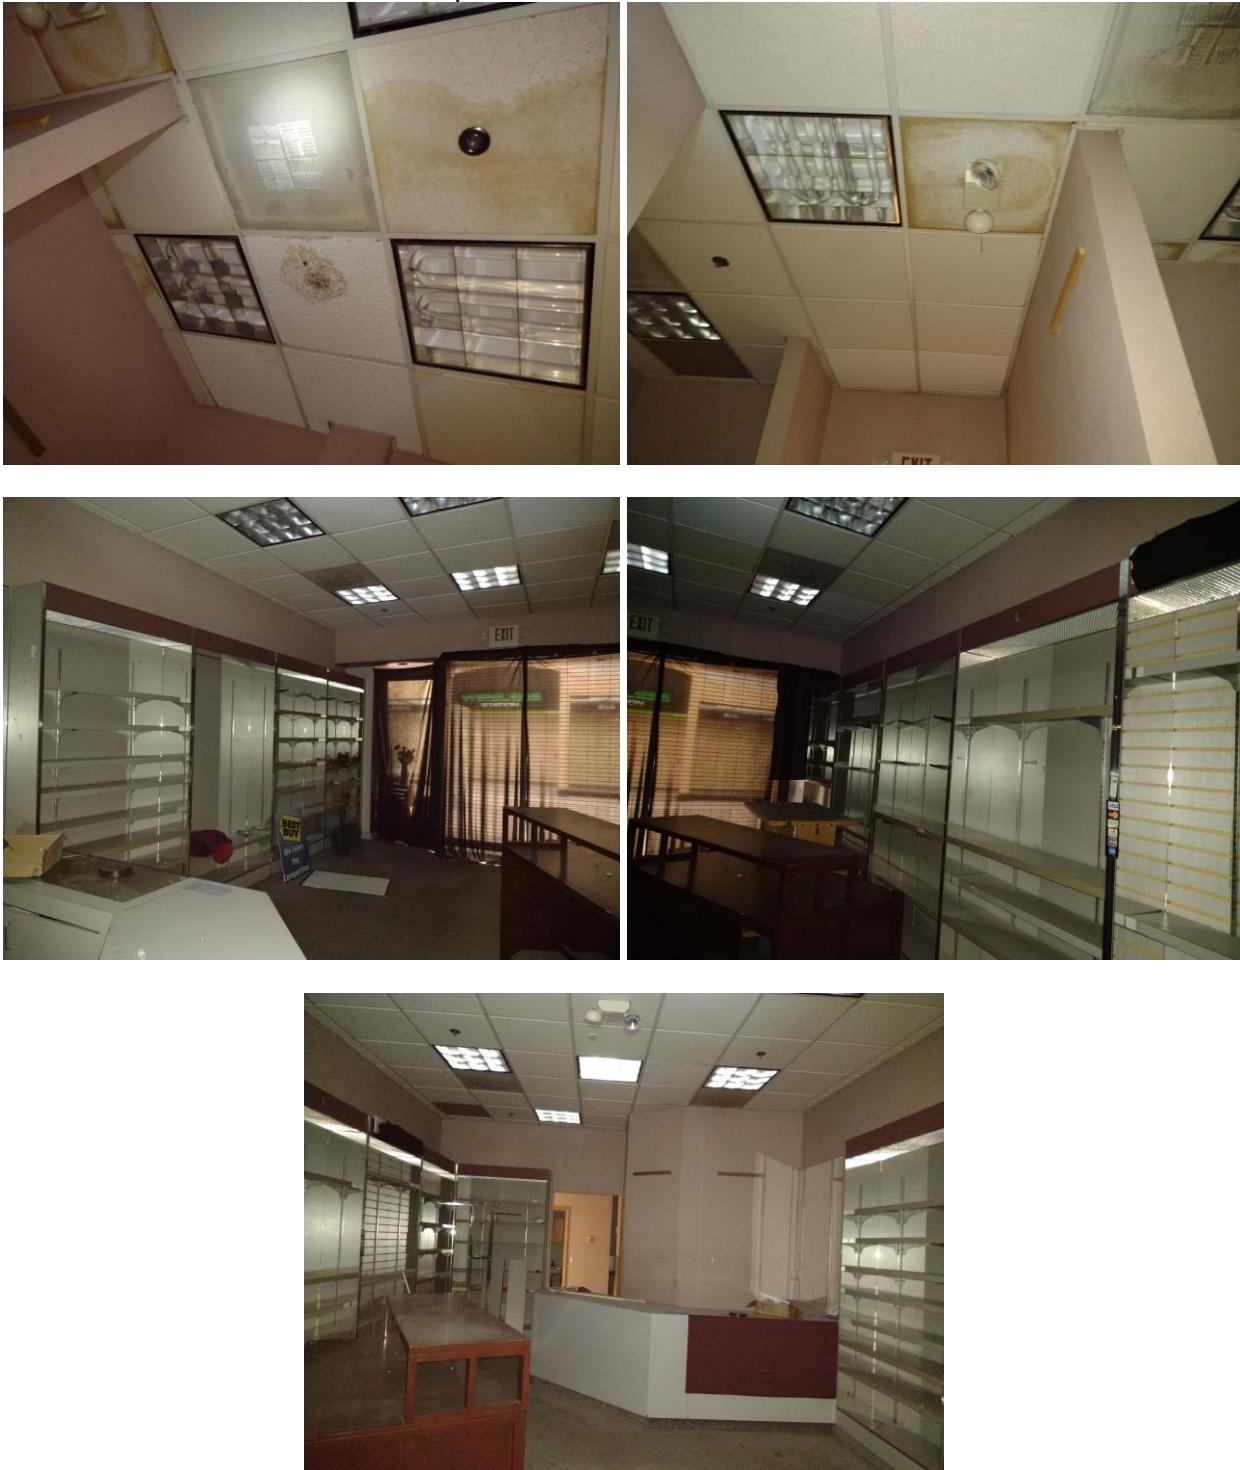
- Random Ceiling tiles stained, and the store area is messy
Refer to General Repair Recommendations #3, #4, and #8

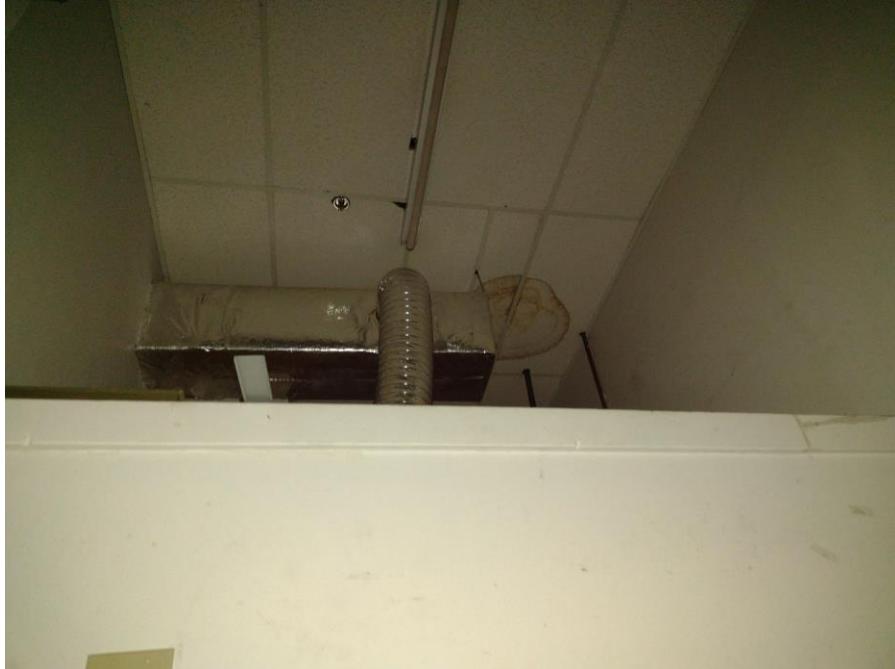
- Tiles stained at the duct above break room/kitchen
Refer to General Repair Recommendations #3, #4, and #8

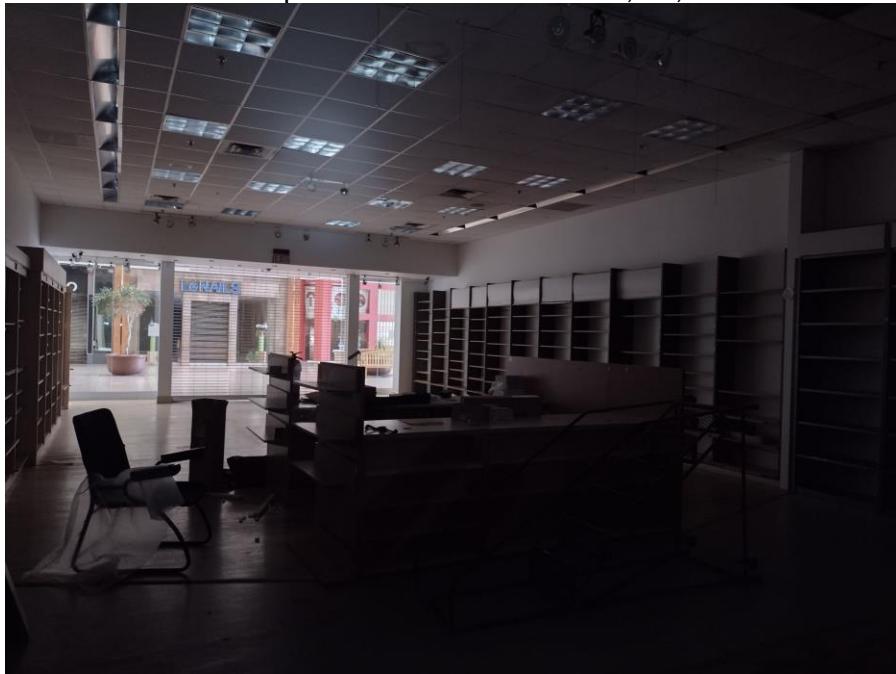
- Random stained tiles in the store
Refer to General Repair Recommendations #3, #4, and #8

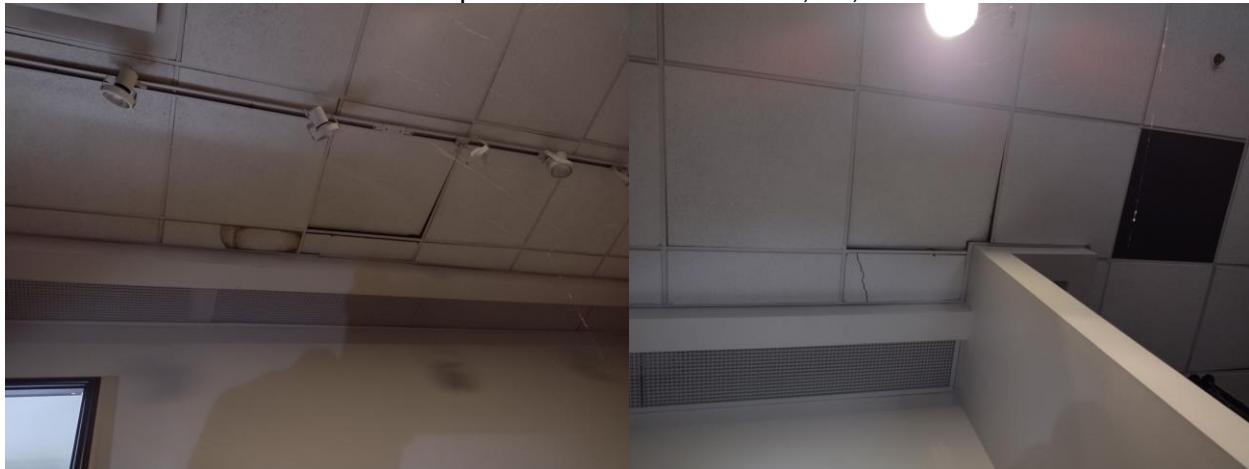
- Random Stained and cracked ceiling tiles
Refer to General Repair Recommendations #3, #4, and #8

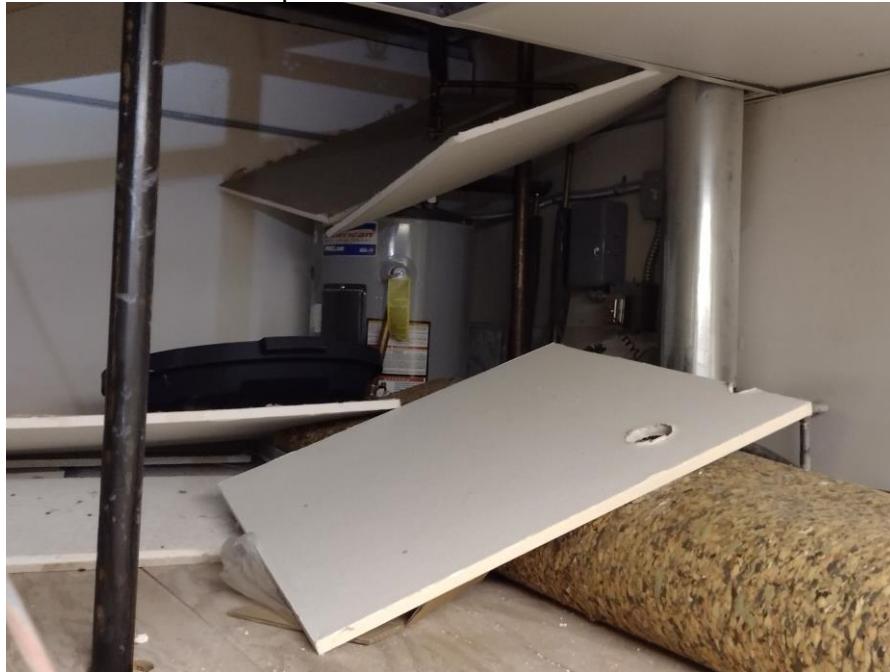
- Debris at Hot Water Tank
Refer to General Repair Recommendations #3 and #18

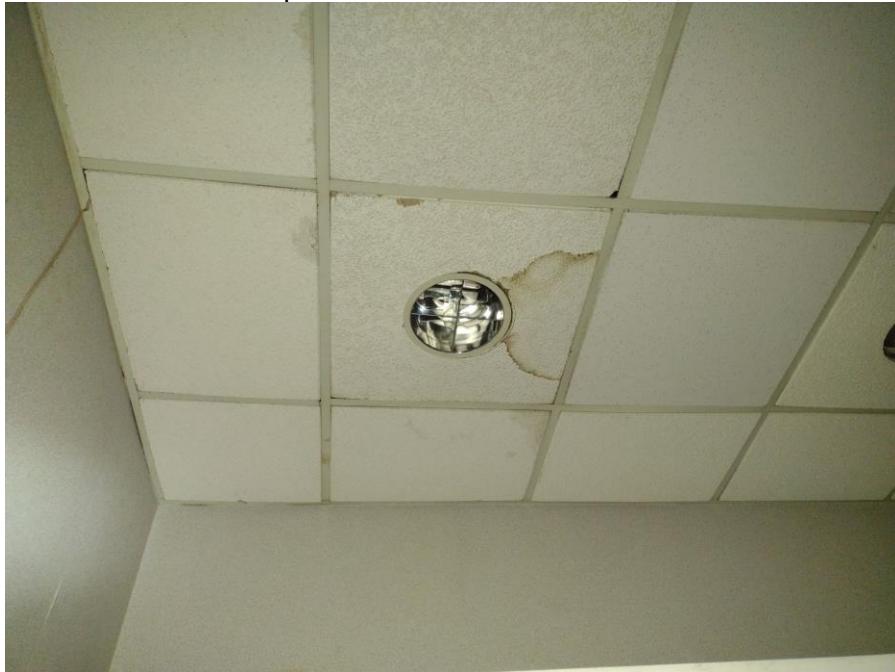
- Stained ceiling tiles above dressing rooms
Refer to General Repair Recommendations #3, #4, and #8

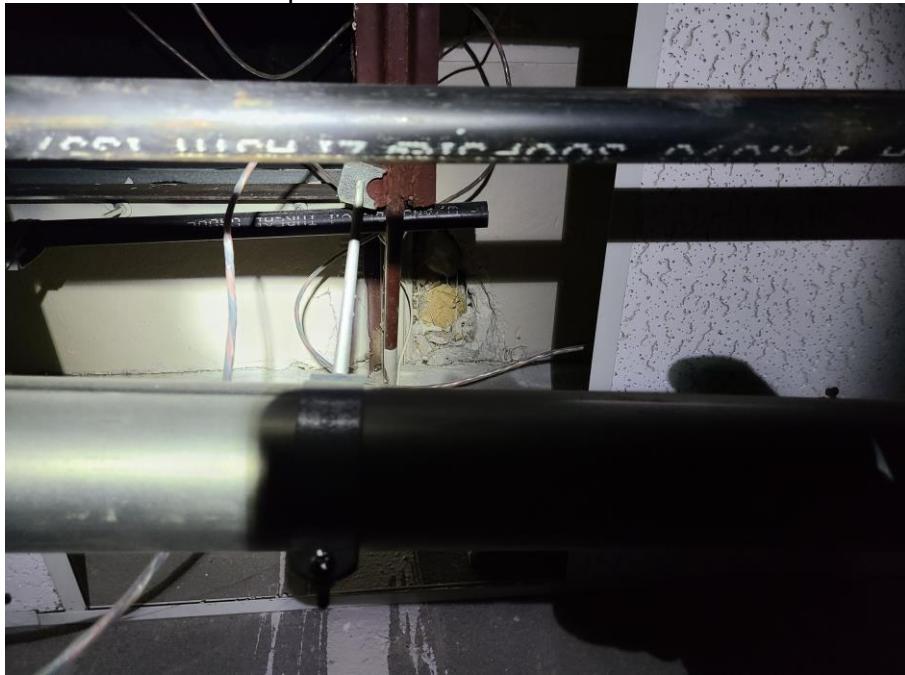
- Concrete roof decking in the back of the store spalling
Refer to General Repair Recommendations #4 and #9

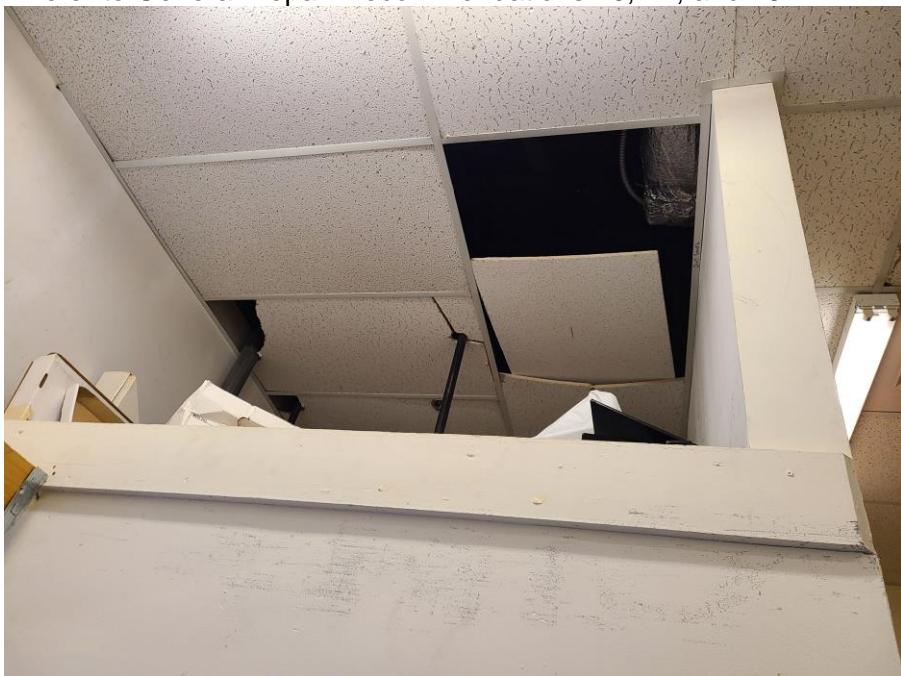
- Storage area has typical damage tiles
Refer to General Repair Recommendations #3, #4, and #8

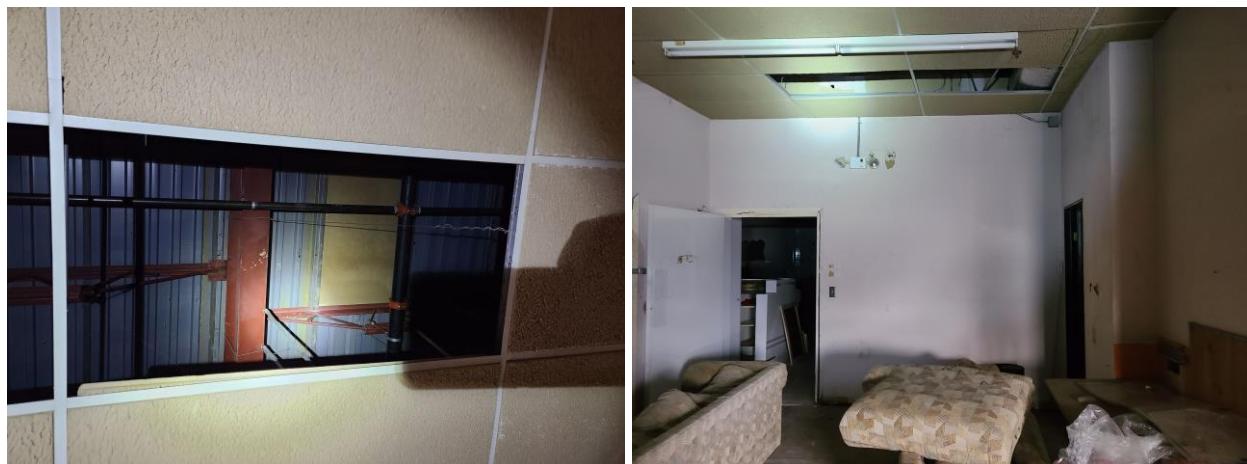
- Fitting room area is in good condition
- In the main store area Ceiling tiles have been removed, damaged, or stained
Refer to General Repair Recommendations #3, #4, and #8

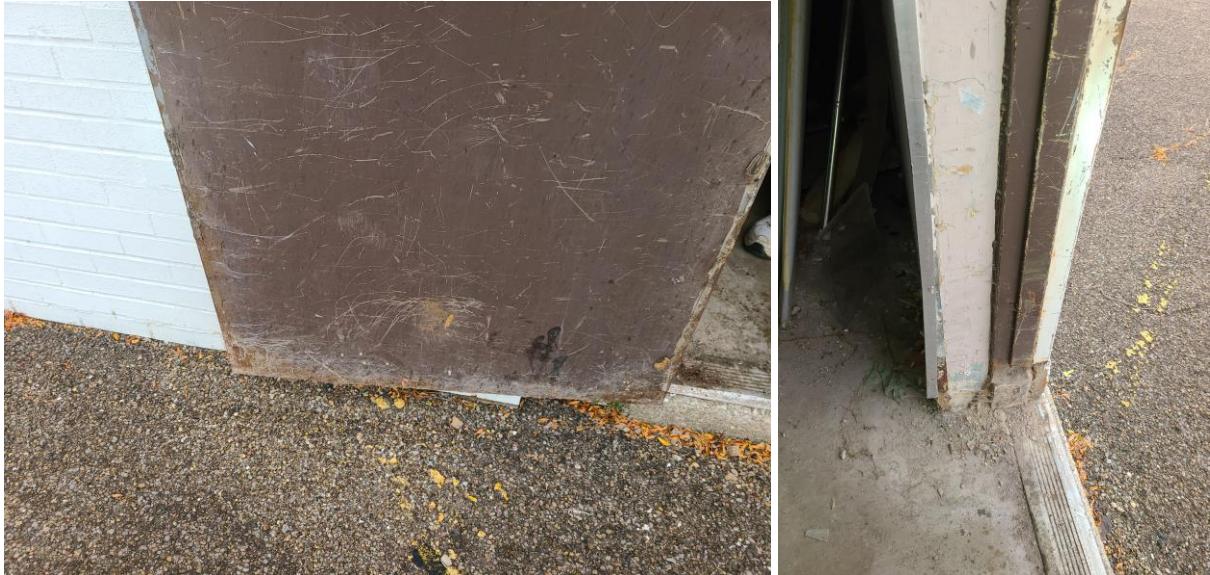
- Metal decking appears to be new
- Rear entry doors are in poor condition

Refer to General Repair Recommendations #5

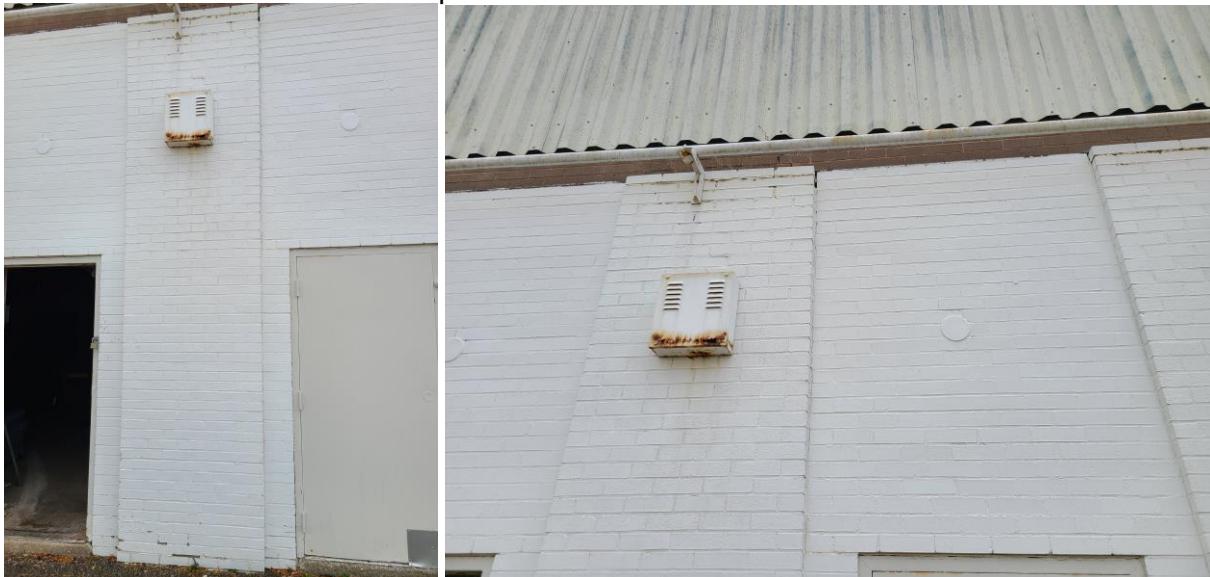
- Brick work has cracked joints and paint is peeling

Refer to General Repair Recommendations #15 and #16

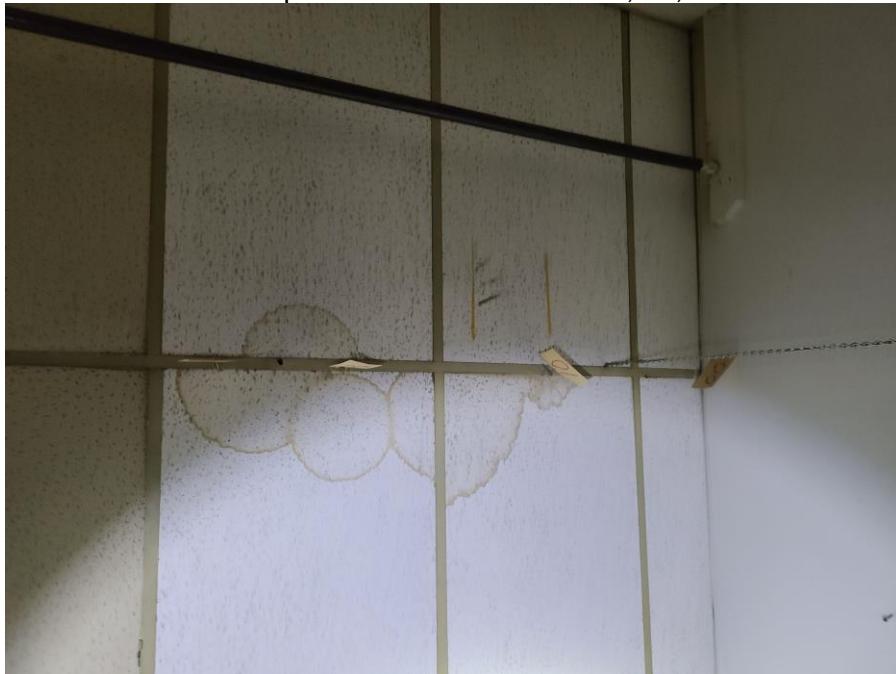
- At the back of the store and in the main store Random Damaged and stained tiles

Refer to General Repair Recommendations #3, #4, and #8

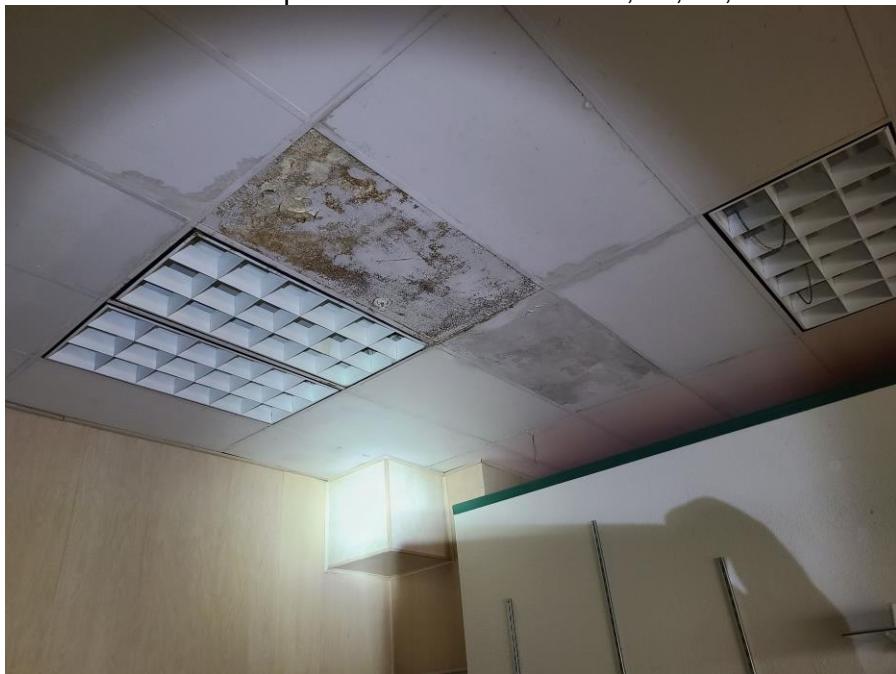
- Possible Mold/ mildew stains

Refer to General Repair Recommendations #2, #3, #4, and #8

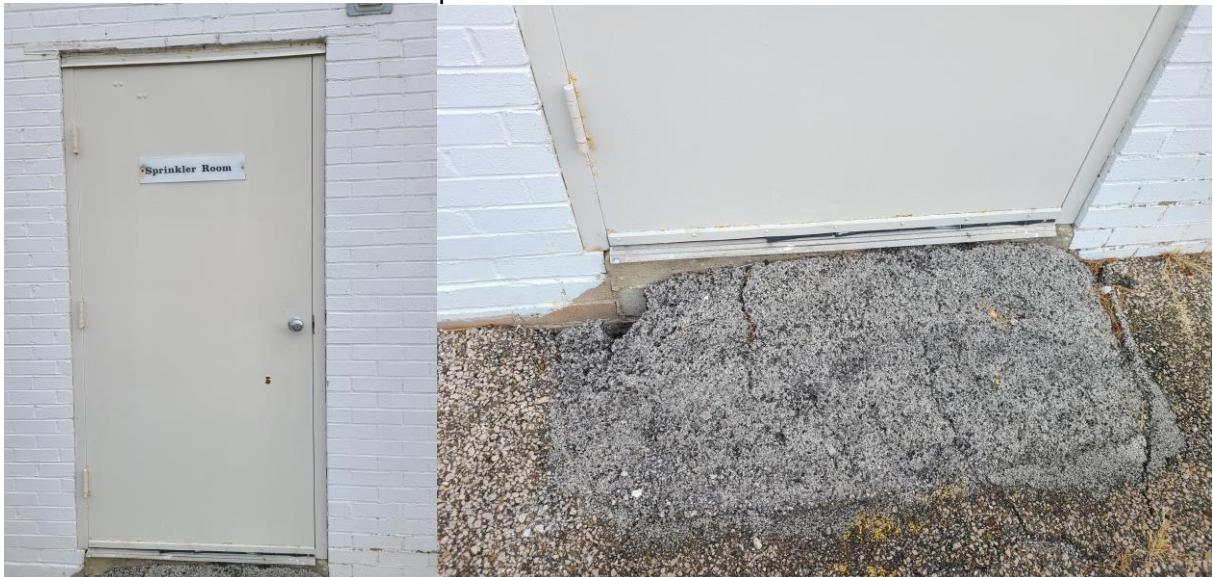
- Sprinkler Room is OK
- Threshold sweep rusted outside of the door
Refer to General Repair Recommendations #5 and #7

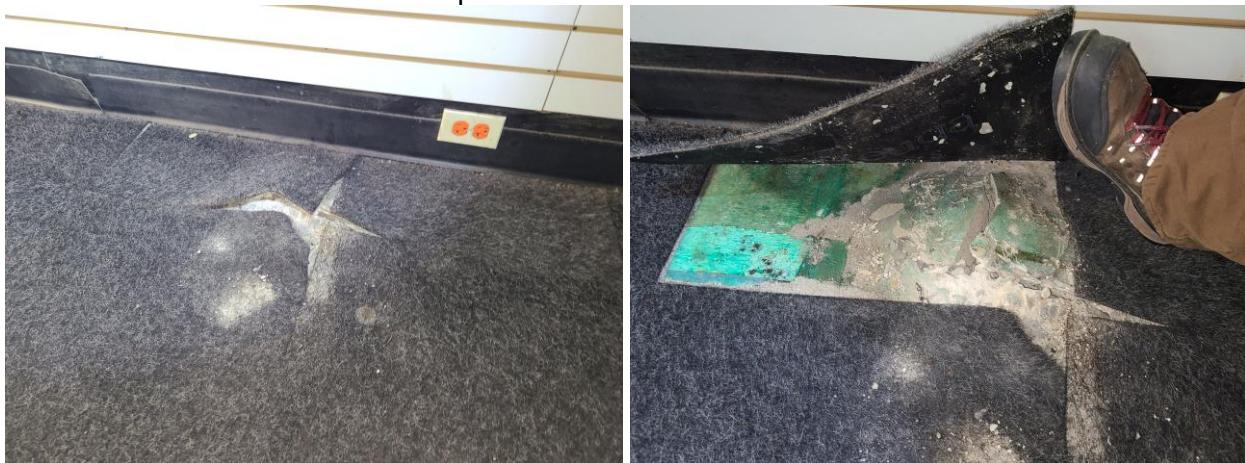
- Up near the front of the floor is heaved up and cracked

Refer to General Repair Recommendations #6 and #7

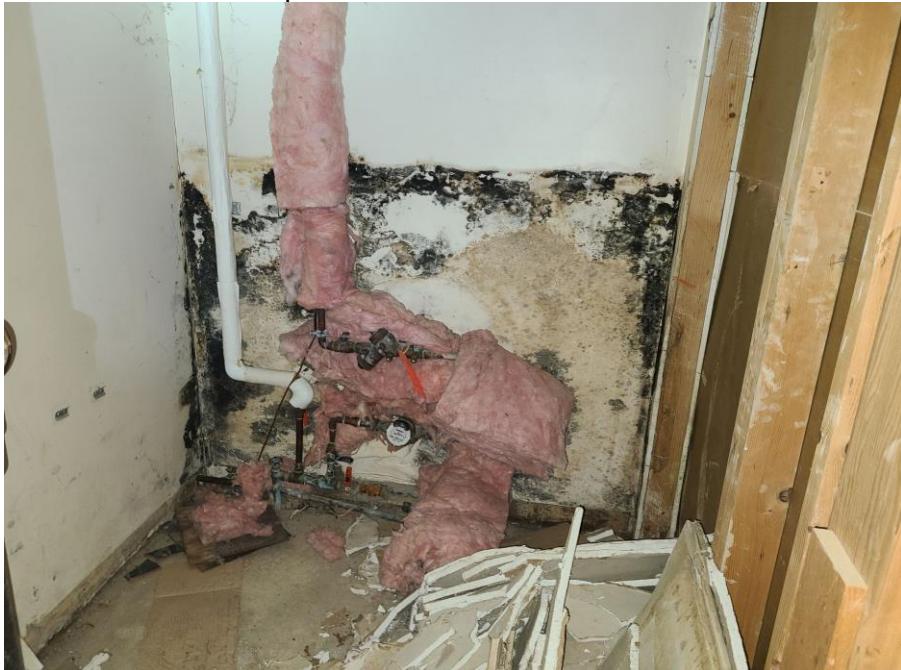
- Along the back wall, lots of mold and mildew
Refer to General Repair Recommendations #2 and #15

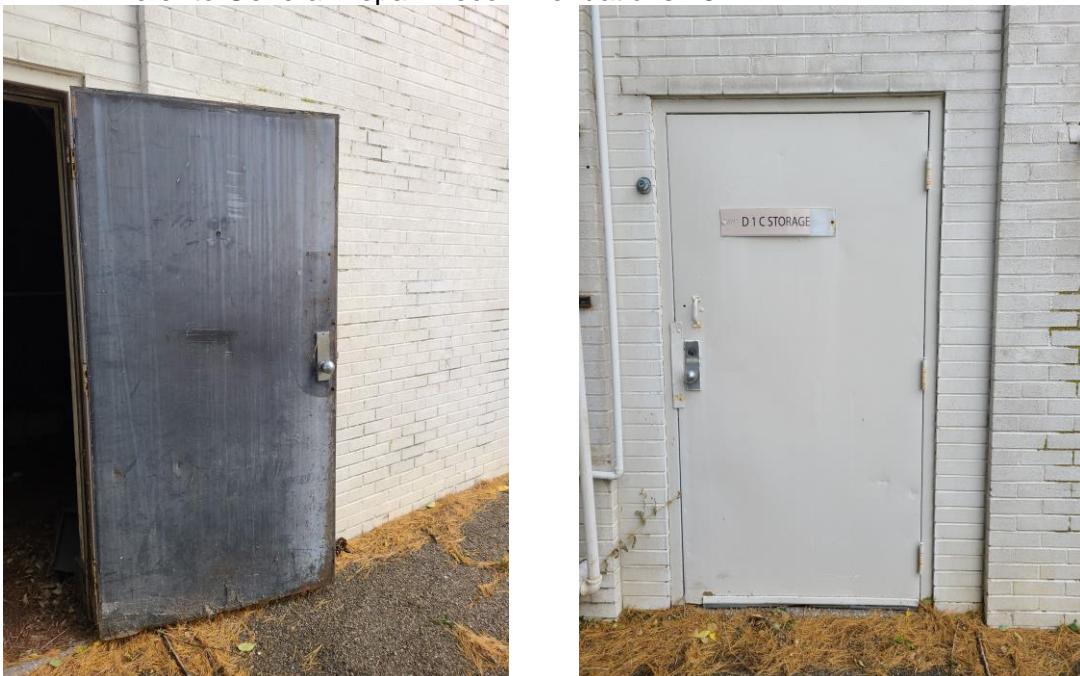
- Metal door – rusted inside and outside
Refer to General Repair Recommendations #5

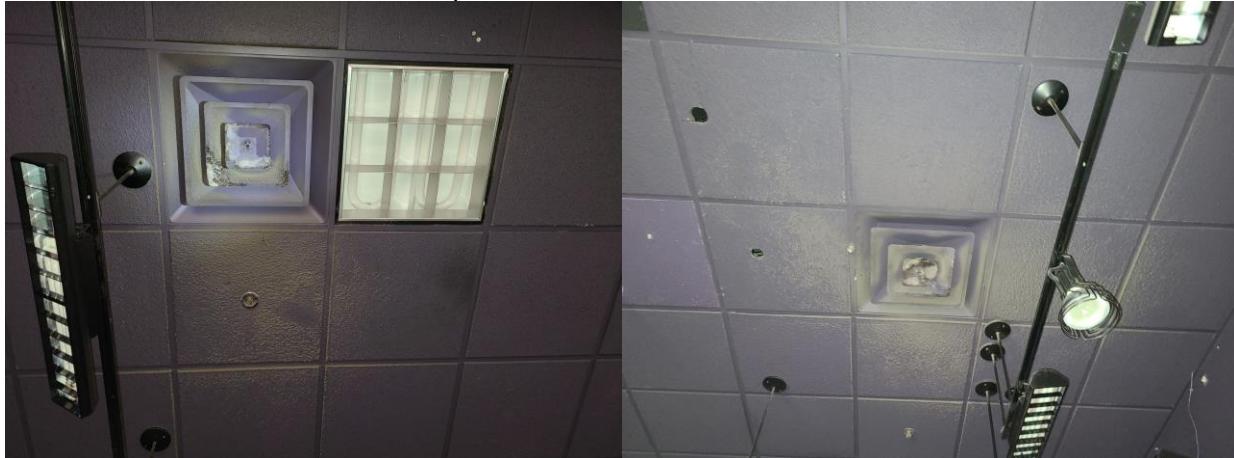
- At (4) vents, minor to moderate surface corrosion with possible mold/mildew in the HVAC
Refer to General Repair Recommendations #2

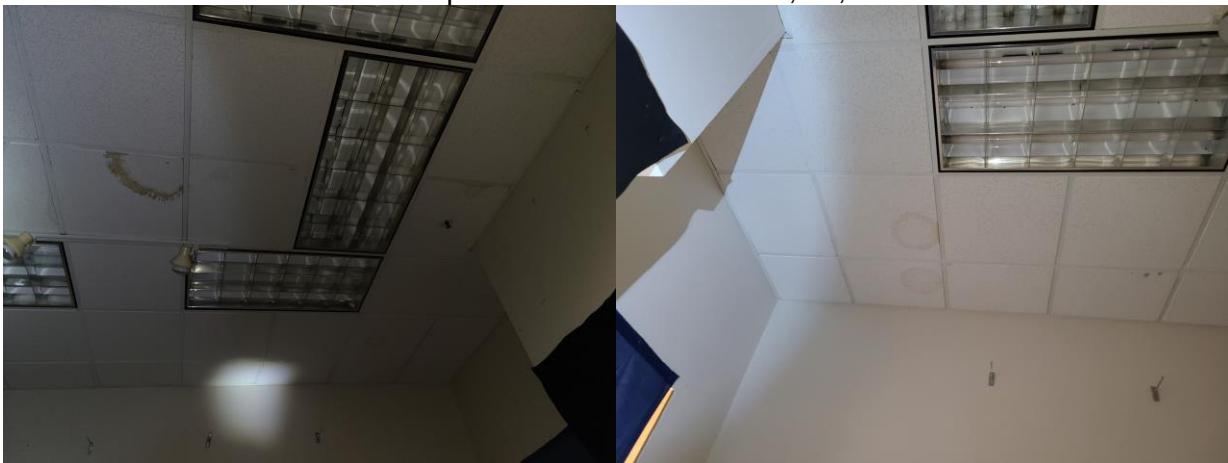
- At the front of the store random there are areas of stained ceiling tiles
Refer to General Repair Recommendations #3, #4, and #8

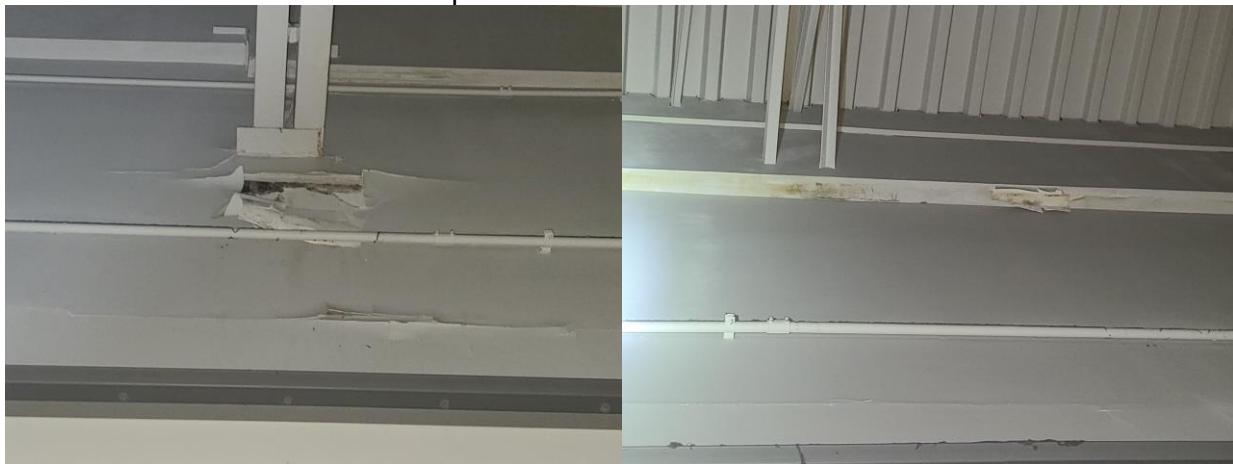
- Peeling paint Damaged Plaster board on the North wall
Refer to General Repair Recommendations #15 and #16

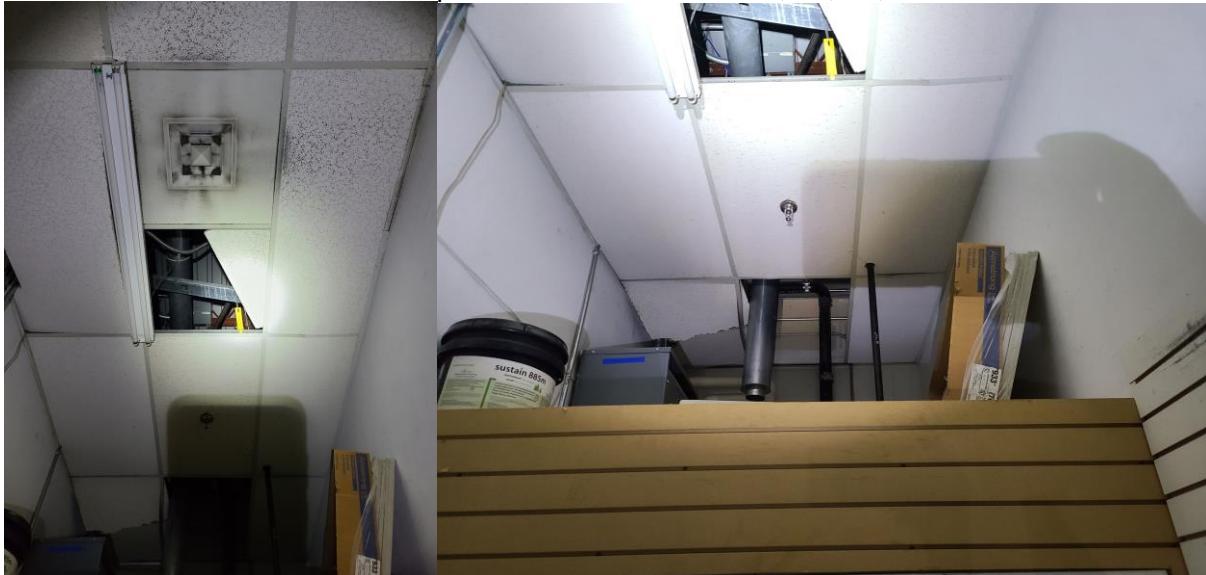
- Loose and missing ceiling tiles in the back of the store possible mold and mildew on the ceiling tiles by vent
Refer to General Repair Recommendations #2, #3, #4, and #8

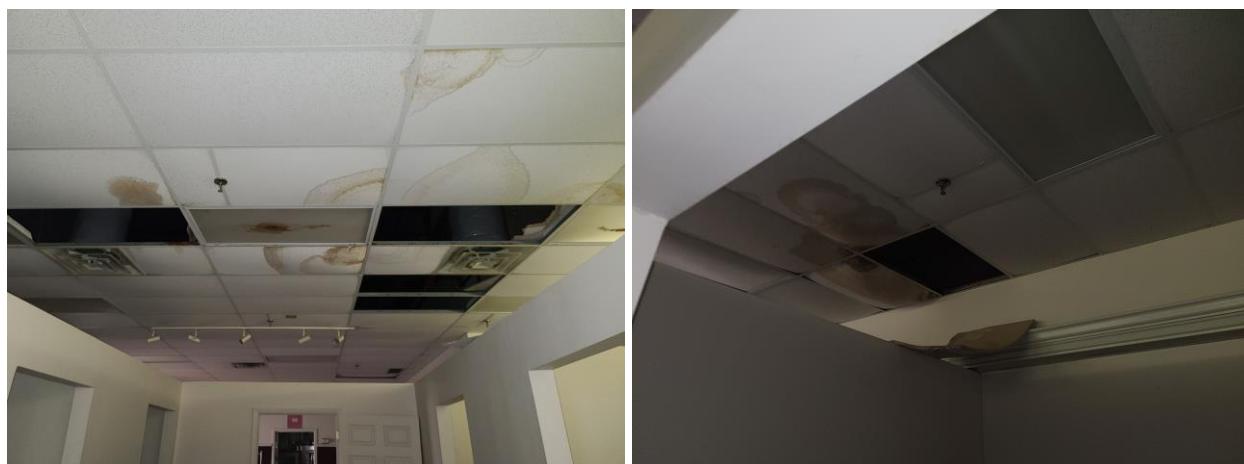
- In the front left corner and All through the middle of the store the ceiling tiles are damaged and missing from water damage
Refer to General Repair Recommendations #2, #3, #4, and #8

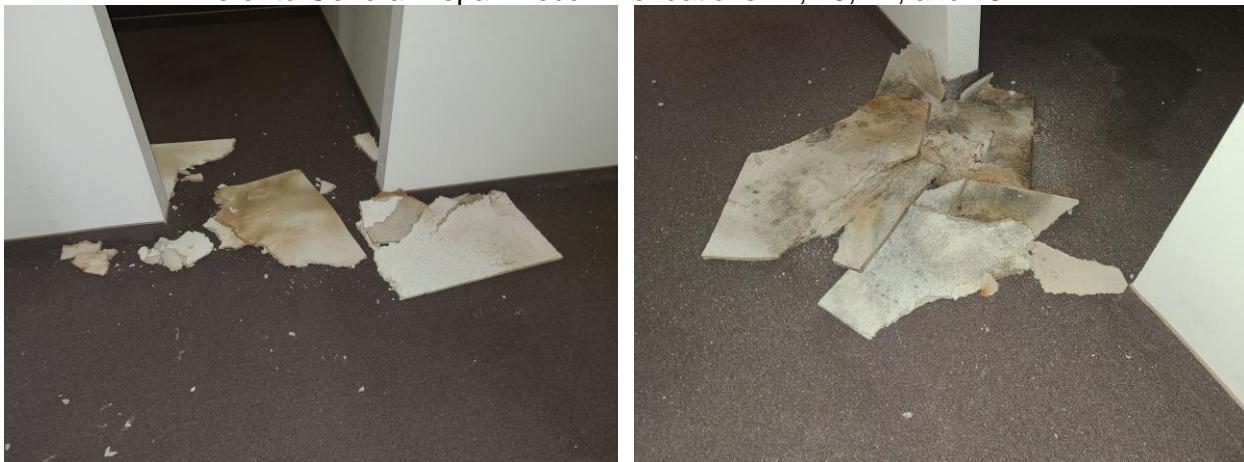
- Lots of ceiling tiles fallen due to water damage causing Mold and mildew panels on the floor.
Refer to General Repair Recommendations #2, #3, #4, and #8

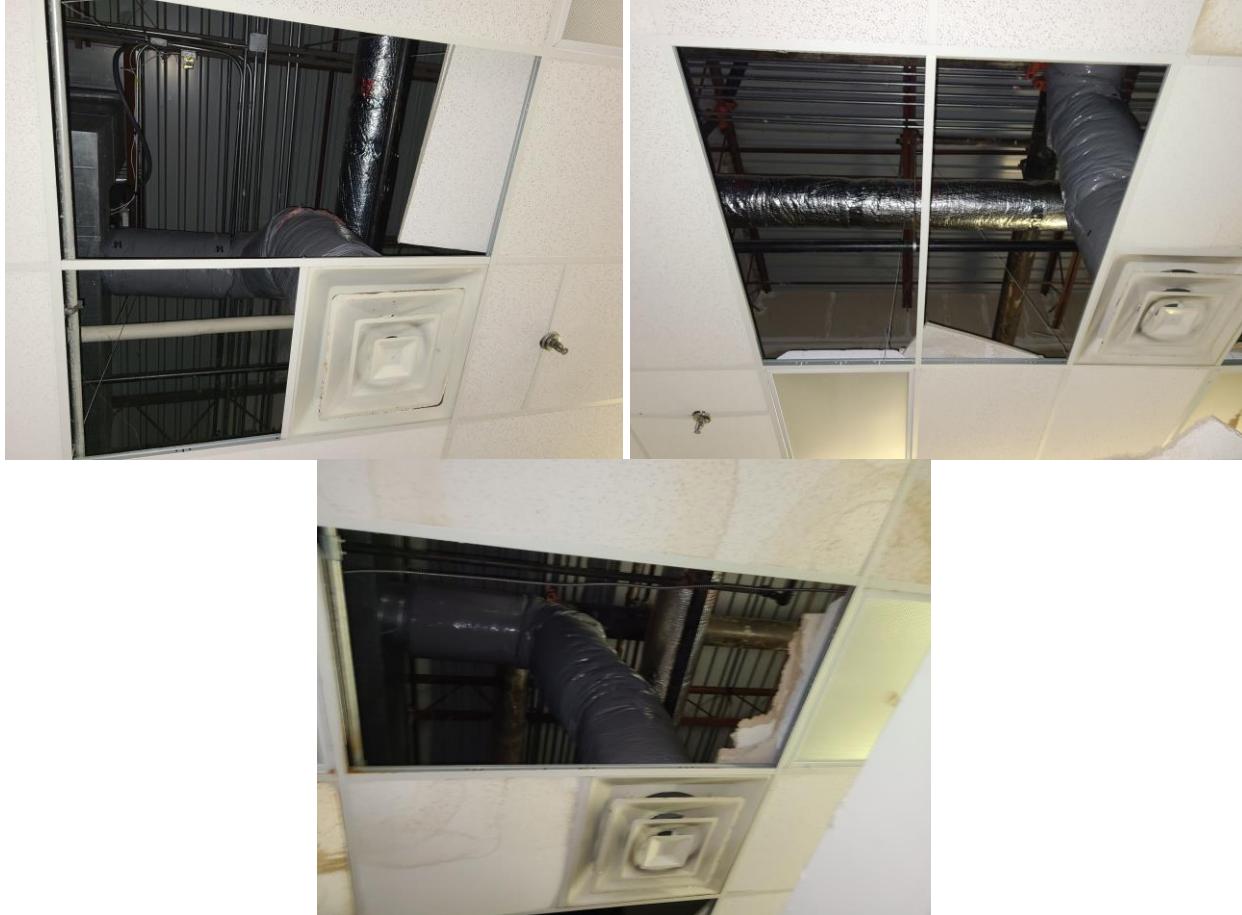
- Metal roof decking is experiencing minor corrosion on some beams, roof trusses have minor corrosion
Refer to General Repair Recommendations #9

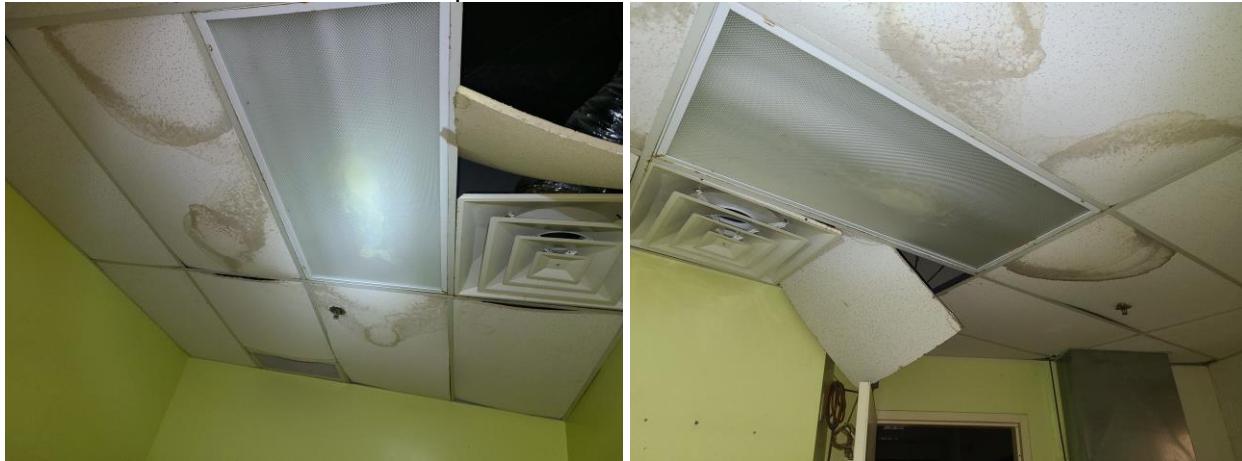
- Near the back door, ceiling tiles are badly stained, sagging, and missing ceiling tiles
Refer to General Repair Recommendations #2, #3, #4 and #8

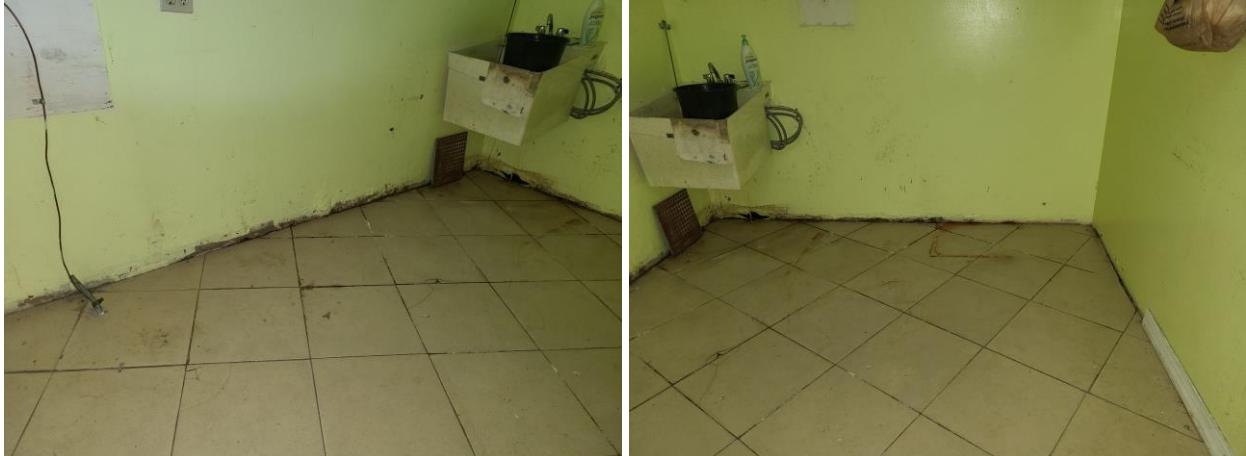
- Along the bottom of the walls there is possible mold and mildew
Refer to General Repair Recommendations #2
