Subject: Elyria Midway Mall Inspection
Store by Store Envelope Inspections
R.E. Warner Project 37422

LORAIN COUNTY PORT AUTHORITY
ELYRIA MIDWAY MALL

R.E. Warner Project No. 37422

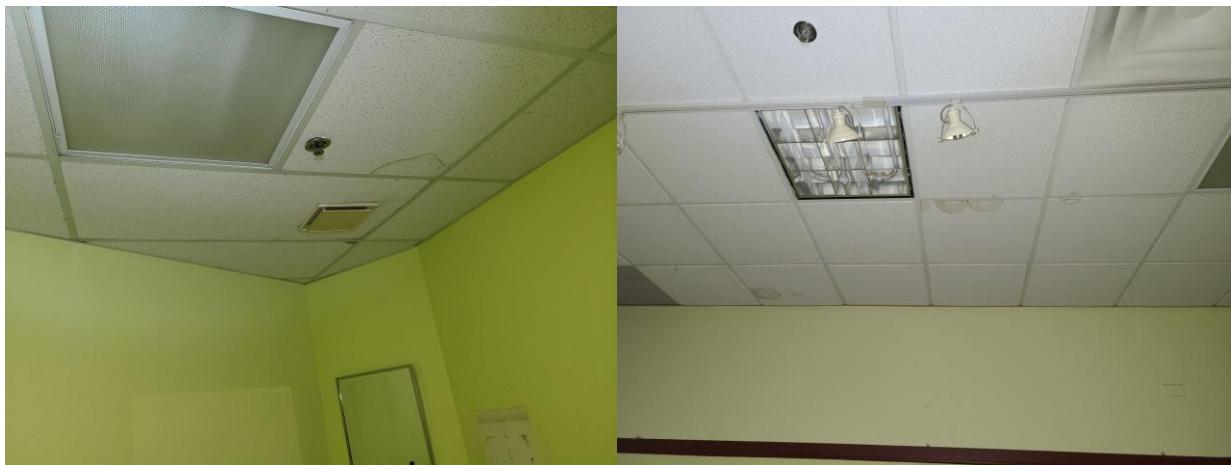
- Minor staining on the ceiling tiles in the main part of the store
Refer to General Repair Recommendations #2, #3, #4 and #8

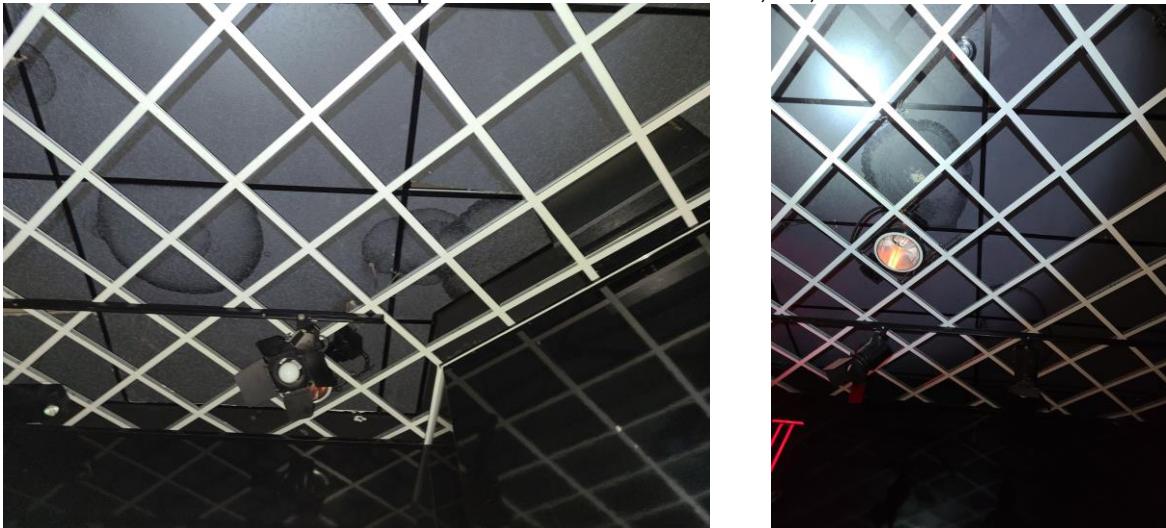
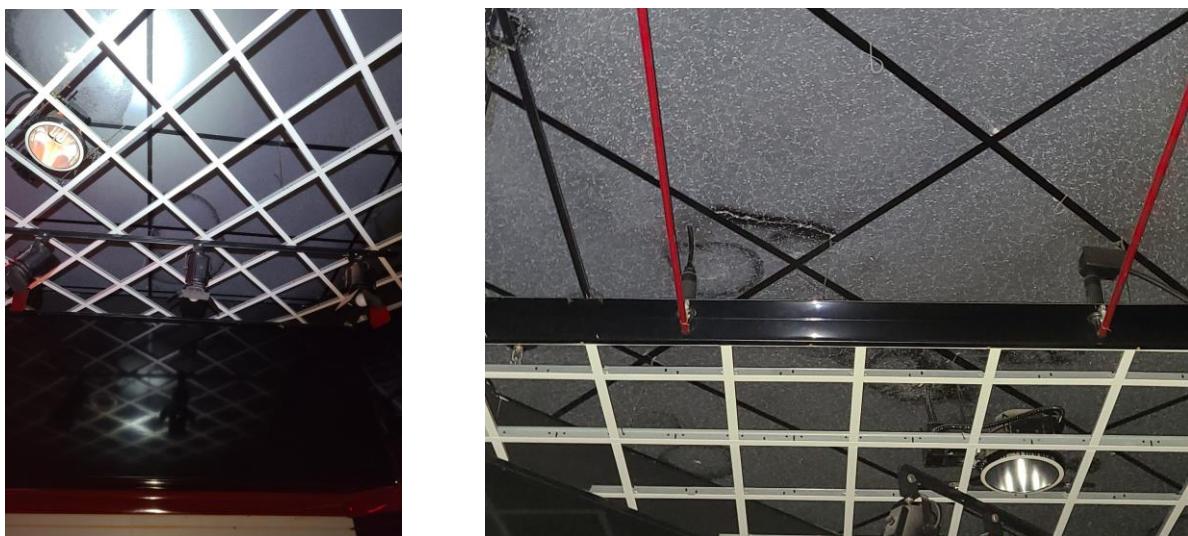
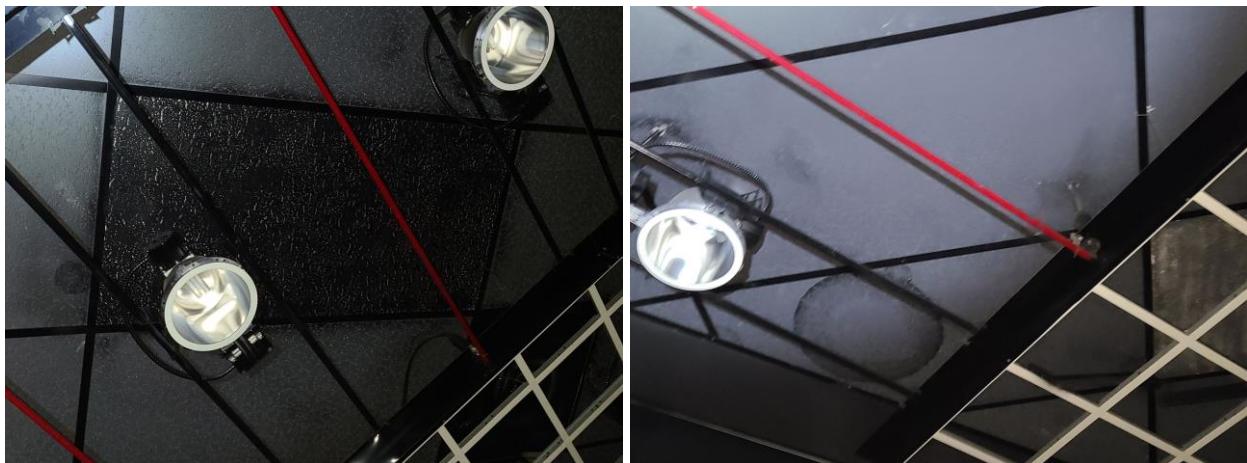
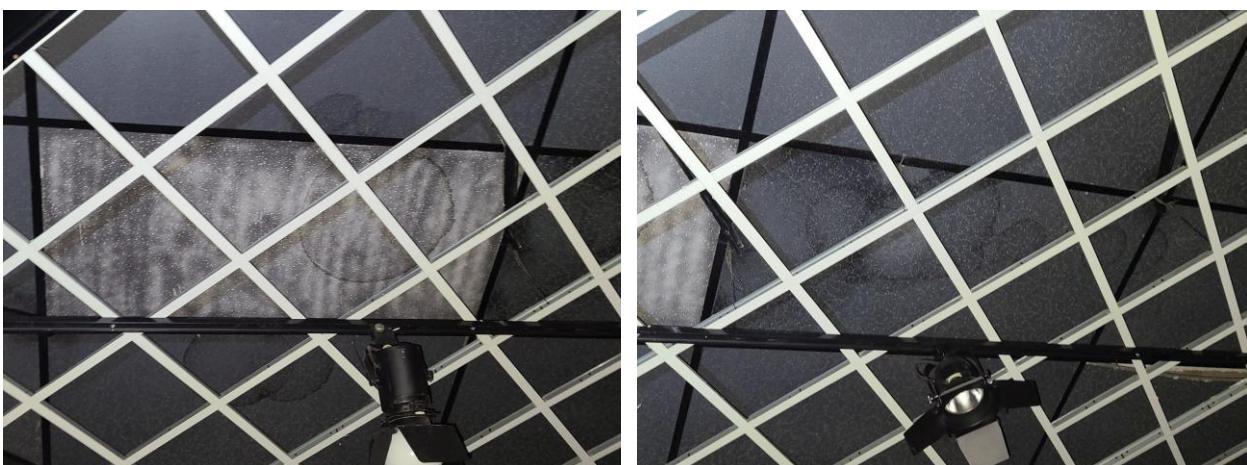
- Near the front of the store random stains on the dark ceiling tiles
Refer to General Repair Recommendations #3, #4, and #8

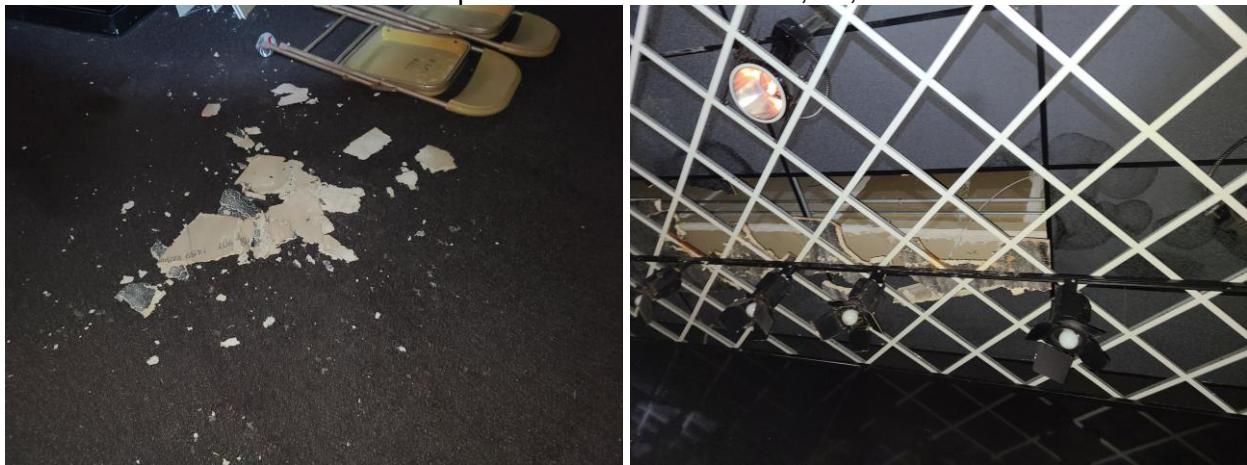
- In the middle of the store random ceiling tiles have fallen due to water damage
Refer to General Repair Recommendations #3, #4, and #8

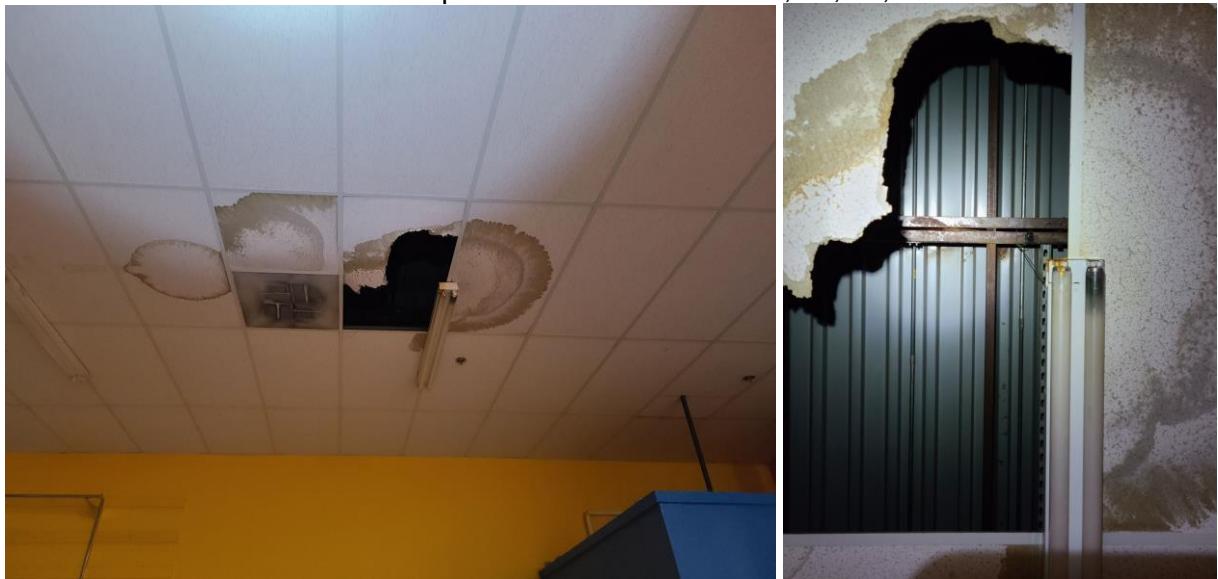
- Some are moderate to heavy staining and the ceiling tile is missing due to water damage
Refer to General Repair Recommendations #2, #3, #4, and #8

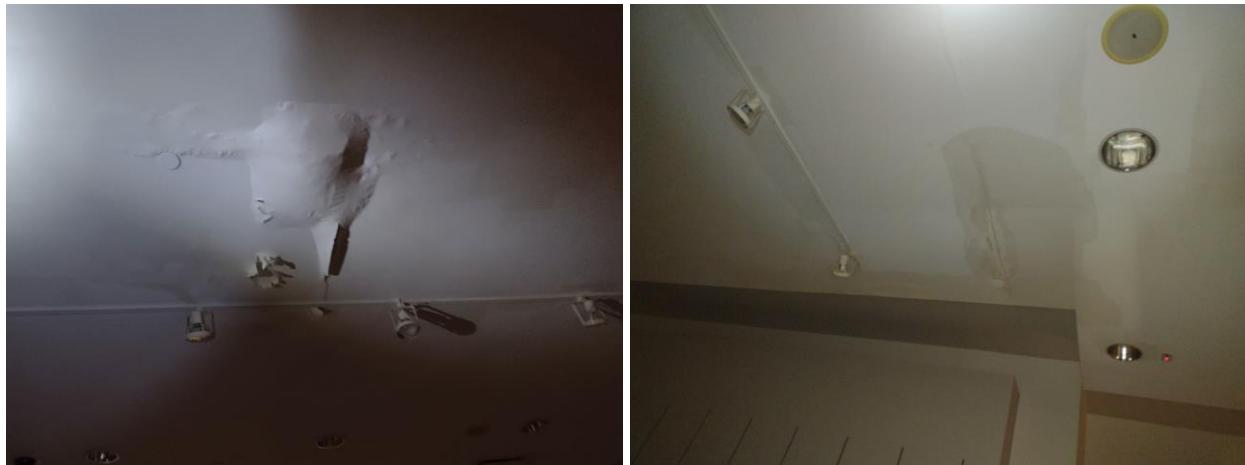
- In the main area there is an area of peeling and blistering paint and an area that was repaired
Refer to General Repair Recommendations #16

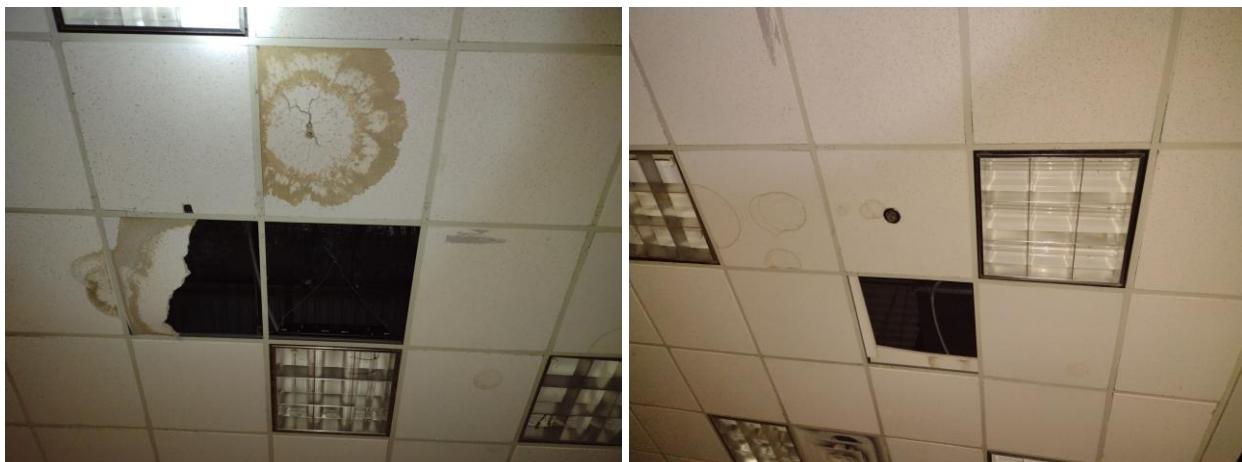
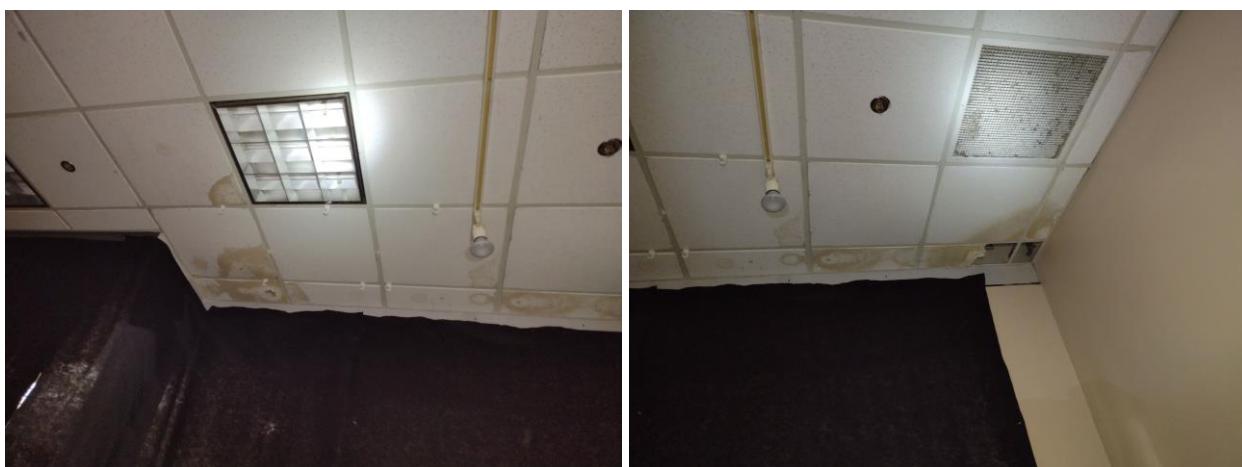
- In the front left and right corners, dark stains, and holes in the ceiling tiles from water damage
Refer to General Repair Recommendations #3, #4, and #8

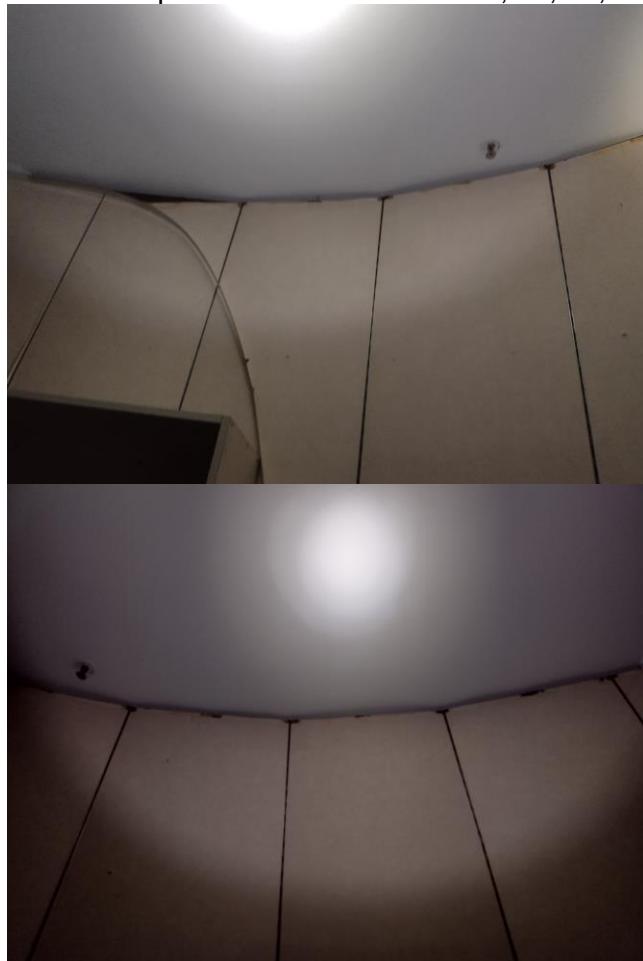
- Near the front of the store, by the 1st column to the right side of the ceiling tile is discolored and damaged
Refer to General Repair Recommendations #2, #3, #4, and #8

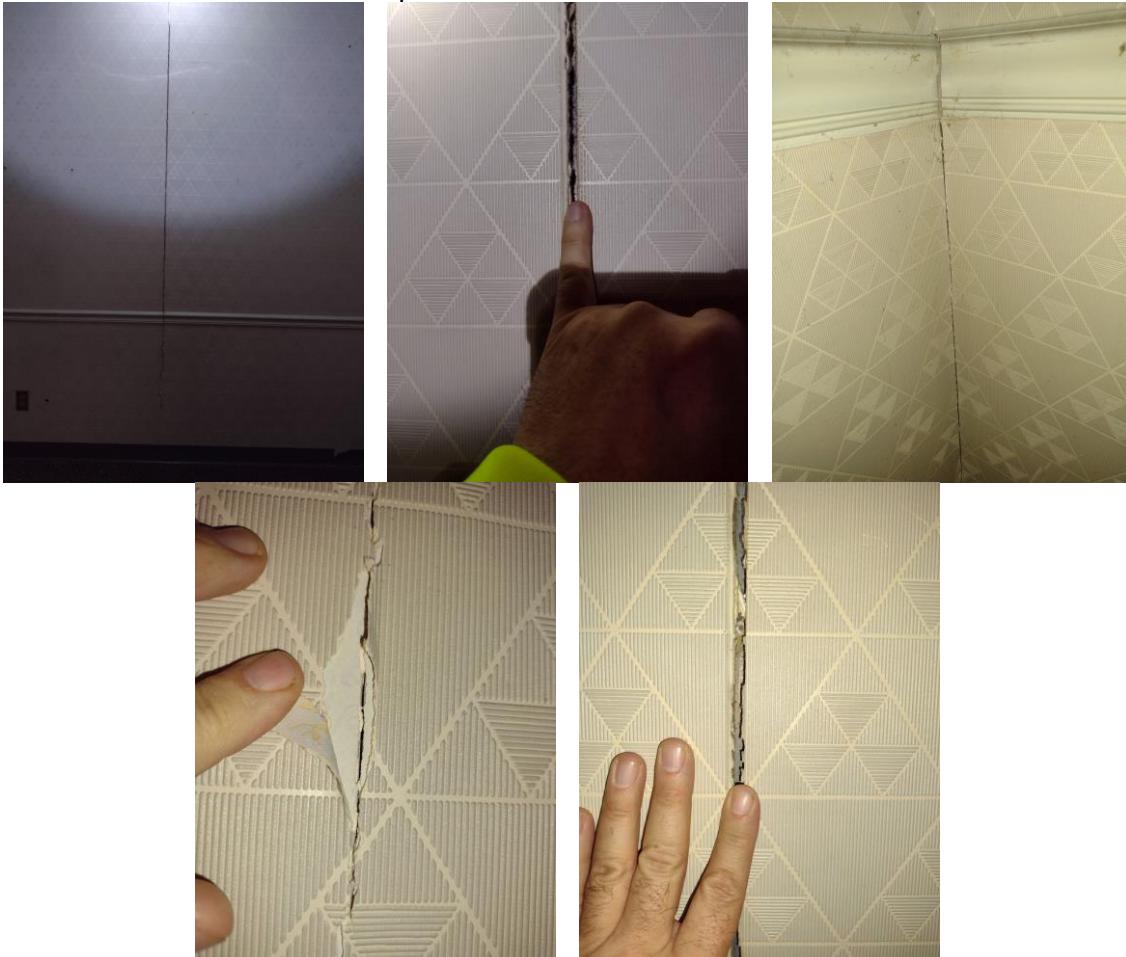
- In the office area, the dry wall is splitting and cracking several places
Refer to General Repair Recommendations #15

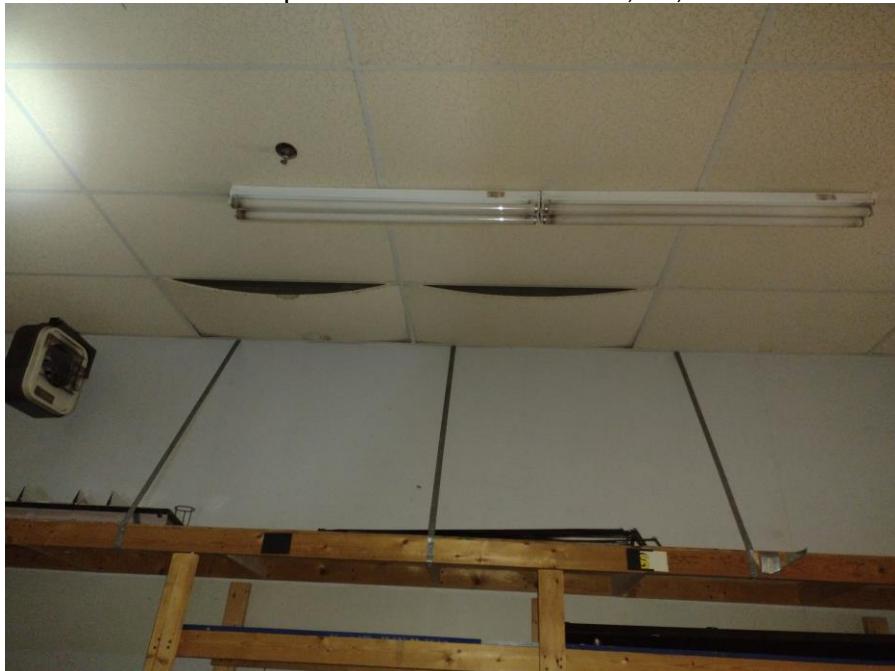
- By the back entrance door, the ceiling tiles are loose, sagging, and missing at random places.
Refer to General Repair Recommendations #3, #4, and #8

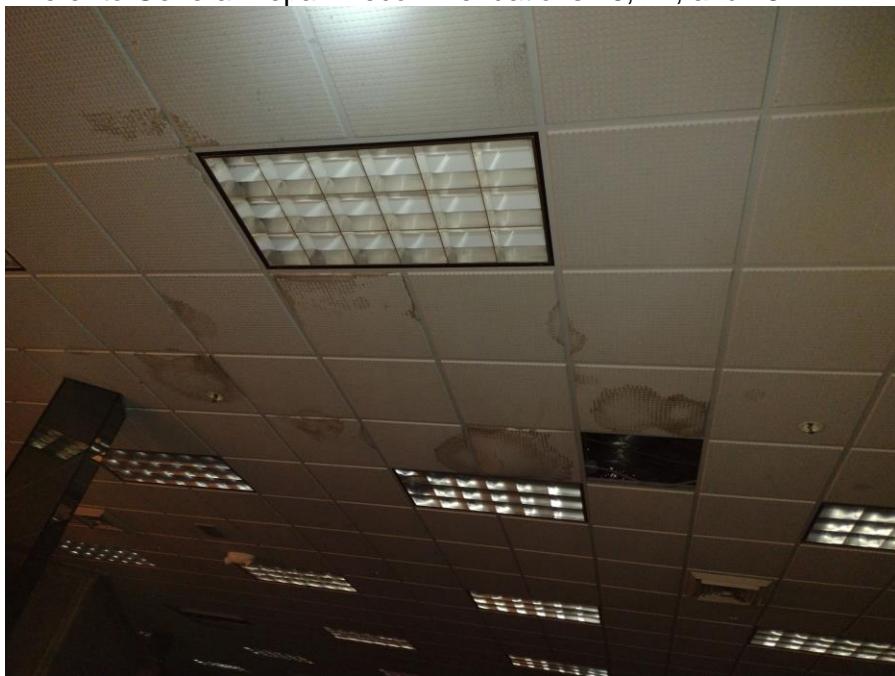
- Several tiles have dark stains from water damage
Refer to General Repair Recommendations #3, #4, and #8

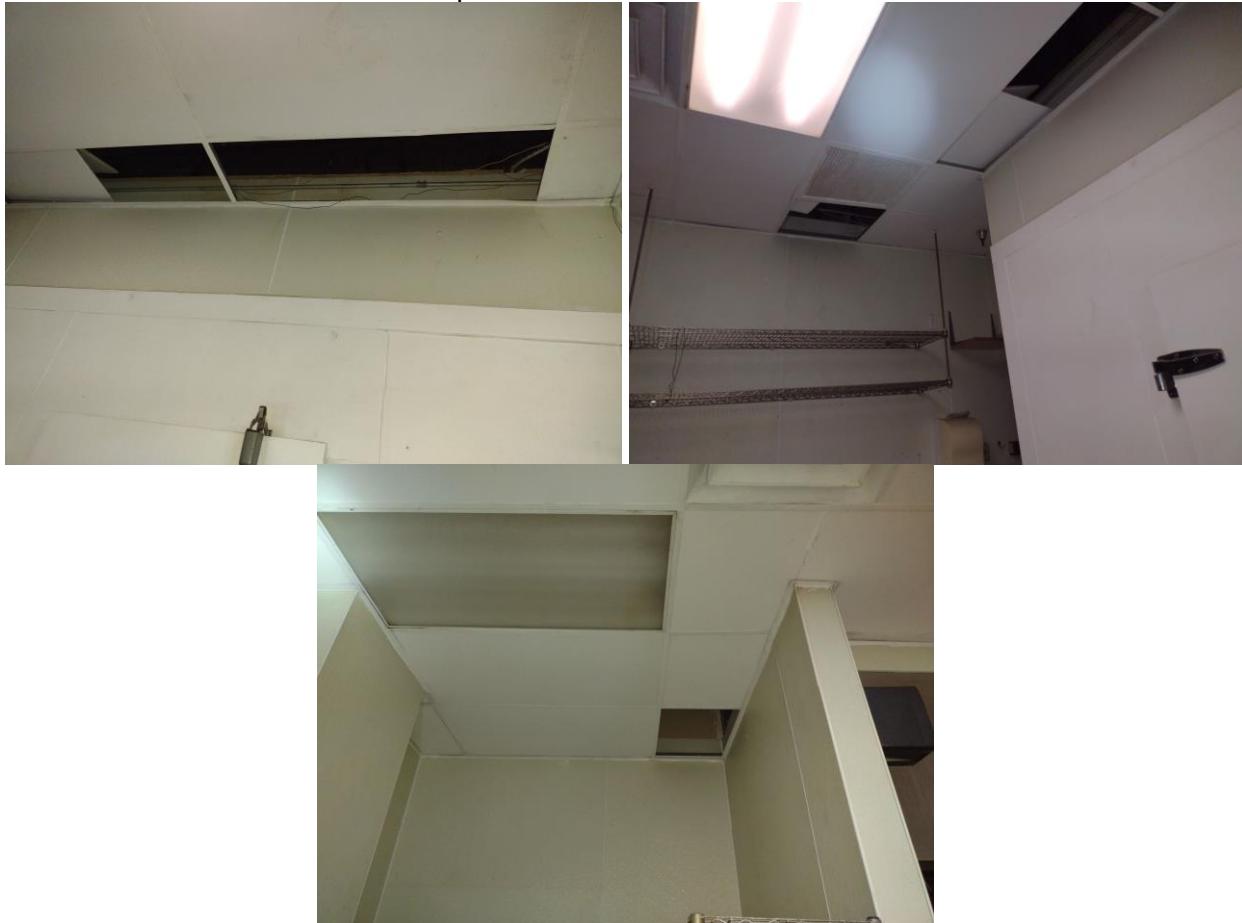
- Random missing ceiling tiles near the back of store and the rear entry door
Refer to General Repair Recommendations #8

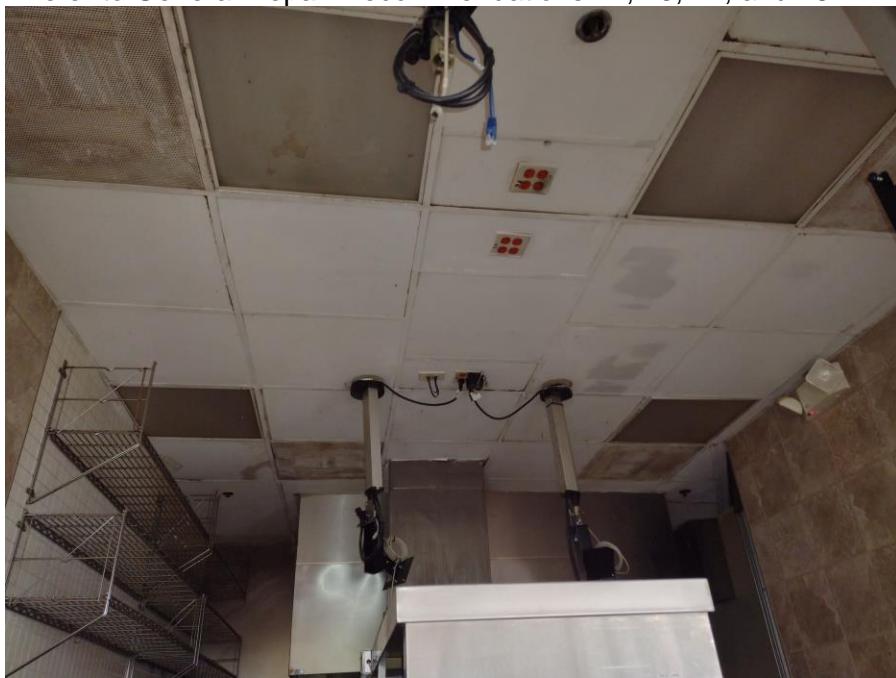
- Random discoloration on the ceiling tiles in the middle.
Refer to General Repair Recommendations #2, #3, #4, and #8

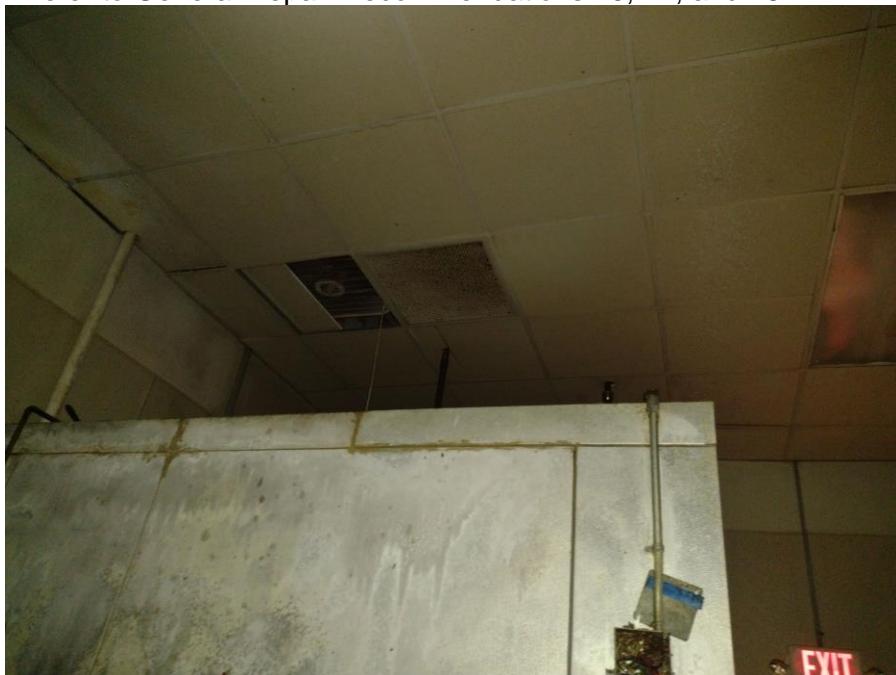
- Lots of discoloration on the ceiling tiles in the cooking area and by the back door
Refer to General Repair Recommendations #3, #4, and #8

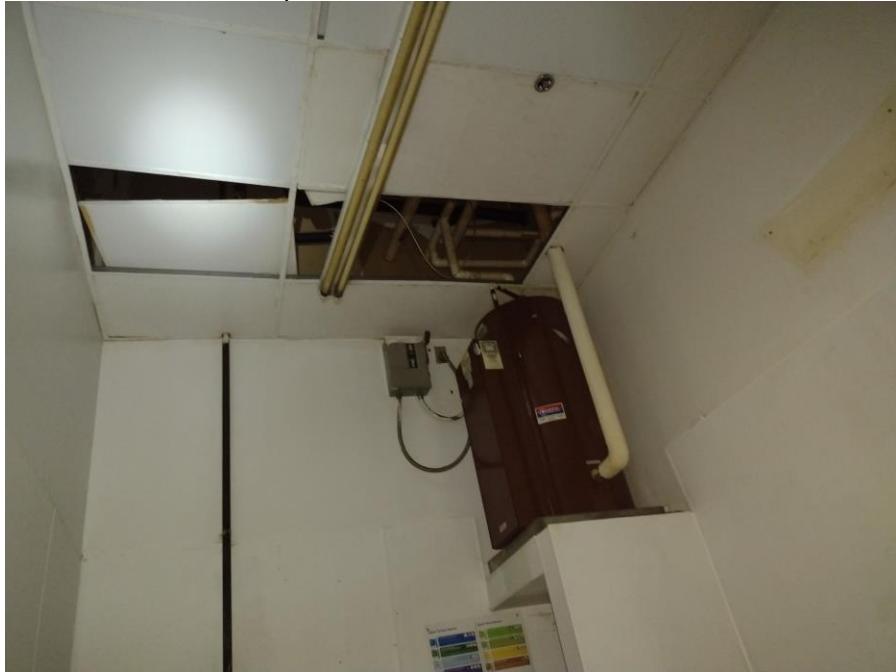
- Near the rear entry door, one ceiling tile is dislodged and one is missing
Refer to General Repair Recommendations #8 and #18

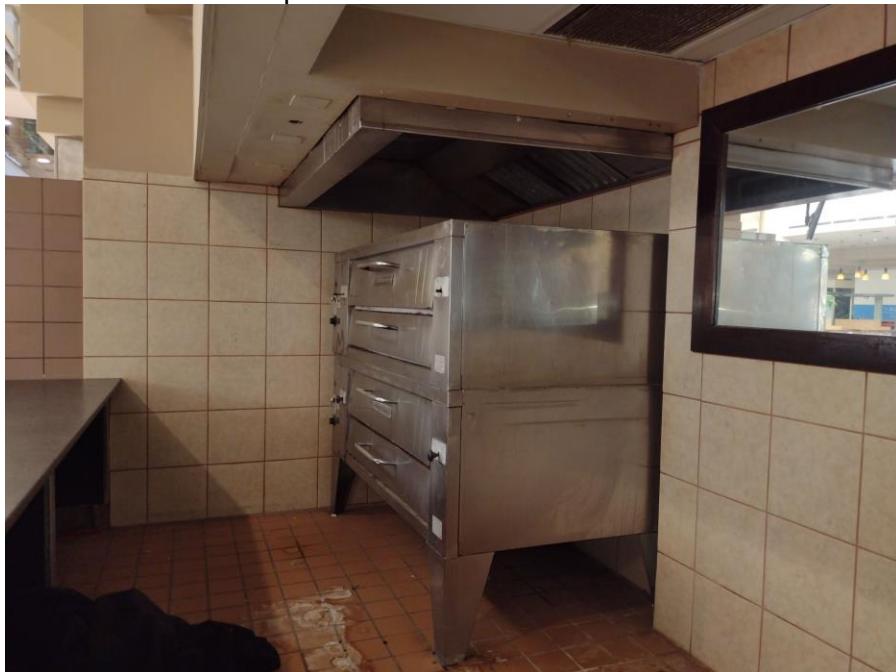
- Typical discoloration of the ceiling tiles
Refer to General Repair Recommendations # 8
