Subject: Elyria Midway Mall Inspection
Store by Store Envelope Inspections
R.E. Warner Project 37422

LORAIN COUNTY PORT AUTHORITY
ELYRIA MIDWAY MALL

R.E. Warner Project No. 37422

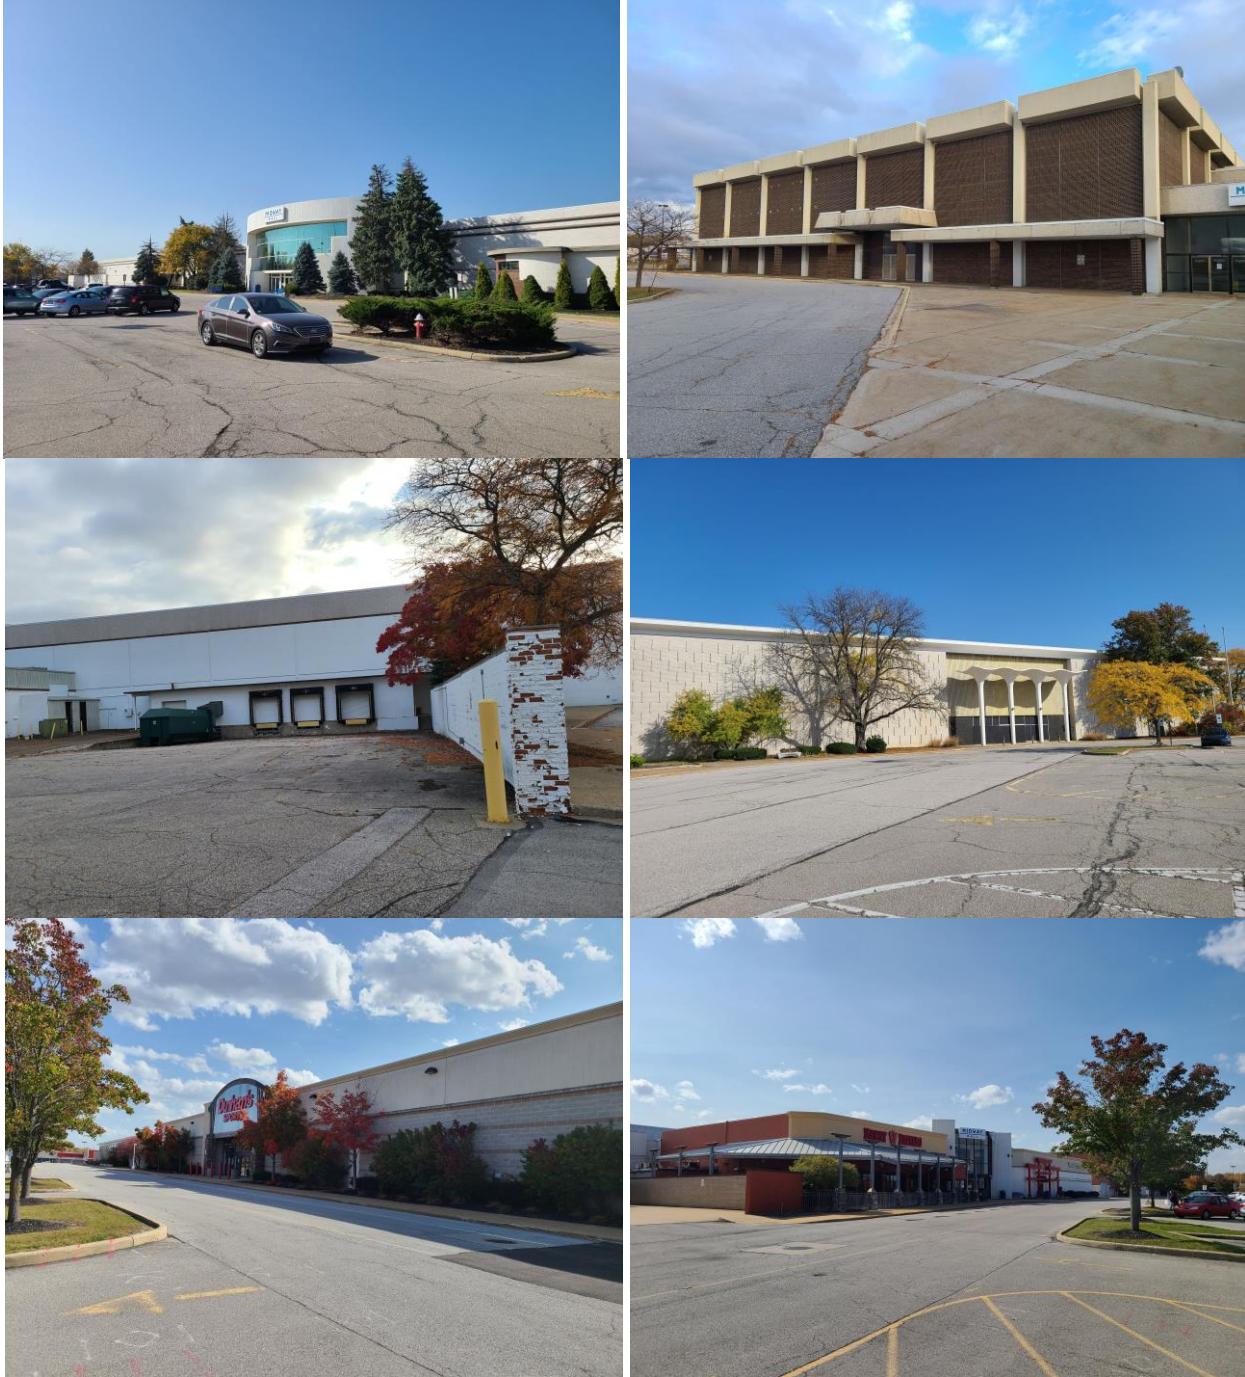
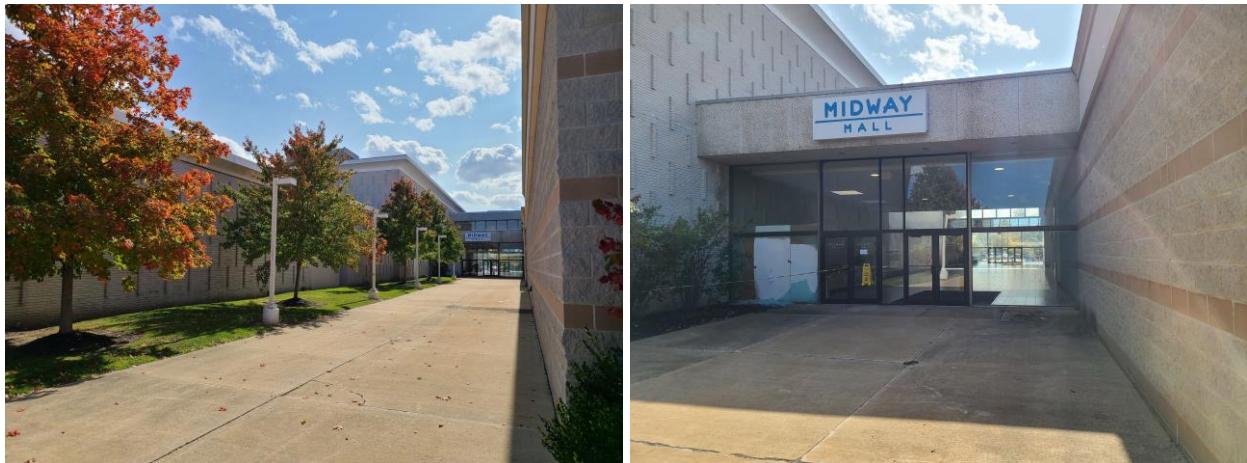
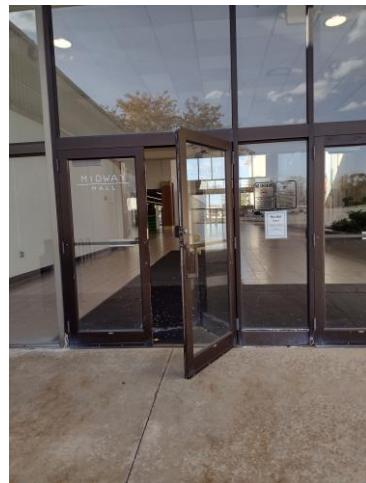
- Typical Outdoor conditions and entrances

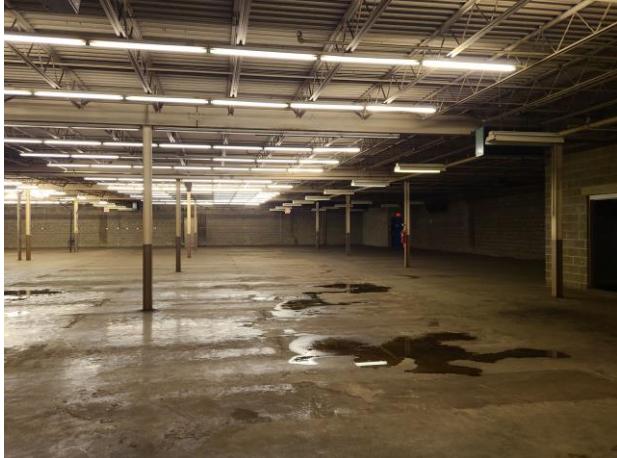
- Overall, Views – in fair to good condition

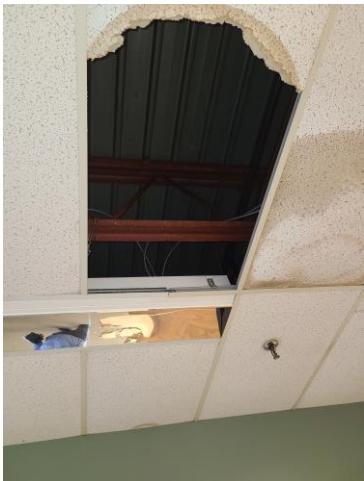
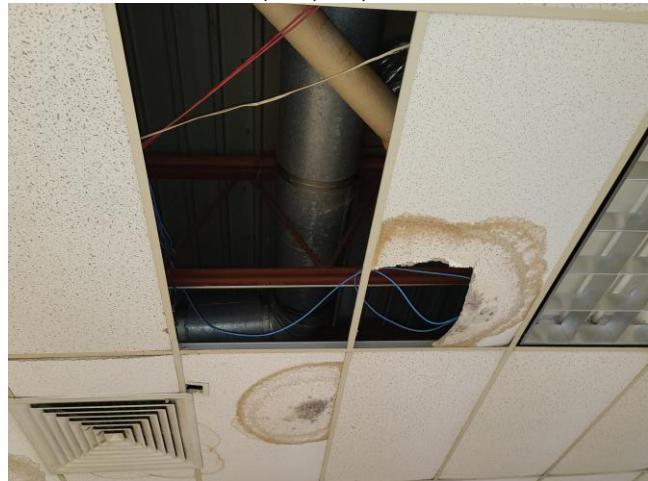
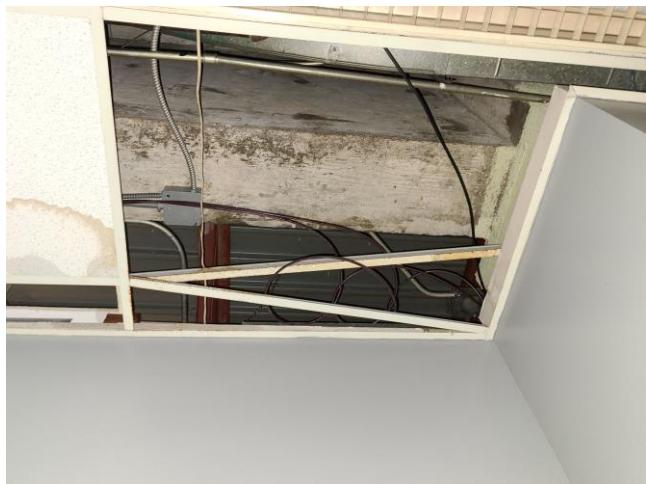
- Rusting roof trusses and ceiling tile broken and stained due to water damage
Refer to General Repair Recommendations #3, #4, #8, and #9

7. Repair concrete floors on a store-by-store basis as necessary.
8. Remove and replace stained and broken ceiling tiles. When removed properly dispose of the materials.

9. Thoroughly clean any rusted roof trusses or structures, once cleaned prime and paint with corrosion resistant coating.
10. Clean ceiling and wall stains using materials and techniques in accordance with current industry standards and ensure there is not a larger issue.

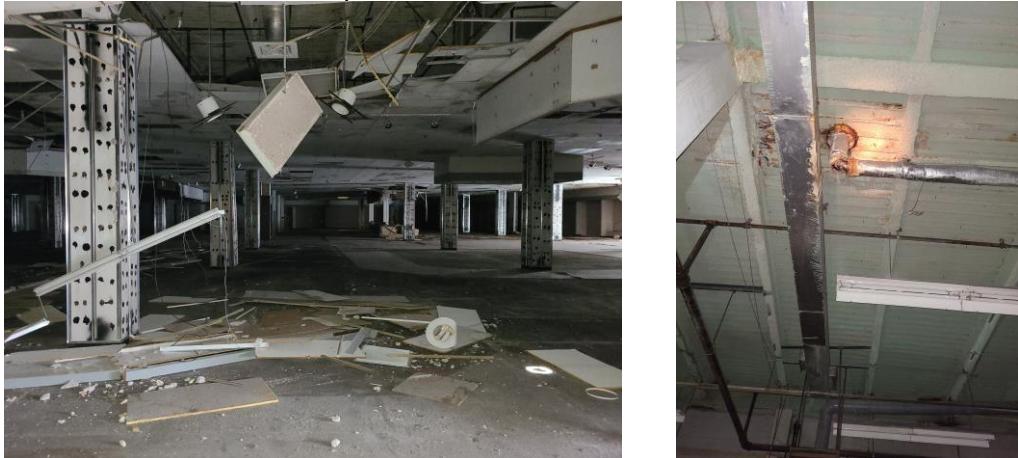
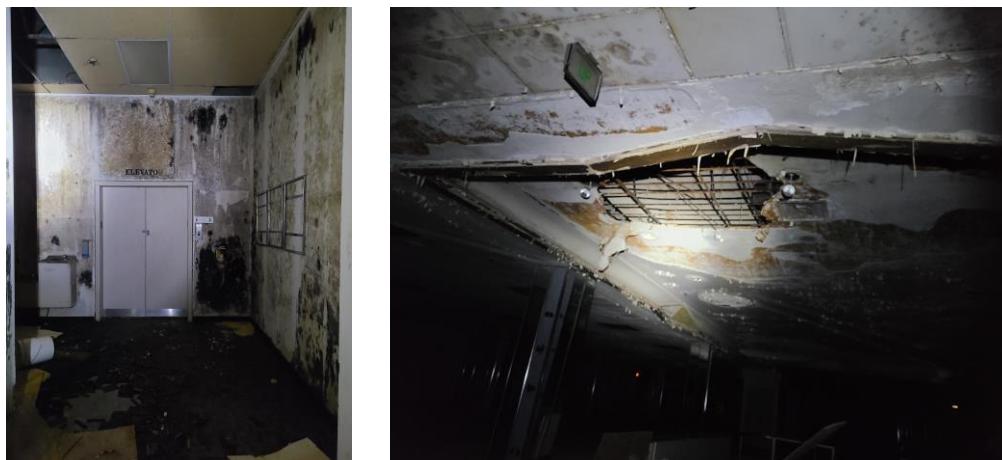
- Building is in very poor condition: water damage, mold, and a large amount of structural damage were noted.

19. The Dillard's (Higbee's) corner store is in poor physical condition. A detailed inspection is required to renovate this structure. The building records indicate that there are asbestos containing materials, and these must be abated whether the building is to be refurbished or demolished.

Refer to General Repair Recommendations #1 and #19

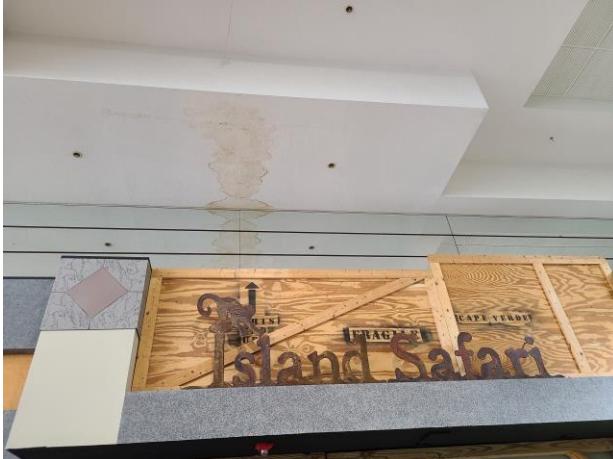
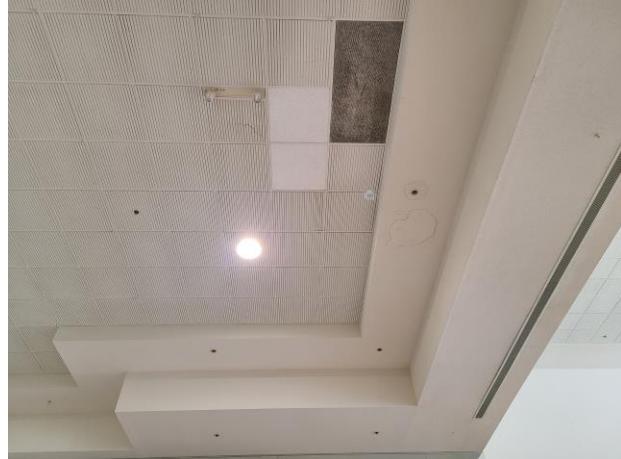
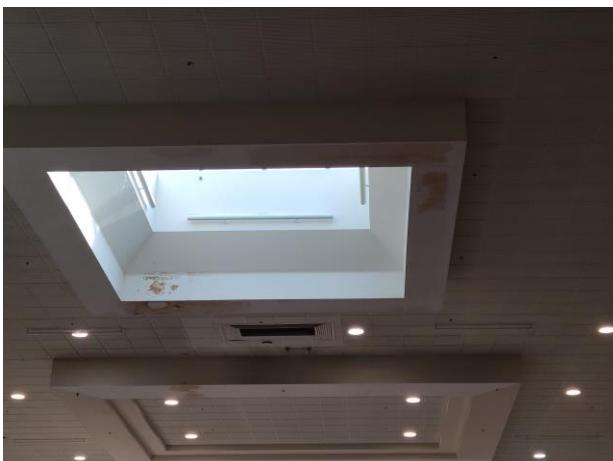
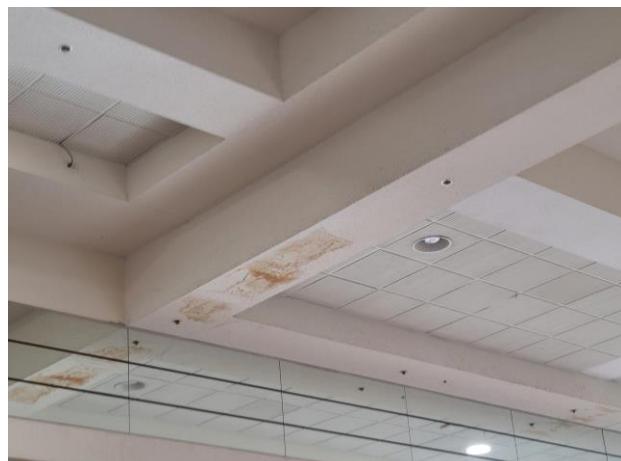
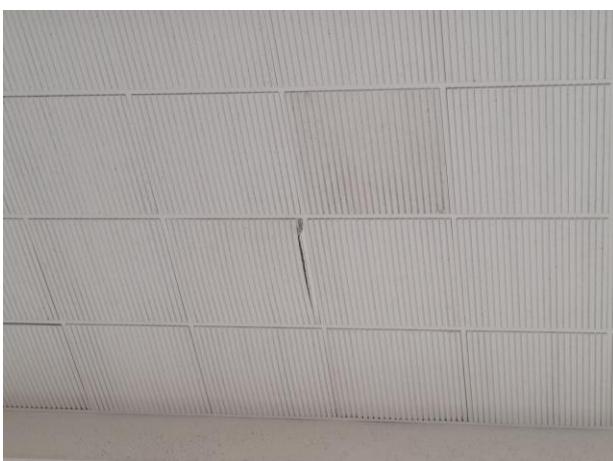
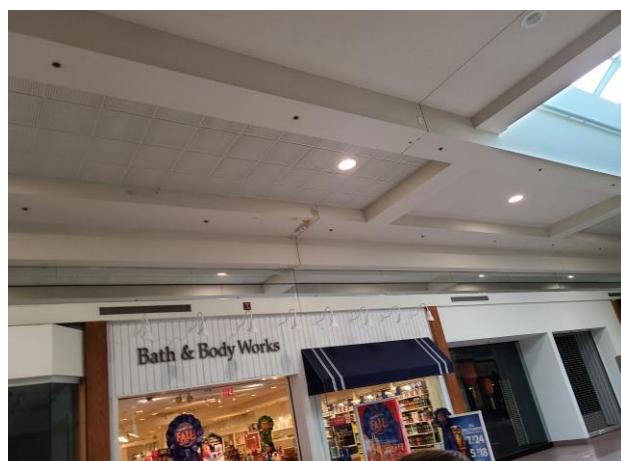
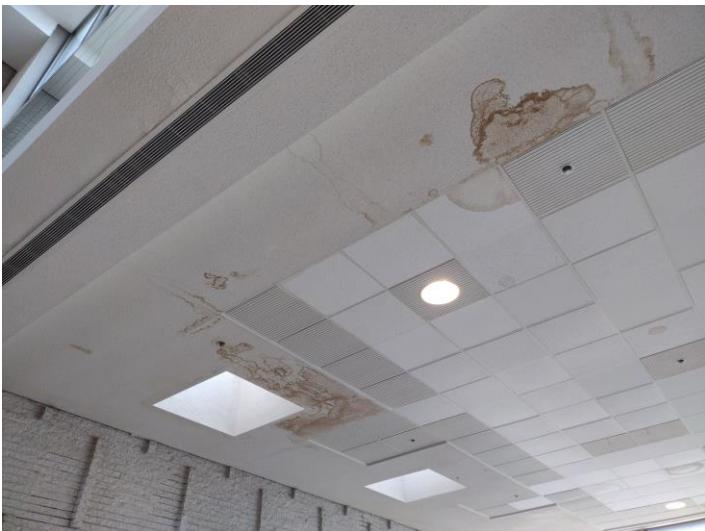
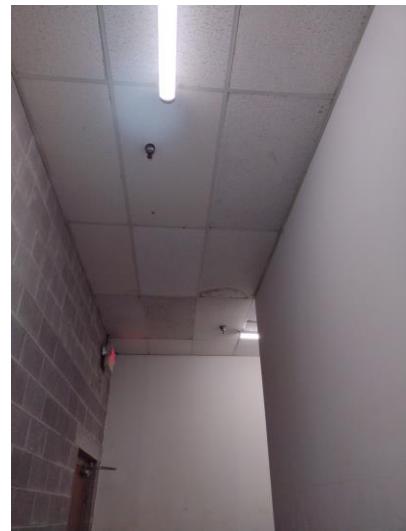
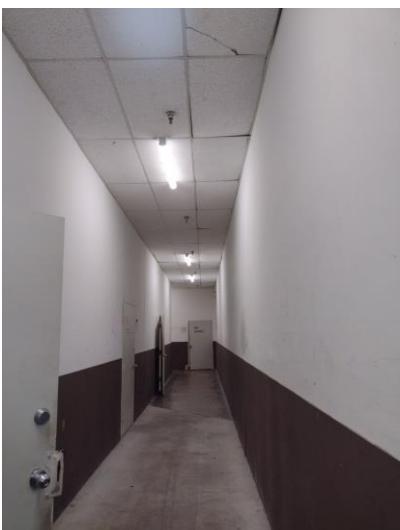
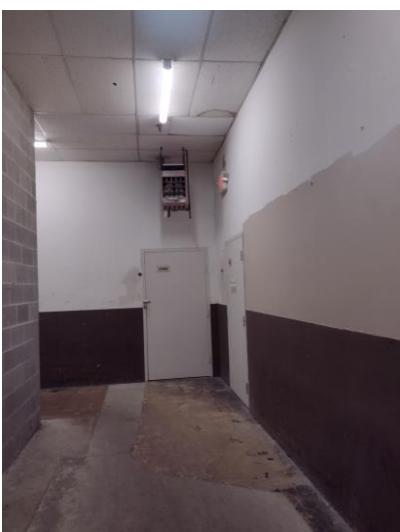
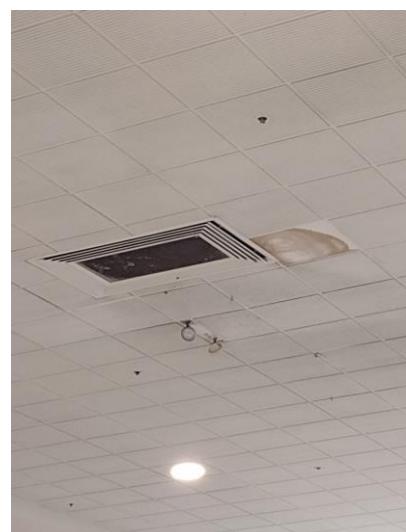
- Random ceiling stains throughout the building
Refer to General Repair Recommendations #4 and 10

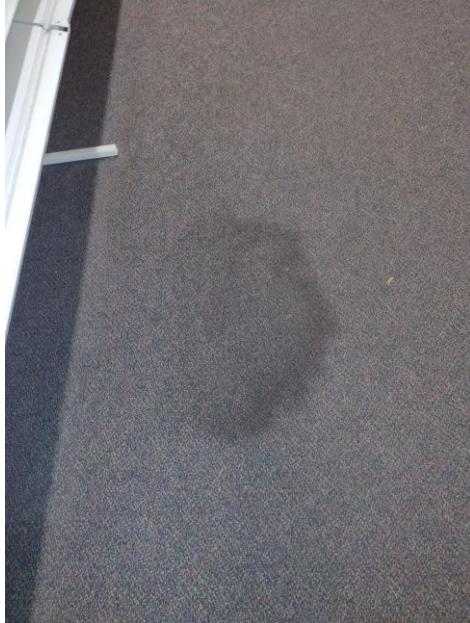
- Carpeting is in Fair condition
Refer to General Repair Recommendations #6

5. Repair or replace all exterior and interior entry doors for security and safety precautions.
6. Repair or replace damaged floor coverings on case-by-case basis.

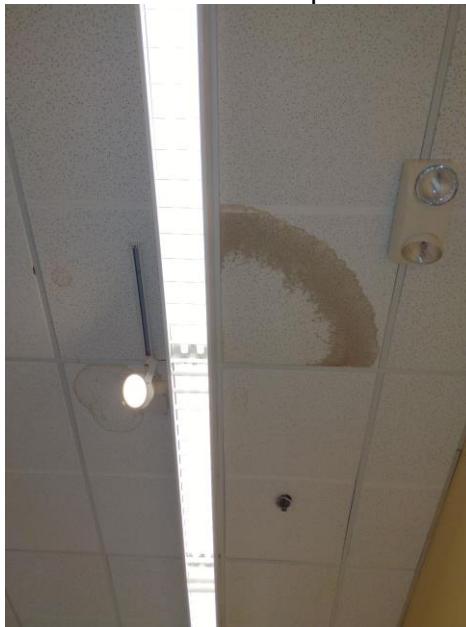
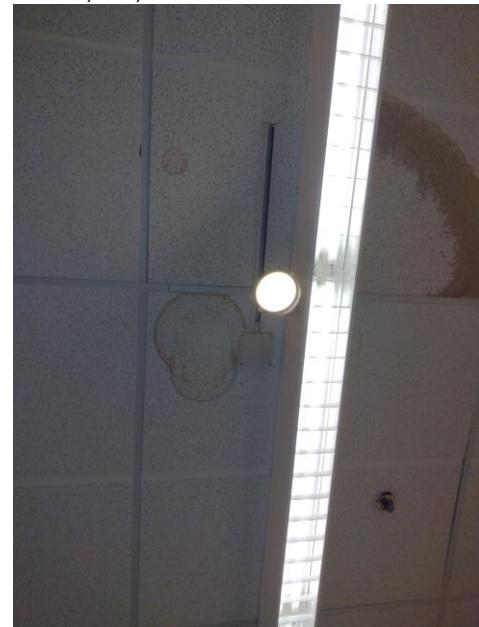
- Ceiling (4) areas with stained tiles
Refer to General Repair Recommendations #3, #4, and #8

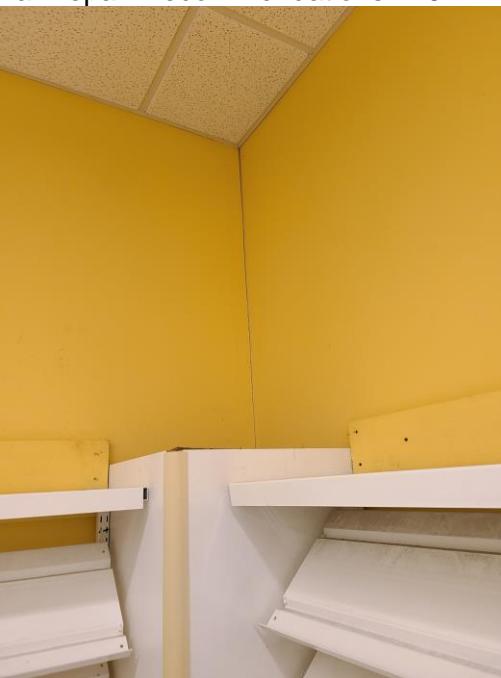
- At the Southwest Corner the wall is cracked
Refer to General Repair Recommendations #15

13. Remove or replace fixed ladders to ensure certification and safety
14. Repair to avoid exposed wires and electrical boxes
15. Fill and fix any wall cracks or holes in kind especially on load bearing and exterior walls

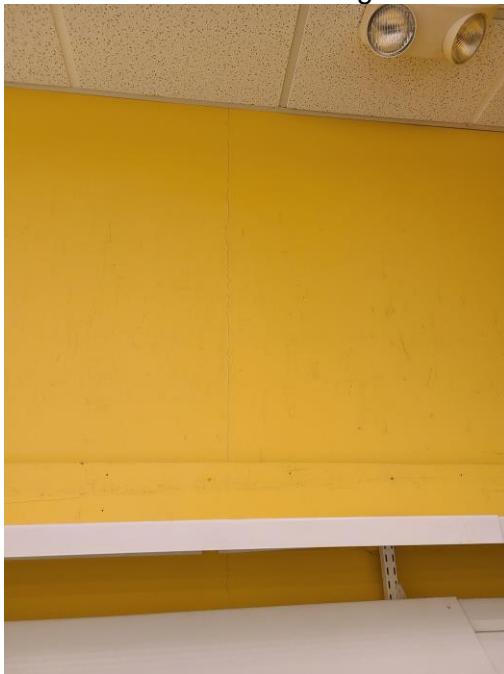
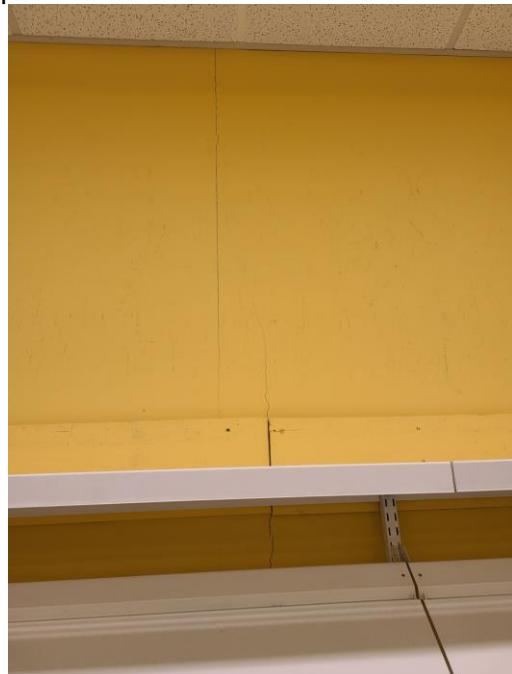
- Along the East Wall near the rear door and Midpoint of the wall, the wall is cracked full height Refer to General Repair Recommendations #15

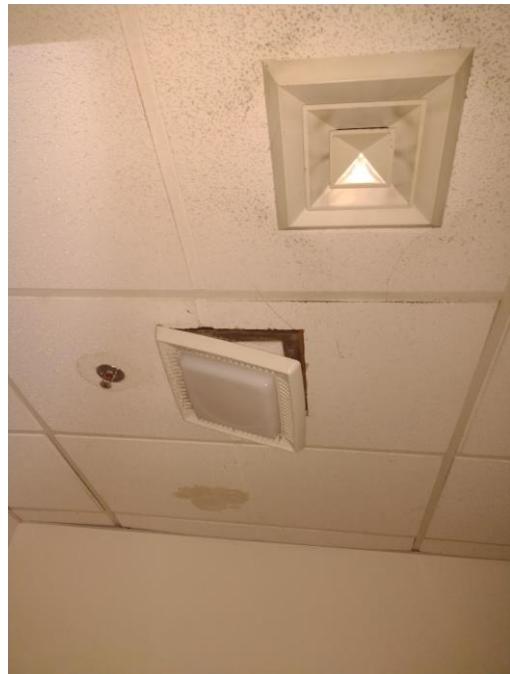
- Employee Restroom- signs of roof leaks
Refer to General Repair Recommendations #4 and #12

3. Remove and properly dispose of all dirt, debris and loose or damaged construction materials.
4. Inspect and repair roof leaks to prevent further damage.

11. Clean or replace any Air vent covers using materials and techniques in accordance with current industry standards.
12. Repair or replace any disconnected or broken ceiling fixtures

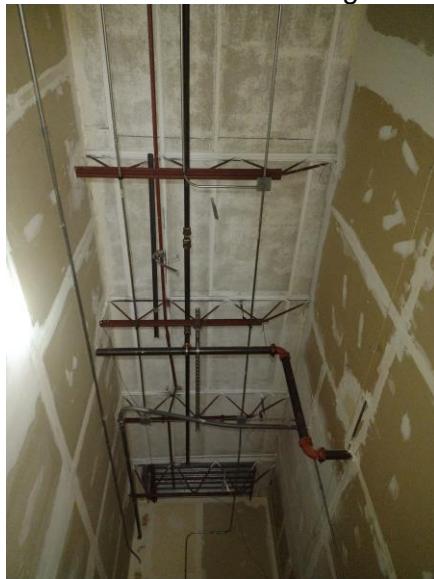
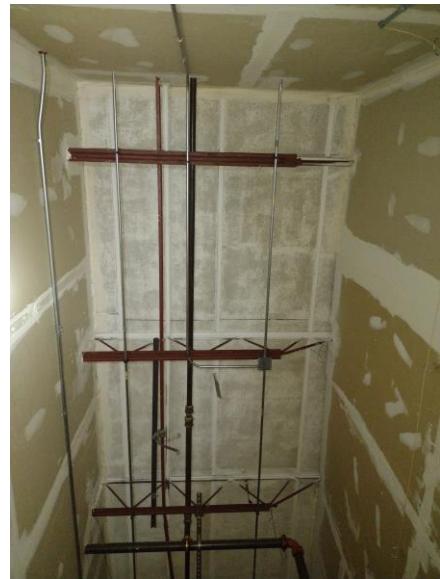
- Roof Trusses are in good condition

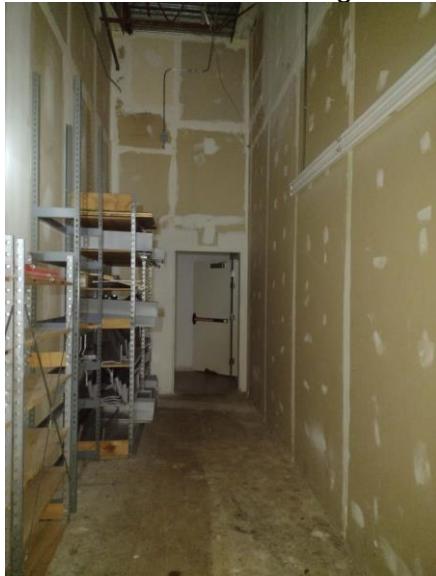
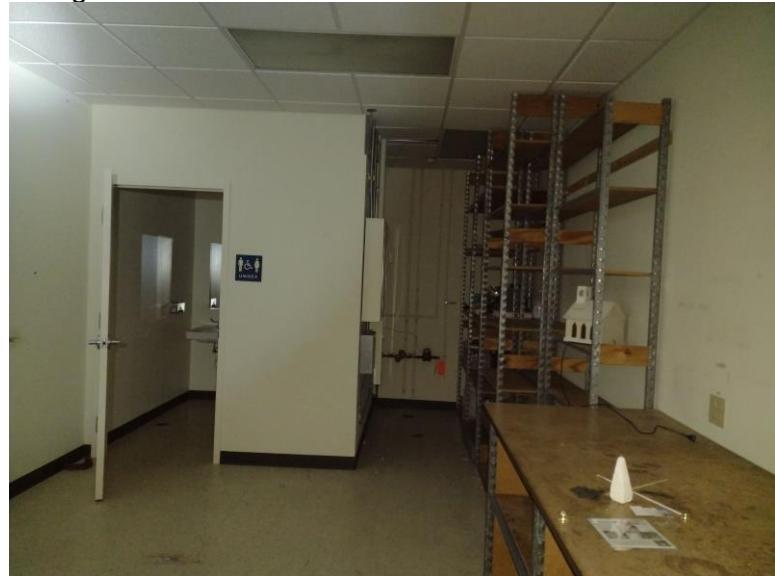
- Rear Storage areas are in good condition

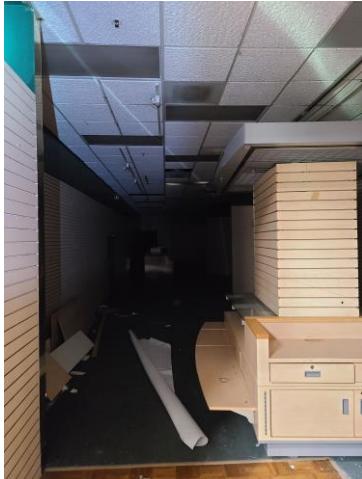
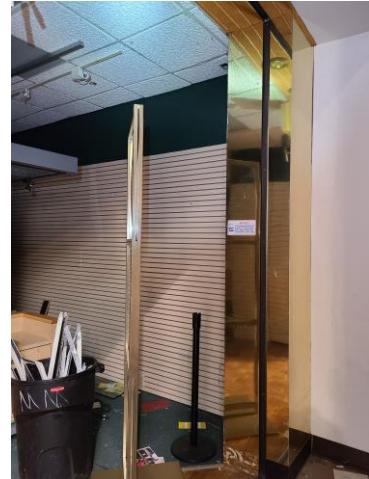
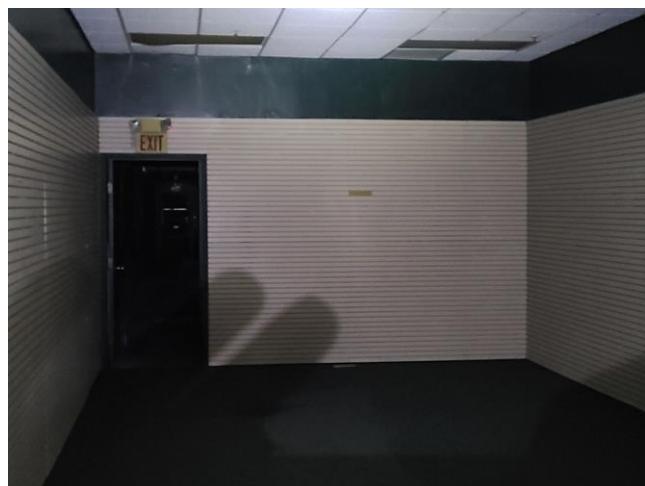
- Small store with Dark Green and tab slat walls

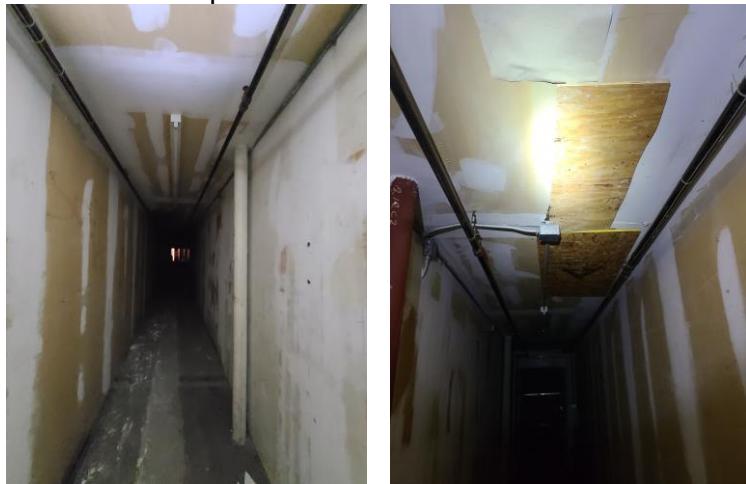
- Rear Storage and entry hall is in poor condition
Refer to General Repair Recommendations #12 and #16

16. Repair and repaint any areas where paint is peeling or coming off
17. Demo and replace furnace and incinerator
18. Repair or replace in-kind any damaged or leaking hot water tanks

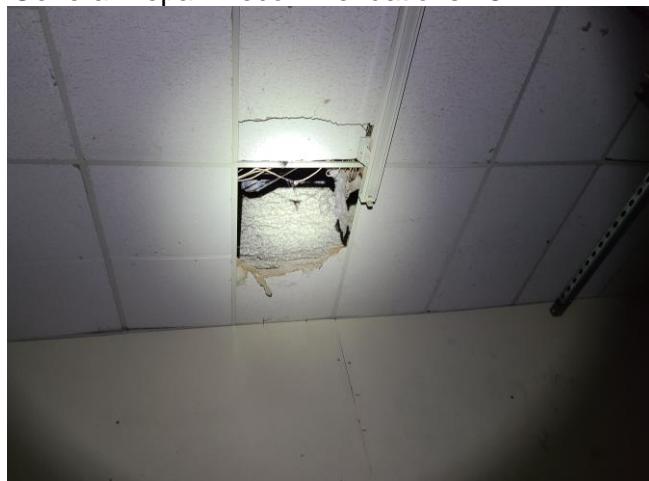
- Ceiling is collapsed in (3) areas continued
Refer to General Repair Recommendations #8

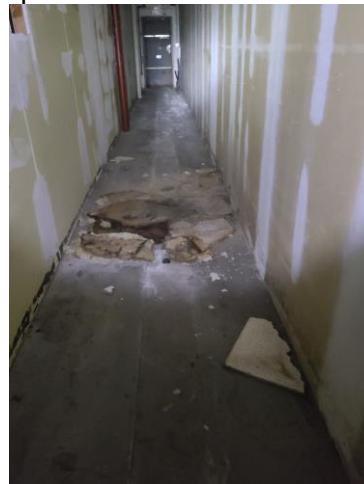
- Signs of major roof leaks

Refer to General Repair Recommendations #3, #4, and #8

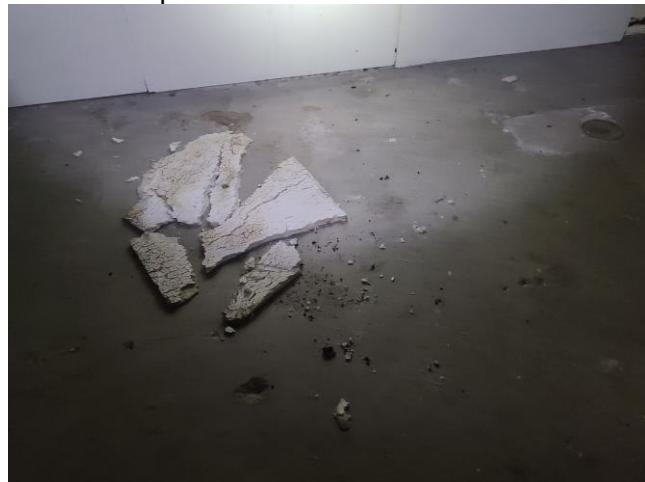
- Spray on insulation material falling

Refer to General Repair Recommendations #3

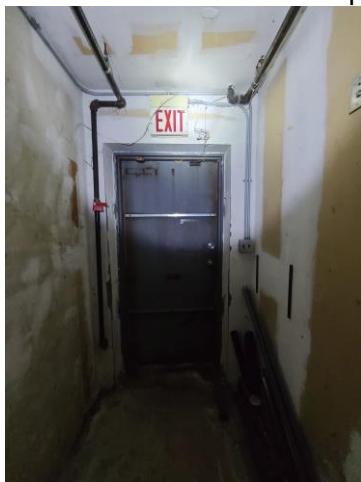
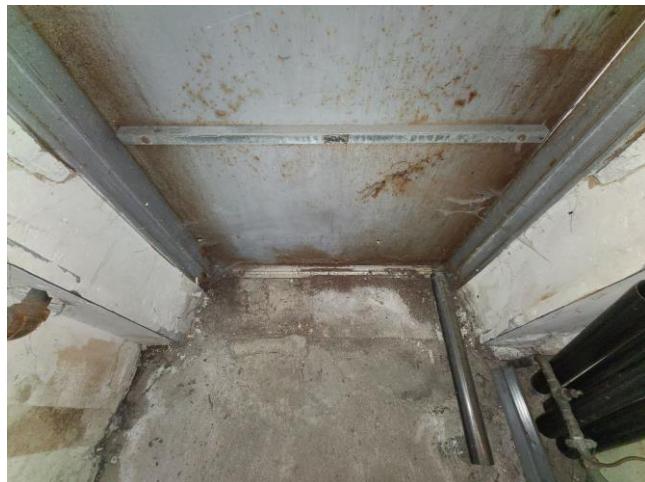
- Rear door and doorway are in poor condition

Refer to General Repair Recommendations #5

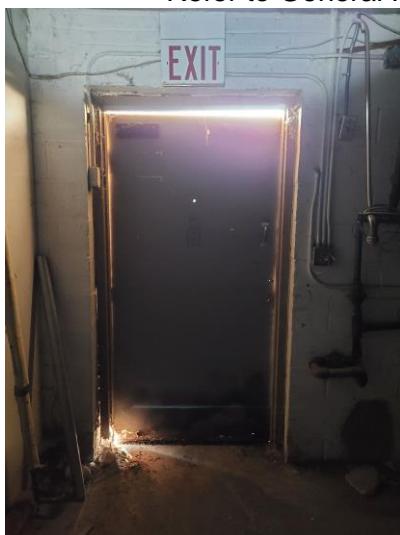
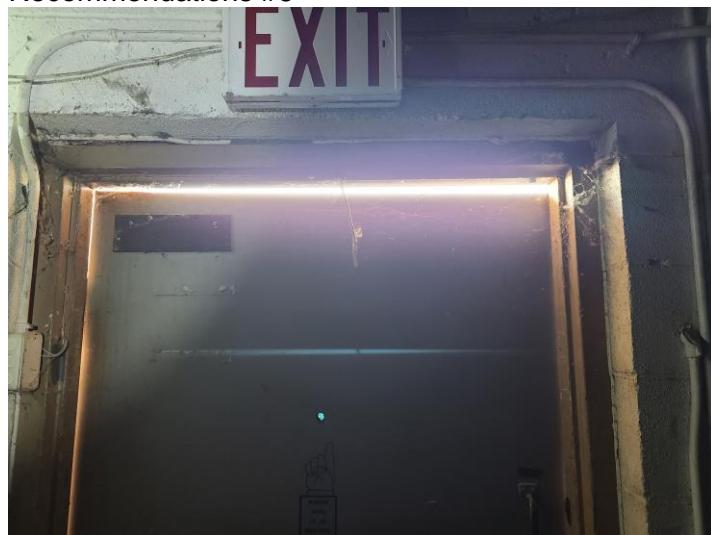
- The Rear entry door is in poor condition
Refer to General Repair Recommendations #5

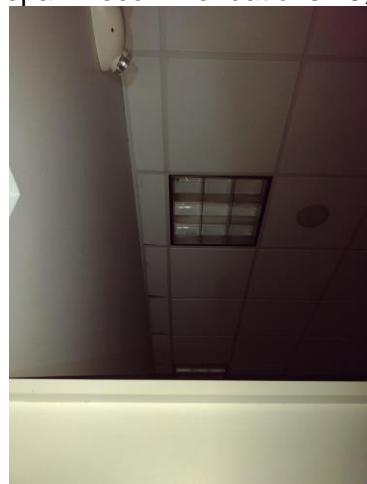
- Ceiling has random warped and stained tiles
Refer to General Repair Recommendations #3, #4, and #8

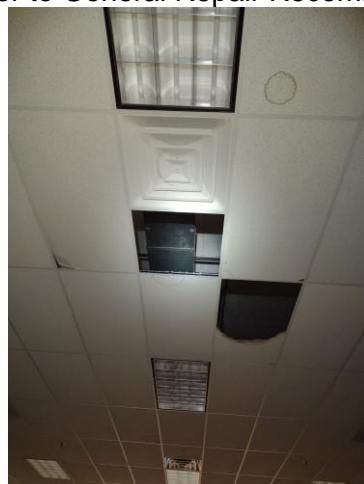
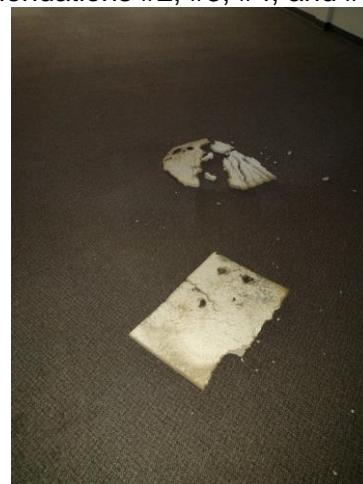
- At the middle rear of the store (2) tiles collapsed from roof and water leaks
Refer to General Repair Recommendations #2, #3, #4, and #8

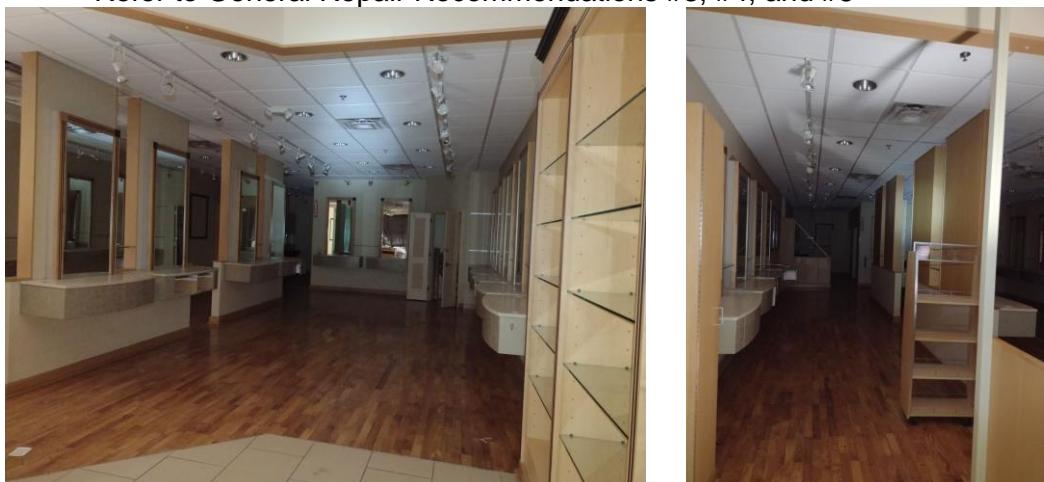
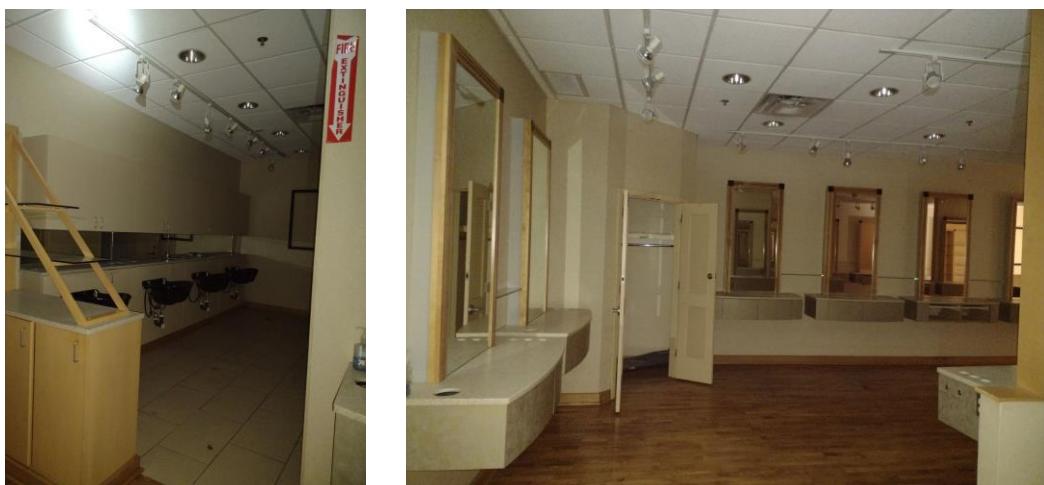
- Random Stained Ceiling Tiles
Refer to General Repair Recommendations #3, #4, and #8

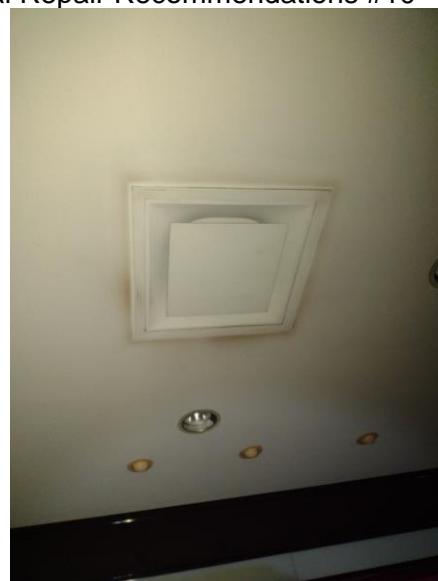
- Minor Discoloration around HVAC vents in the ceiling
Refer to General Repair Recommendations #10

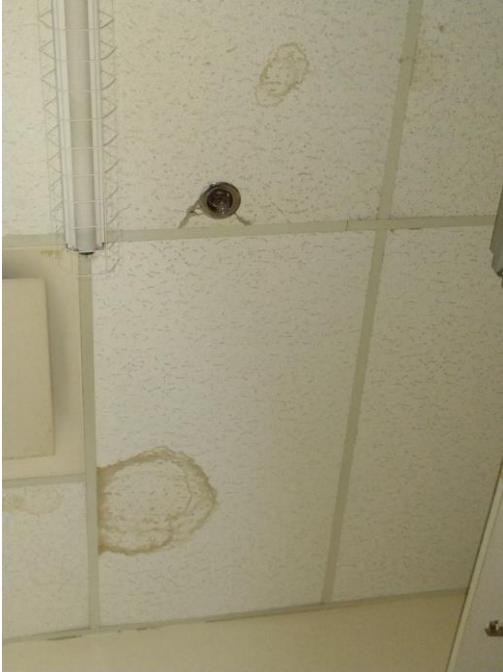
- Random Stained Ceiling Tiles
Refer to General Repair Recommendations #3, #4, and #8

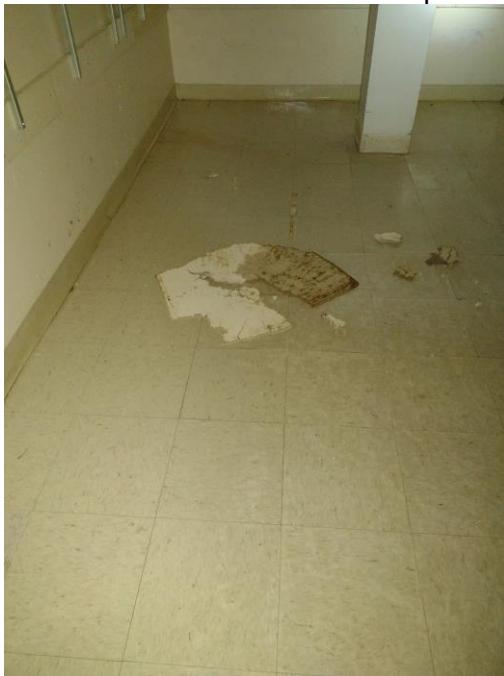
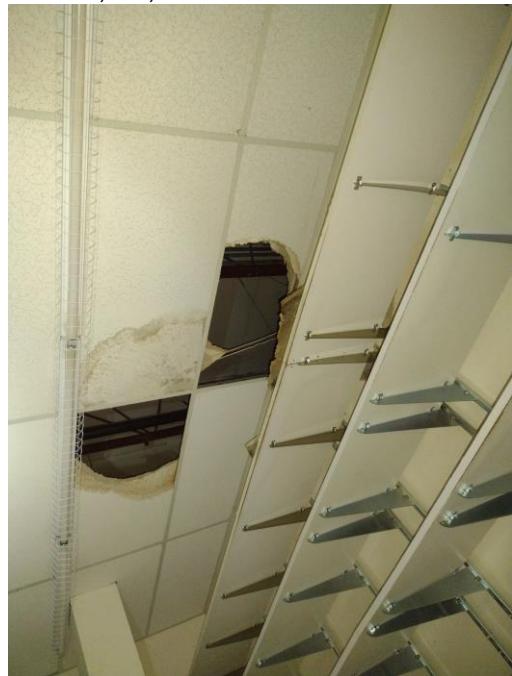
- One area has collapsed tiles in the storage area
Refer to General Repair Recommendations #3, #4, and #8

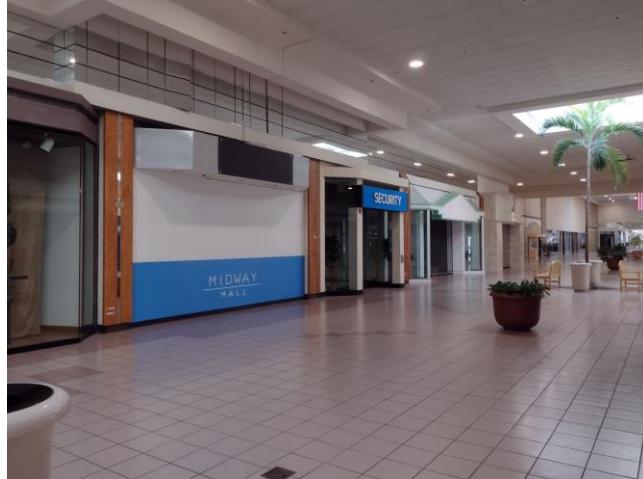
18.0 4388 - SECURITY OFFICE

- Front of the Office is in good condition

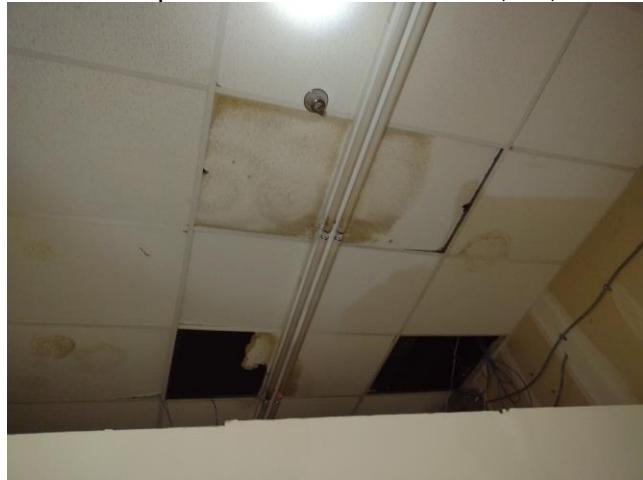
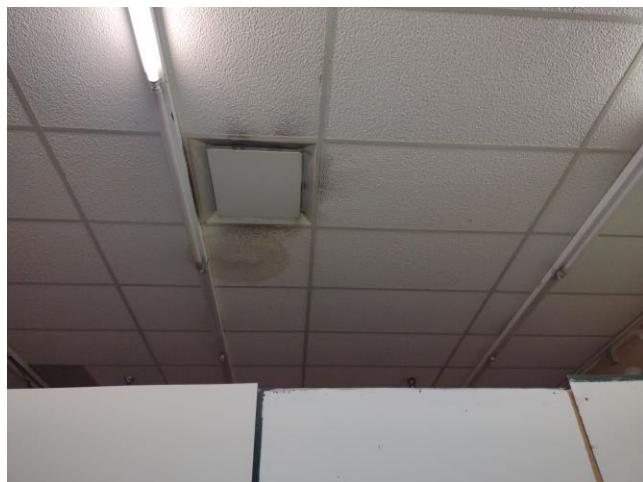
- Rear of the office has random stained ceiling tiles
Refer to General Repair Recommendations #3, #4, and #8

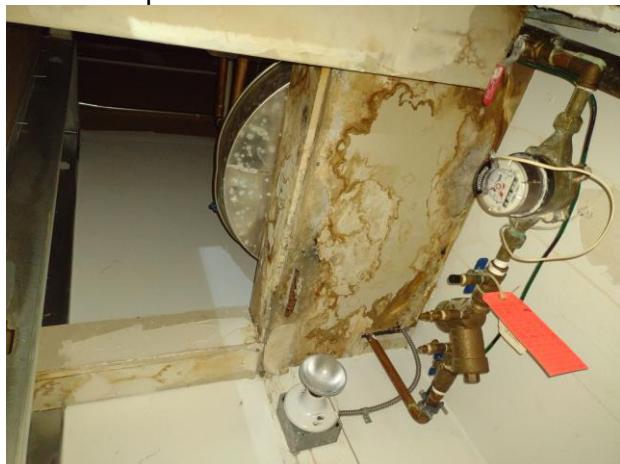
- Hot water Tank in bathroom
Refer to General Repair Recommendations #18

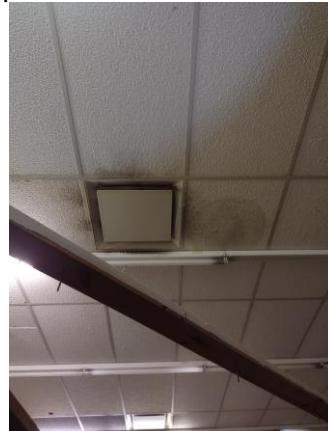
20.0 CUTTER'S CORNER-FKA LADIES FOOTLOCKER

- Typical random stained ceiling tiles, store in good condition
Refer to General Repair Recommendations #3, #4, and #8

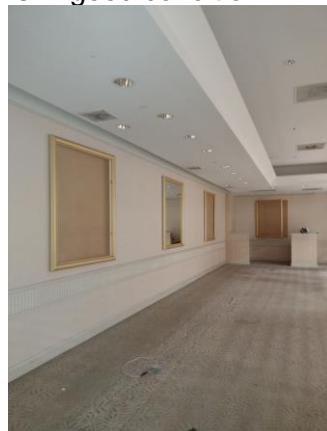
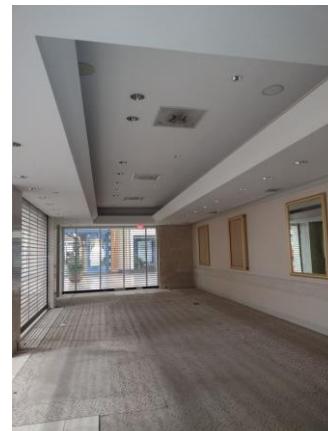
21.0 ROGERS JEWELERS

- Store is in good condition

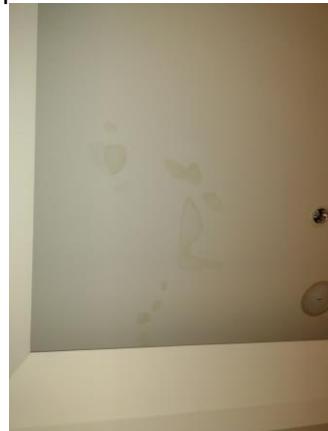
- Staining on the ceiling
Refer to General Repair Recommendations #4 and #10

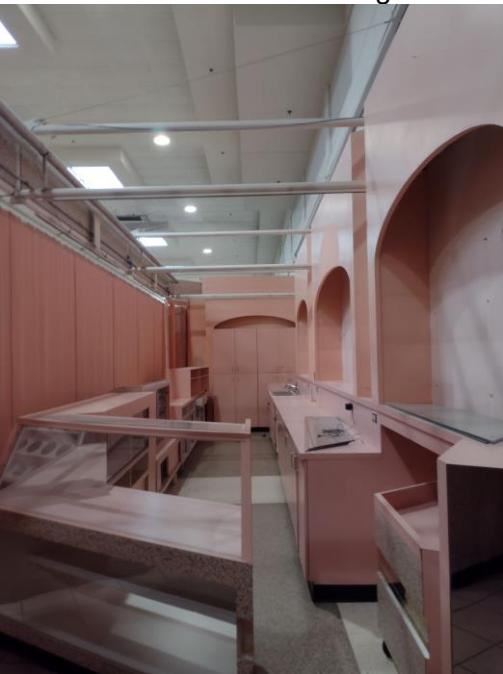
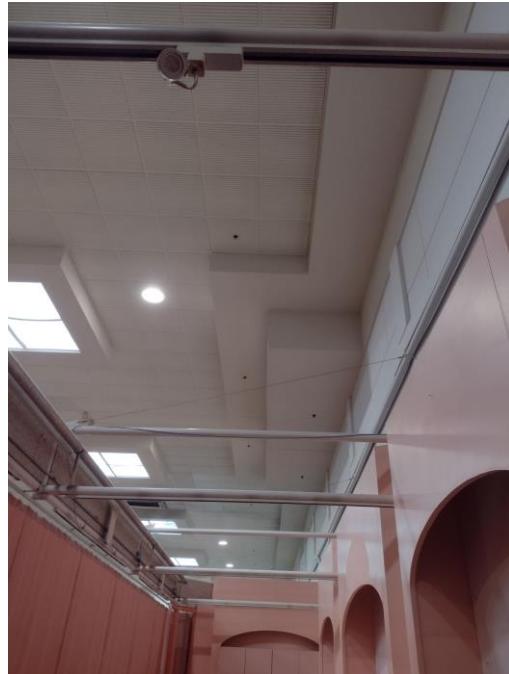
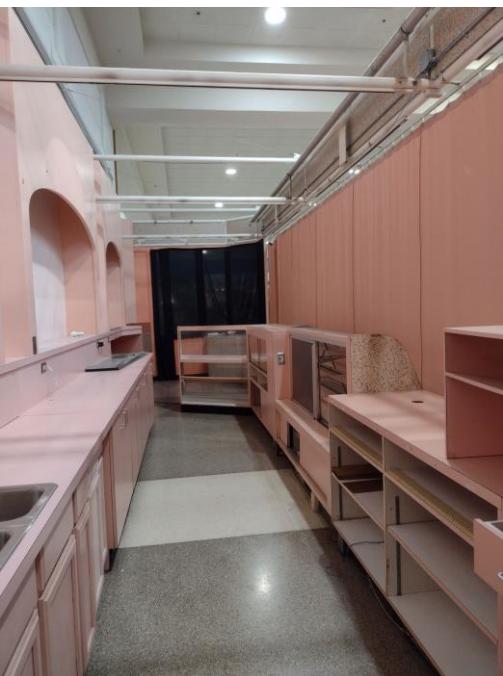
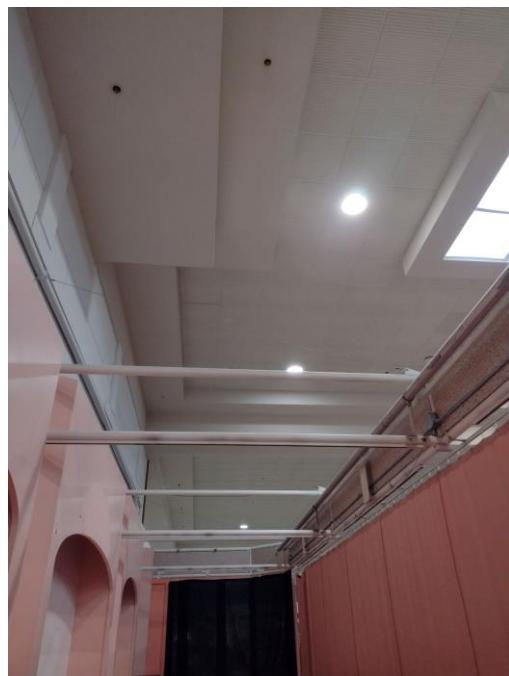
22.0 MALLEY'S CHOCOLATE KIOSK- (PINK)

- The Kiosk area is in good condition

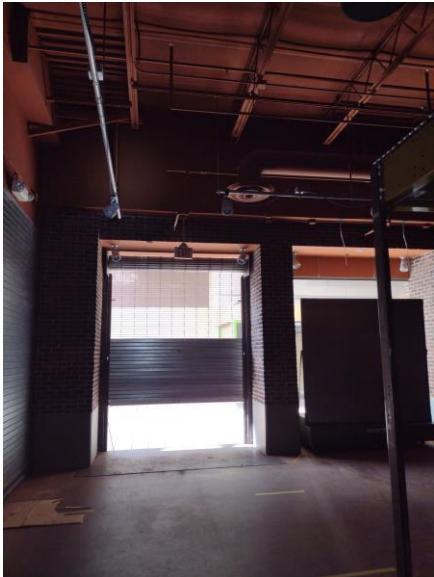
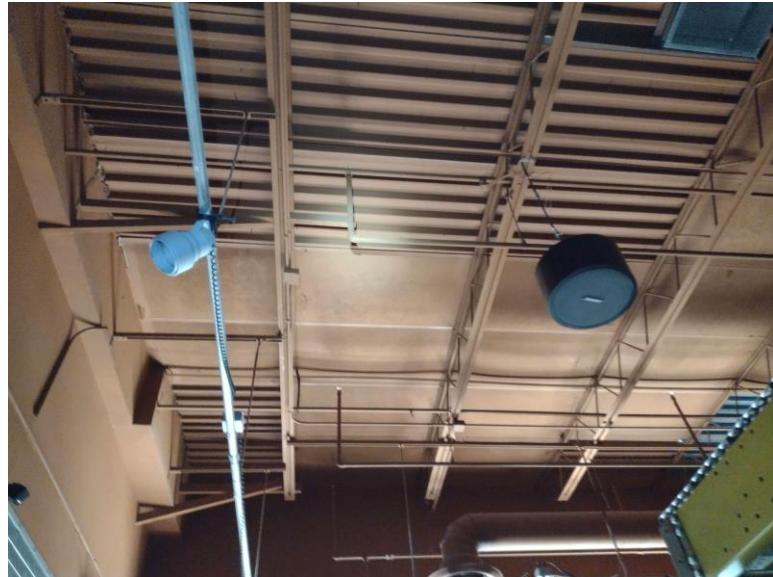
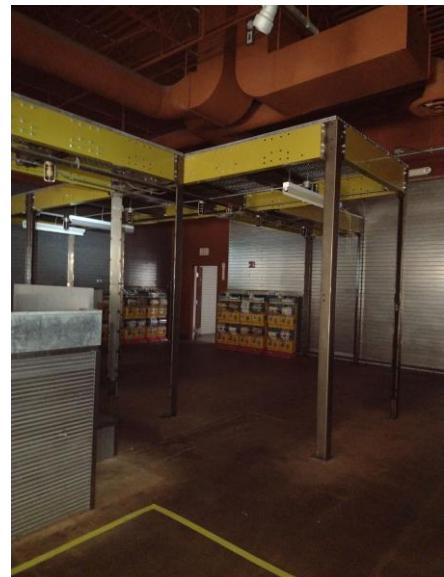
24.0 SPENCERS

- The store is in good condition, the store concrete floor is cracked
Refer to General Repair Recommendations #7
