Subject: Elyria Midway Mall Inspection
Store by Store Envelope Inspections
R.E. Warner Project 37422

LORAIN COUNTY PORT AUTHORITY
ELYRIA MIDWAY MALL

R.E. Warner Project No. 37422

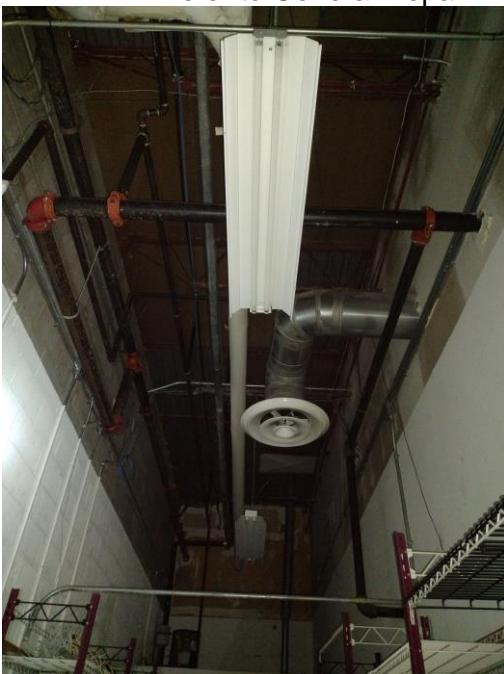
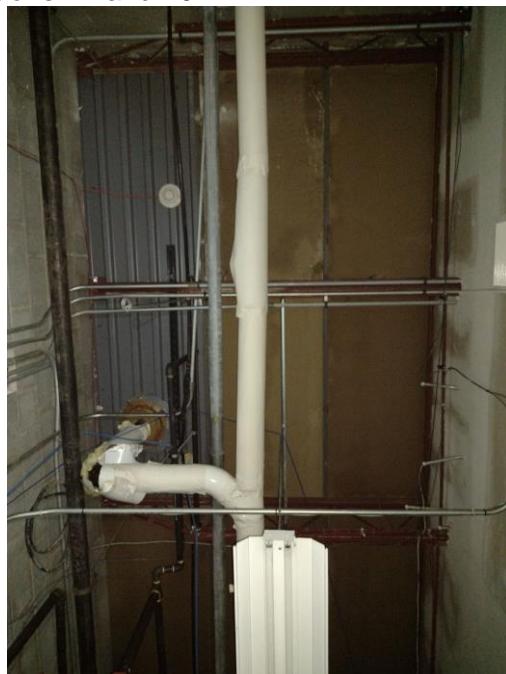
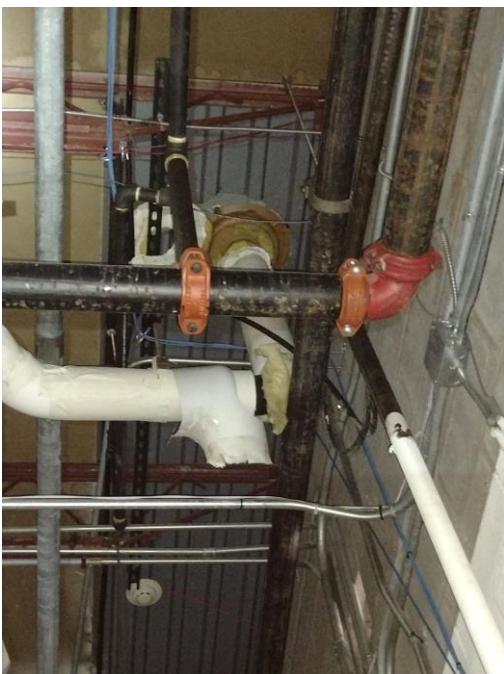
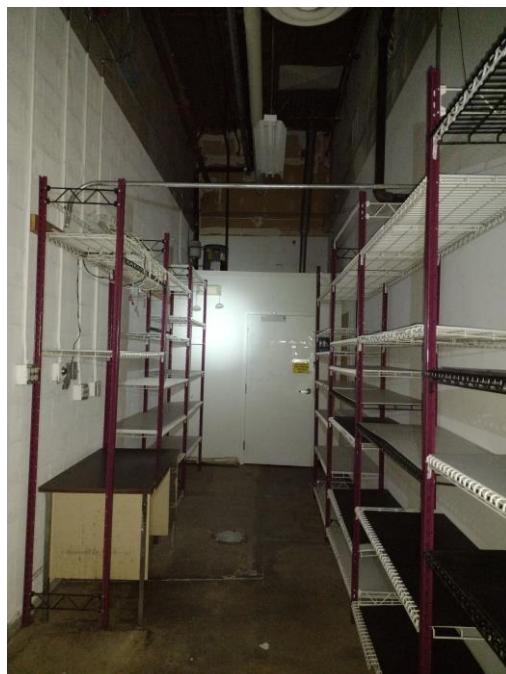
- In the rear storage there are minor and random leaks
Refer to General Repair Recommendations #4 and #9

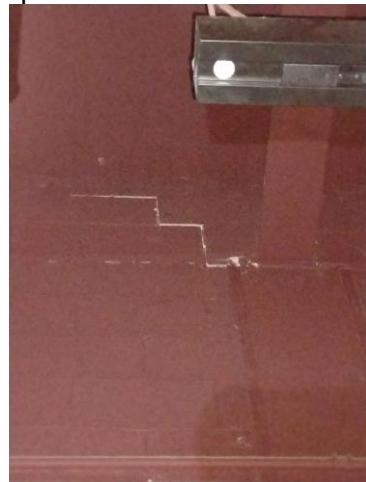
- Random cracks at the upper east block wall near the roof line
Refer to General Repair Recommendations #15

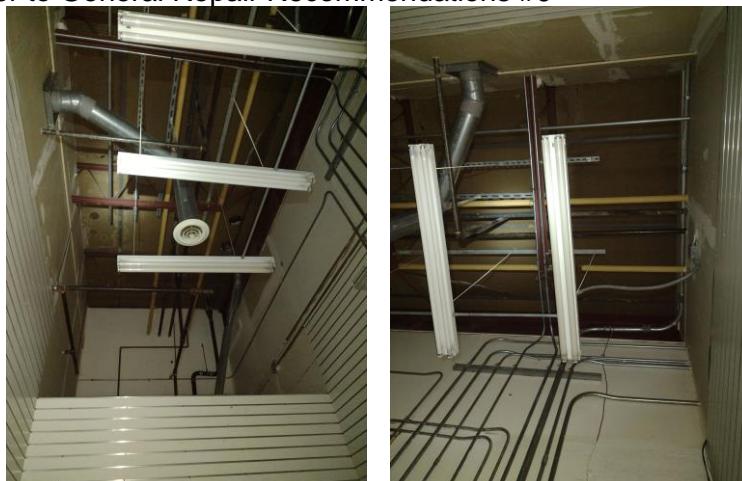
- Random corrosion and movement noted in roof decking
Refer to General Repair Recommendations #9

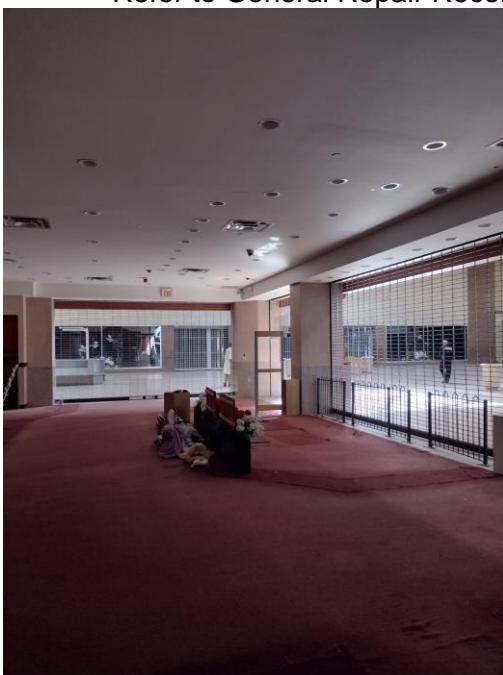
- Minor cracks at the stone front pillars in the Northwest
Refer to General Repair Recommendations #15

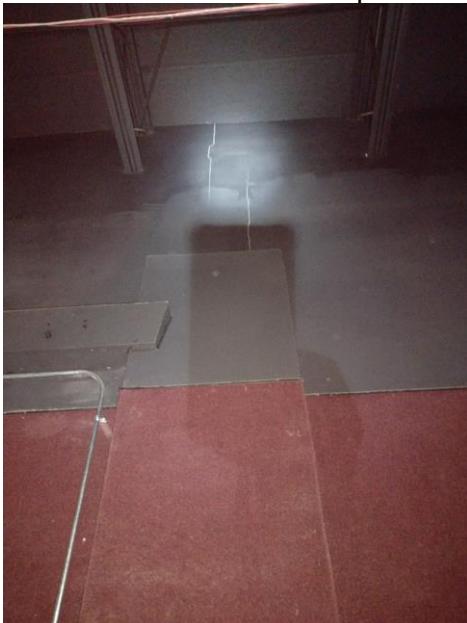
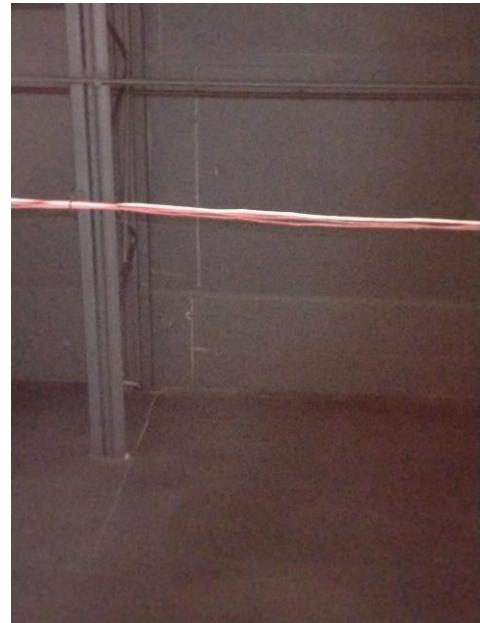
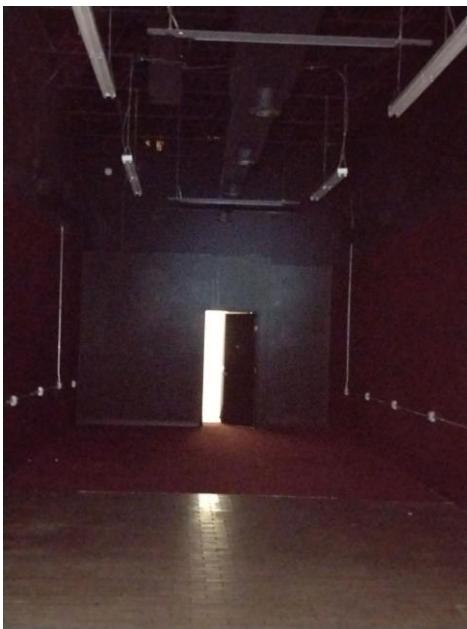
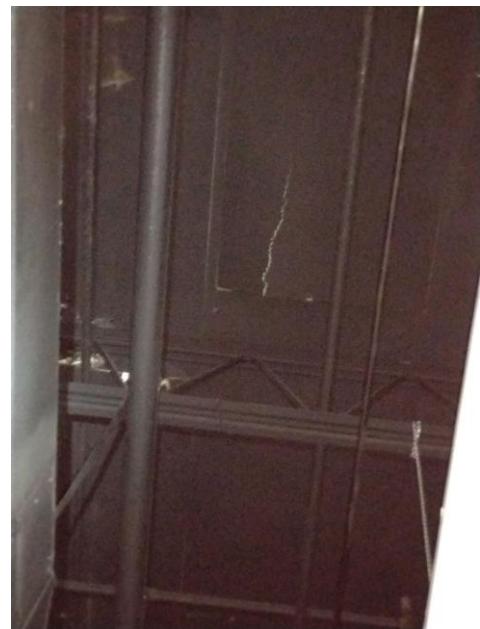
27.0 3573- CAPRIS PIZZA (ACROSS FROM AMERICAN COMMADORE TUXEDO)

- Similar to Hot Topic with North and South walls and deck. Cracks in deck covering

Refer to General Repair Recommendations #15

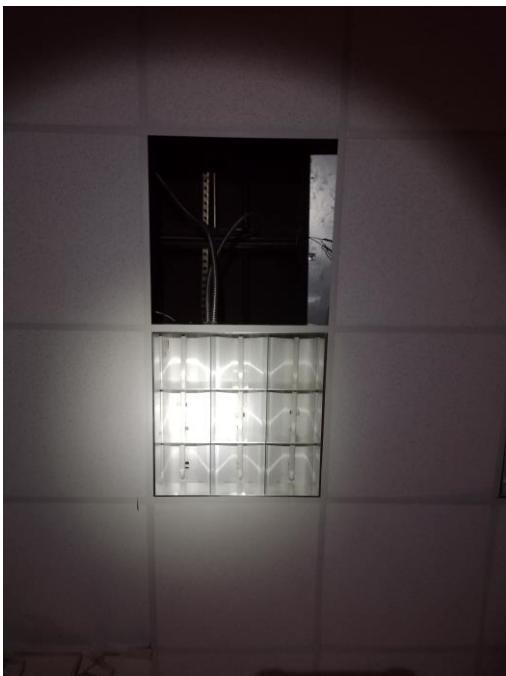
28.0 3583-GNC

- Random stained tiles in the store
Refer to General Repair Recommendations #3, #4, and #8

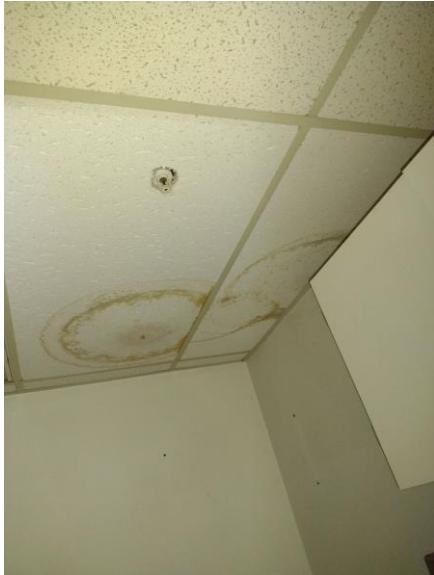
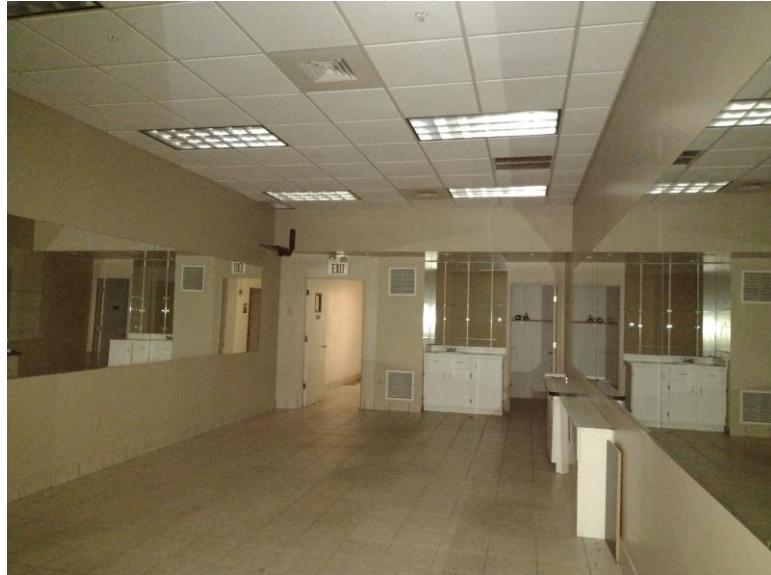
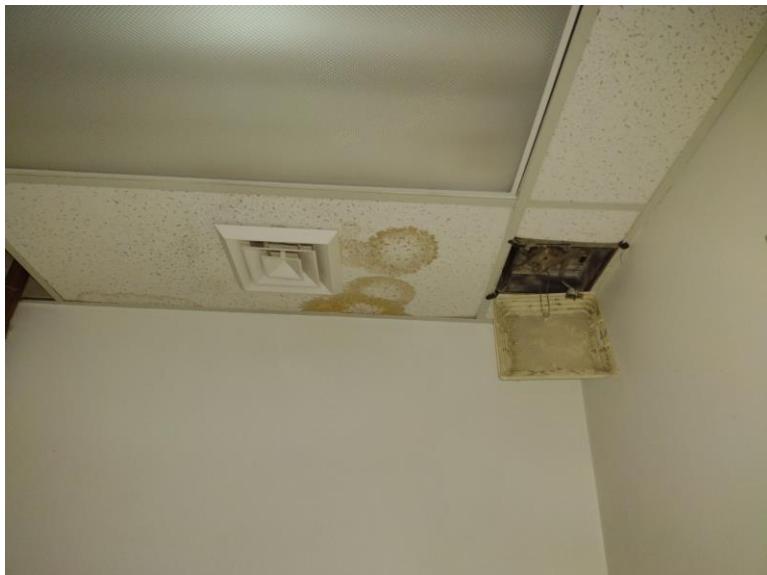
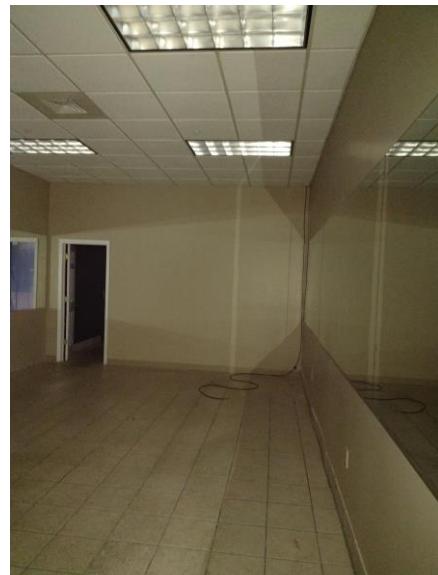
29.0 3561-WOBL RADIO STATION

- Random stained ceiling tiles in the rear areas
Refer to General Repair Recommendations #3, #4, #8, and #12

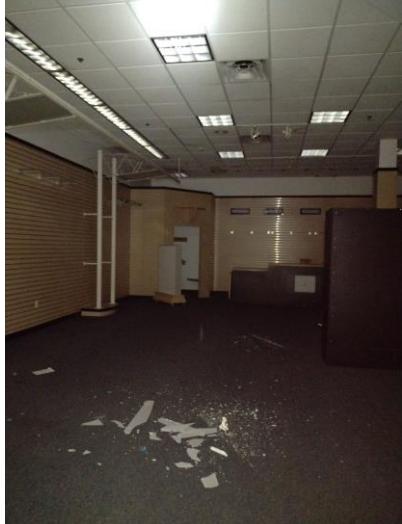
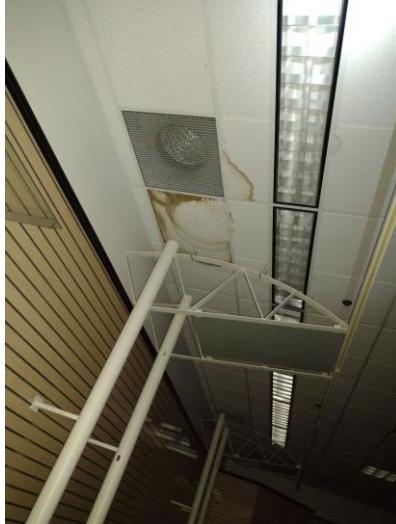
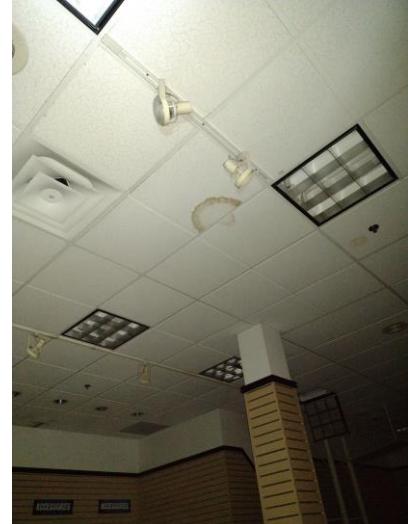
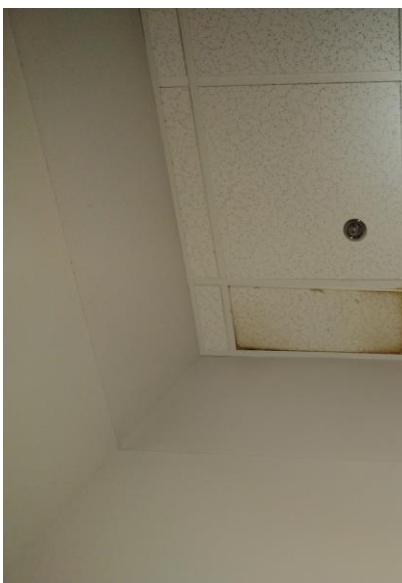
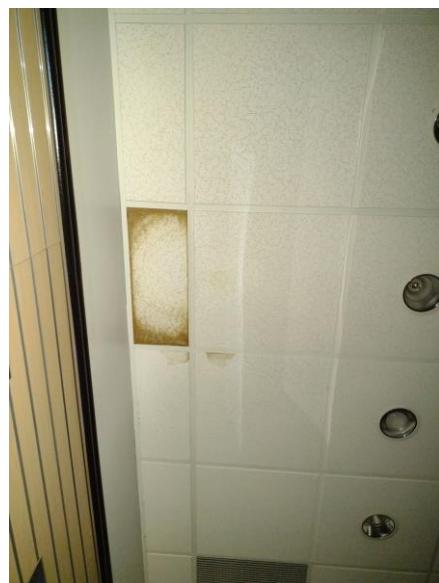
30.0 SPORTS STORE

- Random stained ceiling tiles in the store and rear areas mainly the South half of the store
Refer to General Repair Recommendations #3, #4, and #8

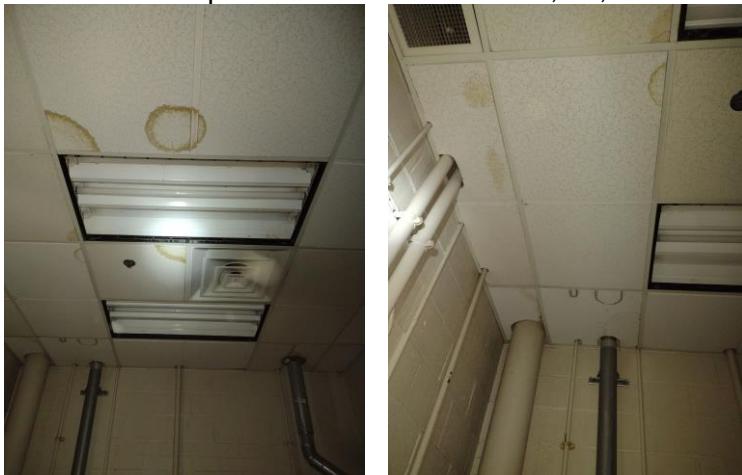
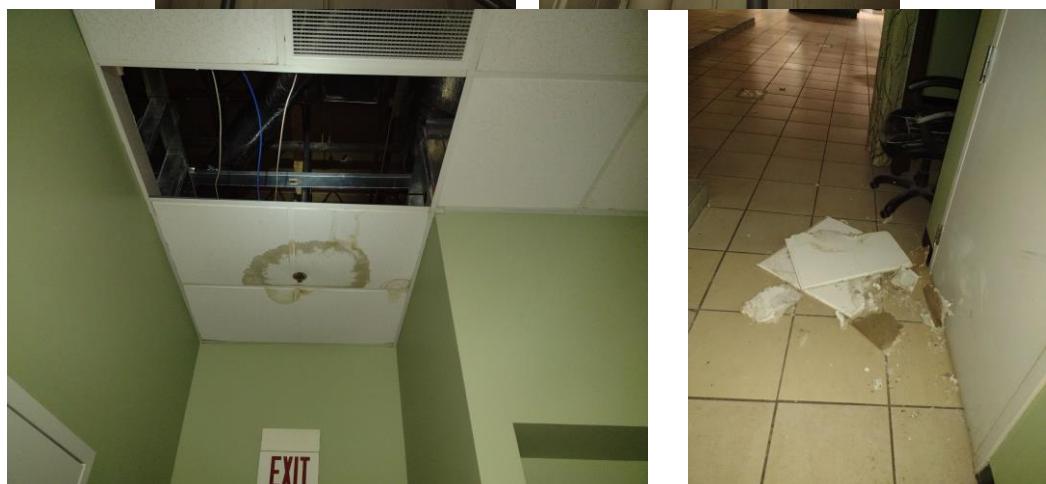
- Typical random stained tiles in rear area
Refer to General Repair Recommendations #3, #4, and #8

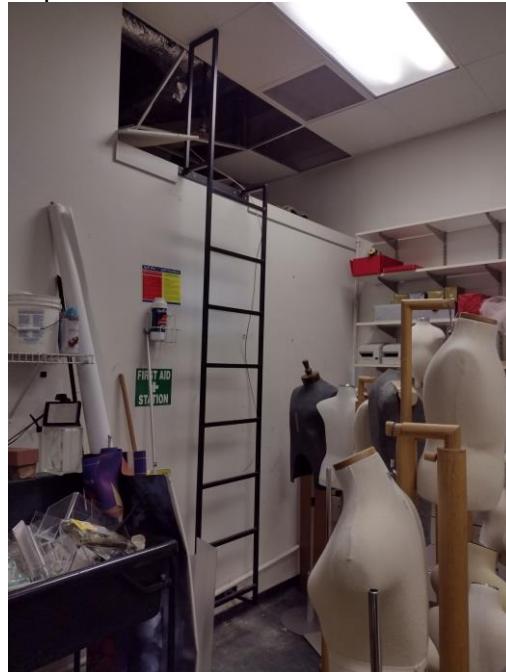
- Access Ladder not certified (weak, flexes)
Refer to General Repair Recommendations #13

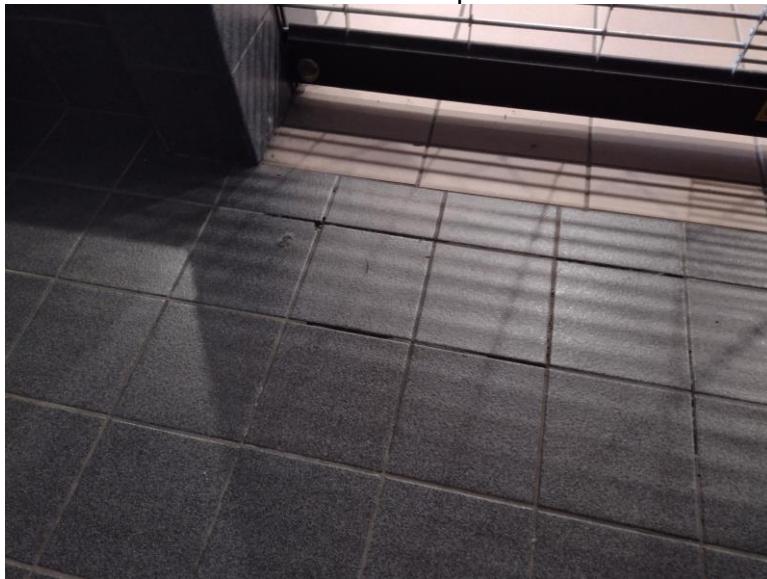
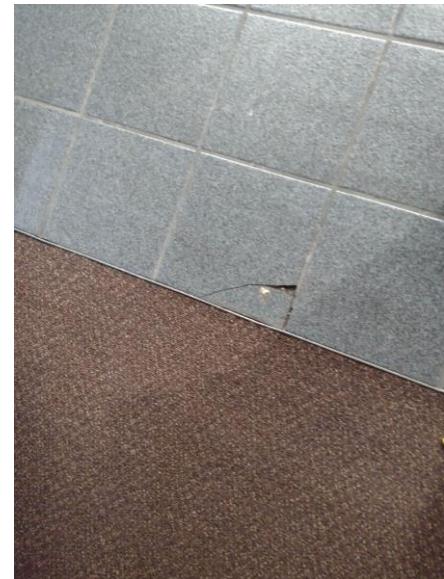
- Floor at entryway damaged and uneven
Refer to General Repair Recommendations #6

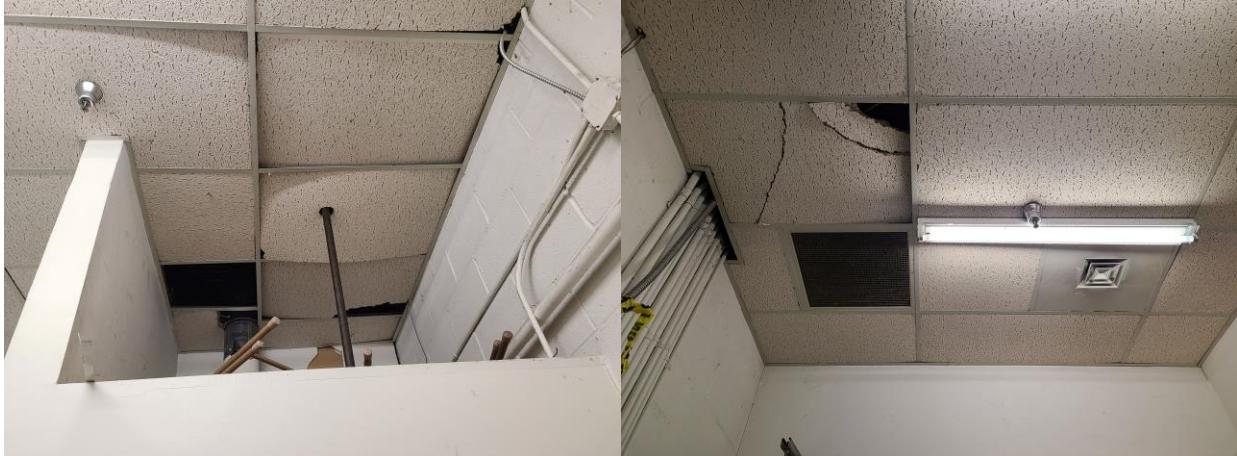
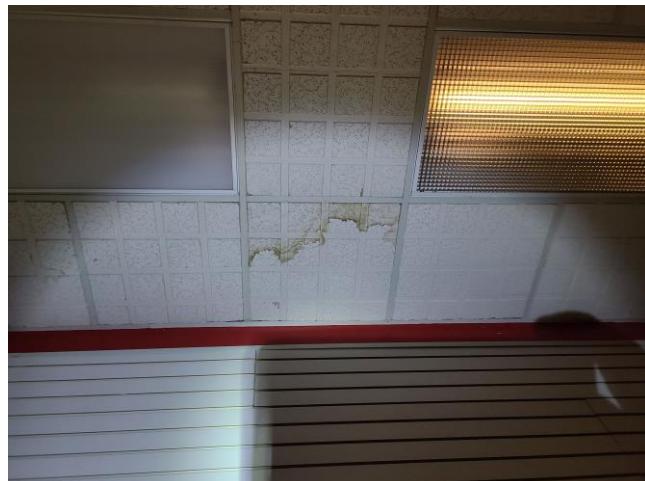
- Random broken, damaged, and stained ceiling tiles
Refer to General Repair Recommendations #3, #4, and #8

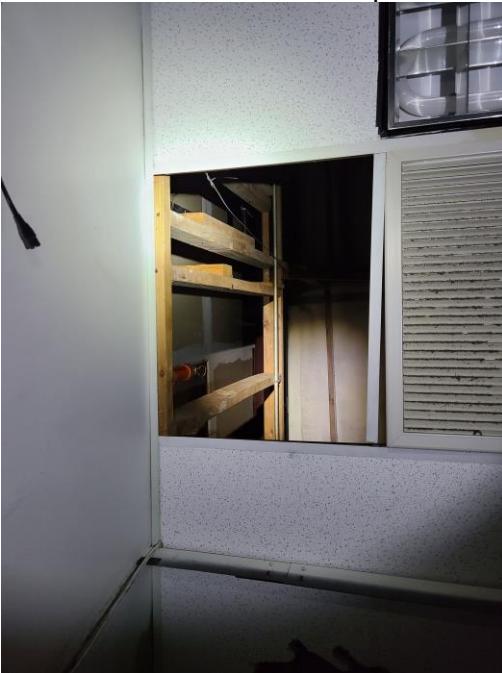
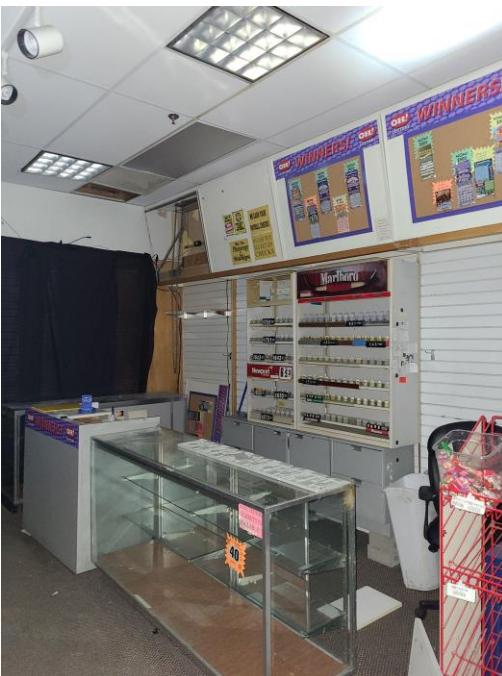
- Random broken, damaged, and stained ceiling tiles
Refer to General Repair Recommendations #3, #4, and #8

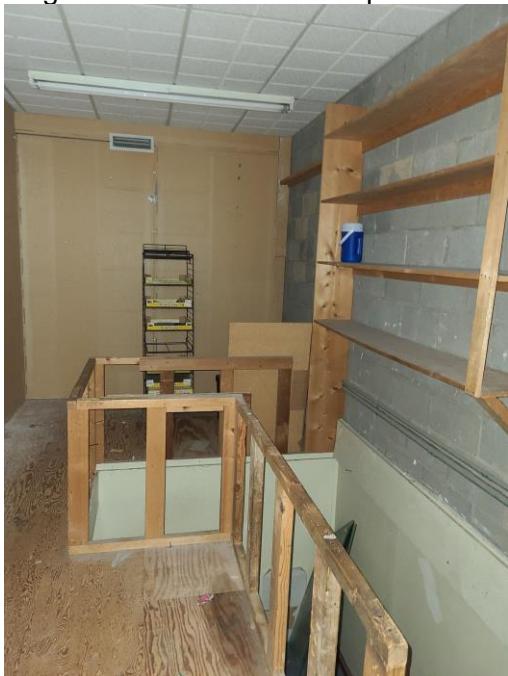
- North wall Damaged block and the wall repaired

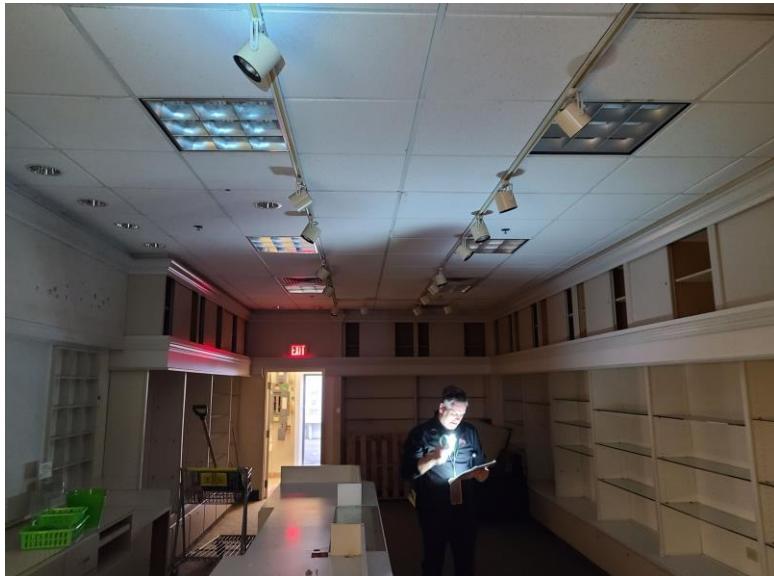
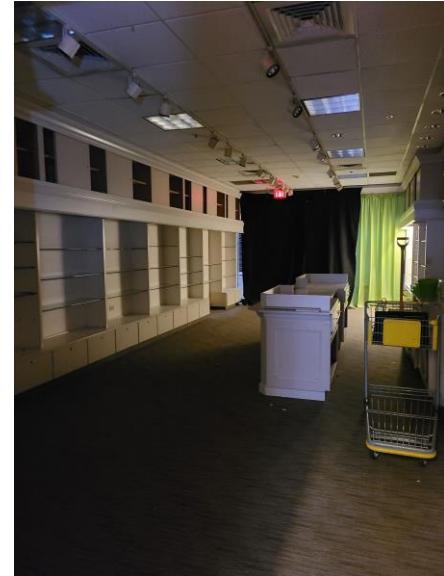
- Storage area has typical damage tiles
Refer to General Repair Recommendations #3, #4, and #8

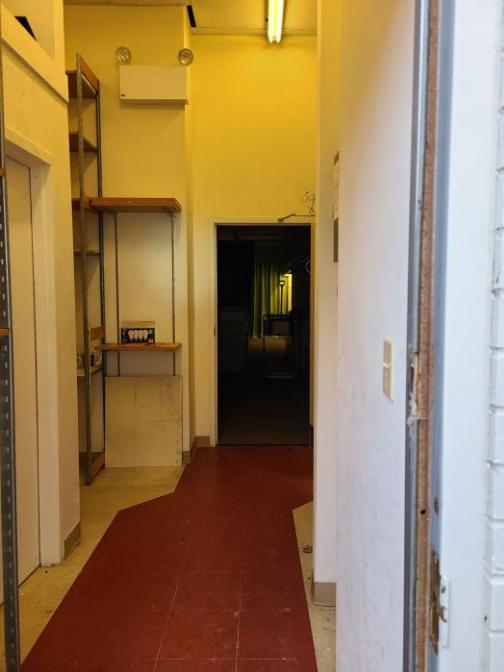
- Some discoloration and stains on the underside of the roof deck
Refer to General Repair Recommendations #4 and #9

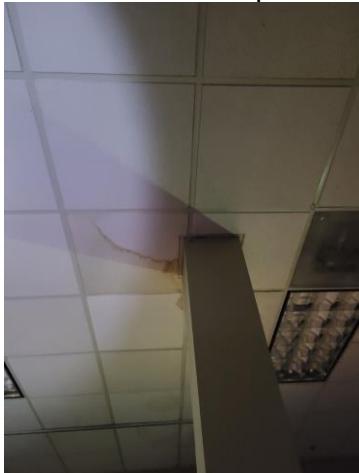
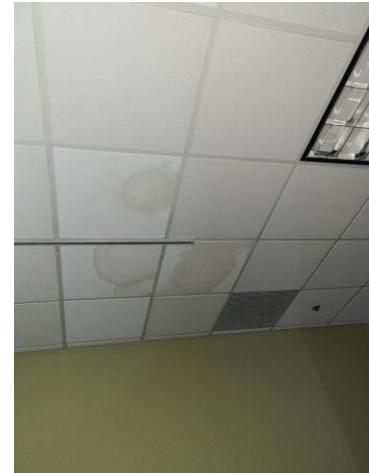
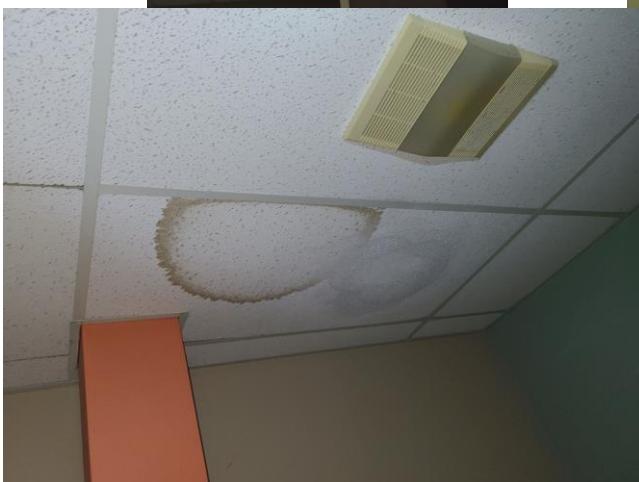
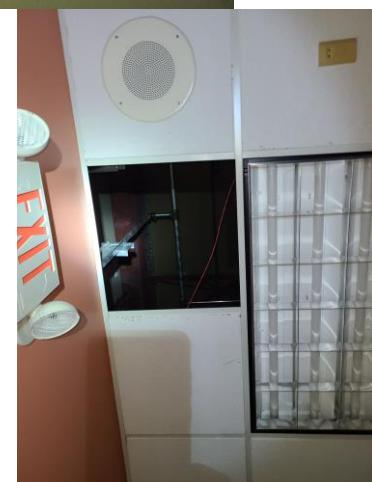
- Random Stained and one missing ceiling tile in the lobby
Refer to General Repair Recommendations #3, #4, and #8

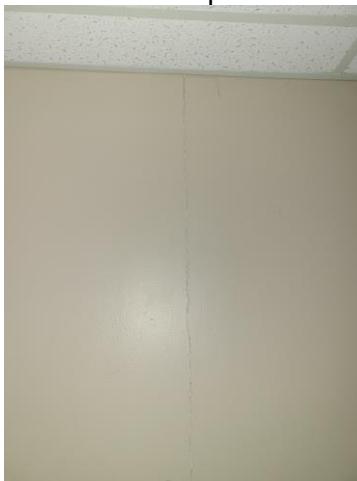
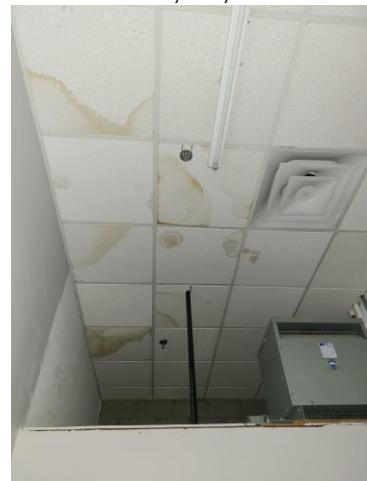
- Stained tile and cracked wall board on the North wall of the bathroom
Refer to General Repair Recommendations #3, #4, and #8

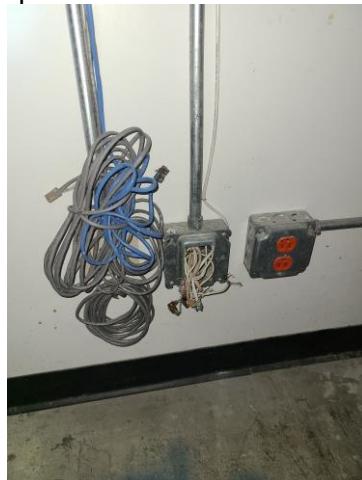
- Exposed wires and electrical box on the North Wall
Refer to General Repair Recommendations #14

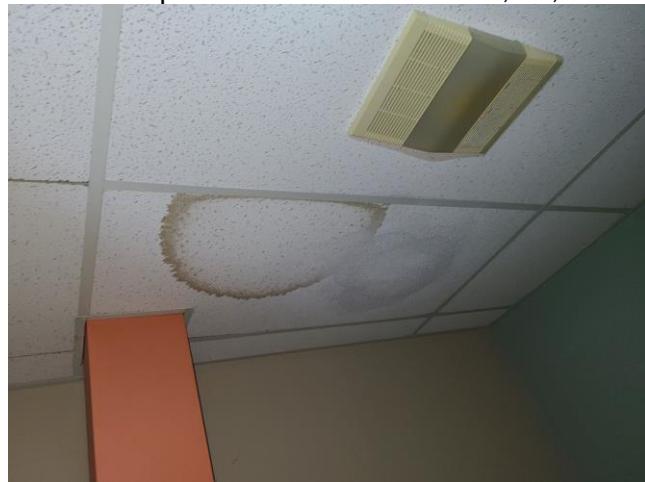
- Stained tiles in the bathroom
Refer to General Repair Recommendations #3, #4, and #8

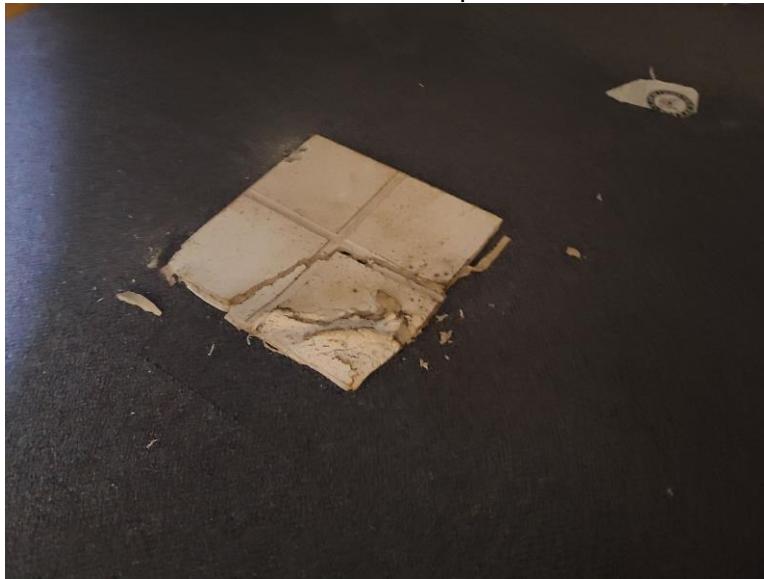
- Navy Office has (2) areas where the ceiling collapsed from water damage
Refer to General Repair Recommendations #3, #4, #8, and #9

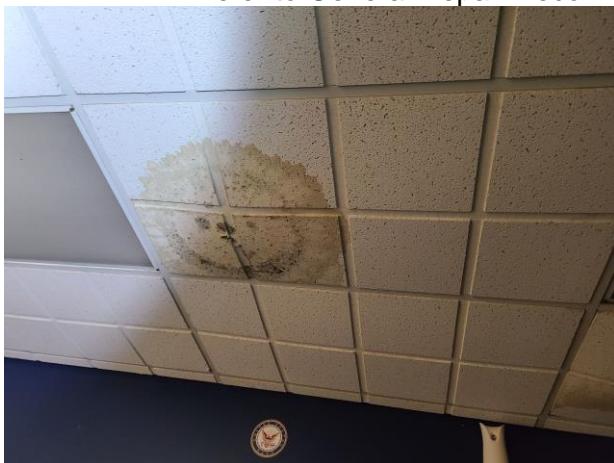
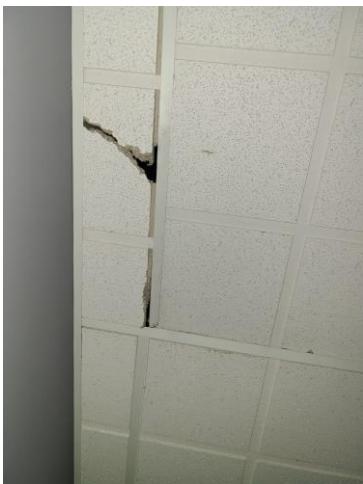
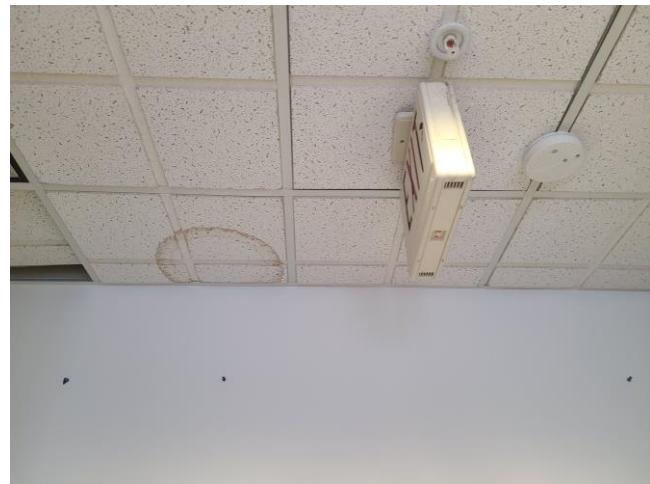
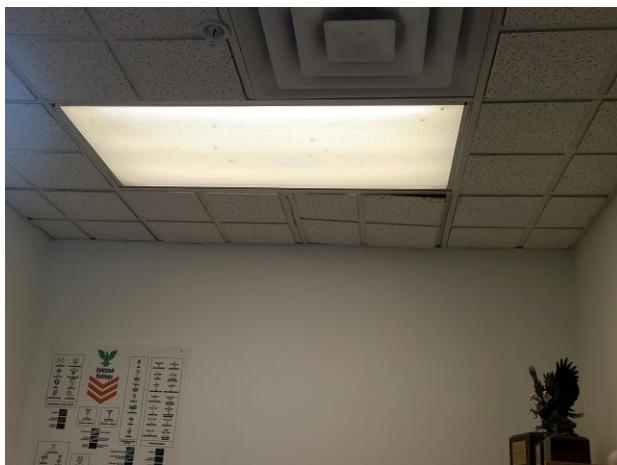
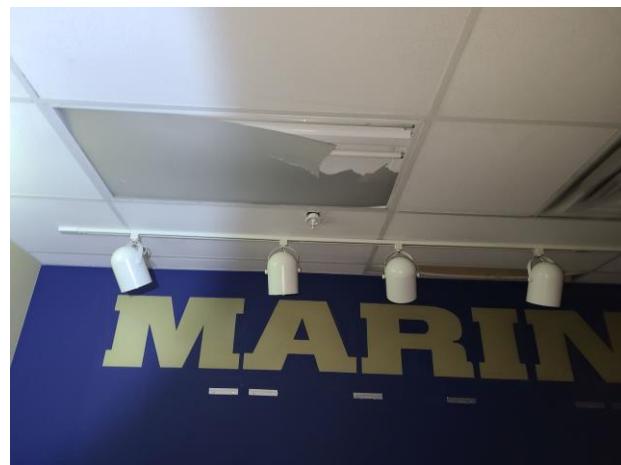
- Ceiling tiles stained from water damage
Refer to General Repair Recommendations #3, #4, #8, and #12

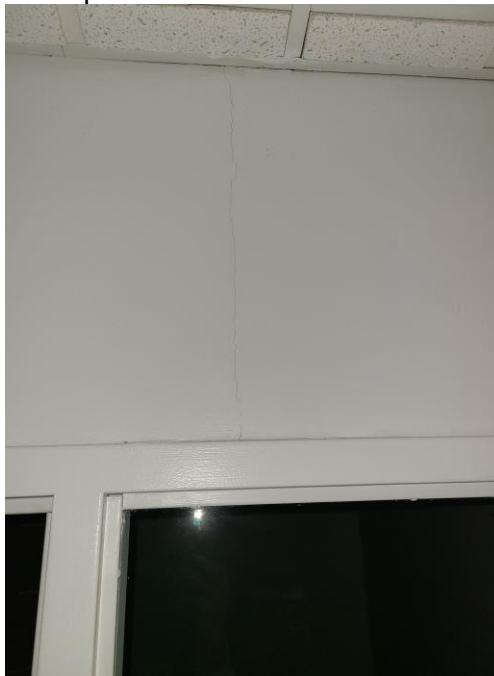
- The wall boards have random cracks
Refer to General Repair Recommendations #15

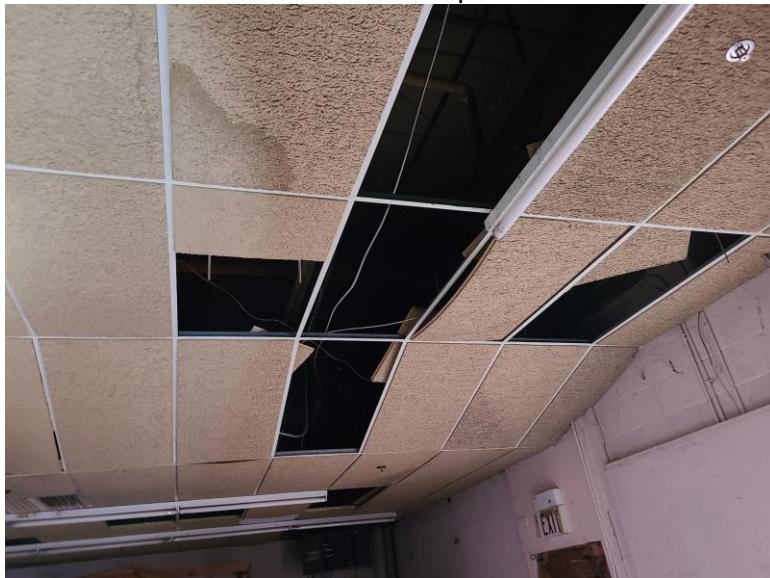
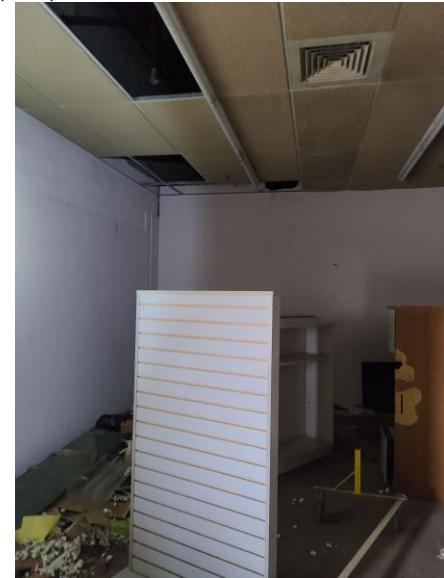
40.0 4564 CLOTHING STORE/NOW STORAGE

- Fitting room area is in good condition
- In the main store area Ceiling tiles have been removed, damaged, or stained
Refer to General Repair Recommendations #3, #4, and #8

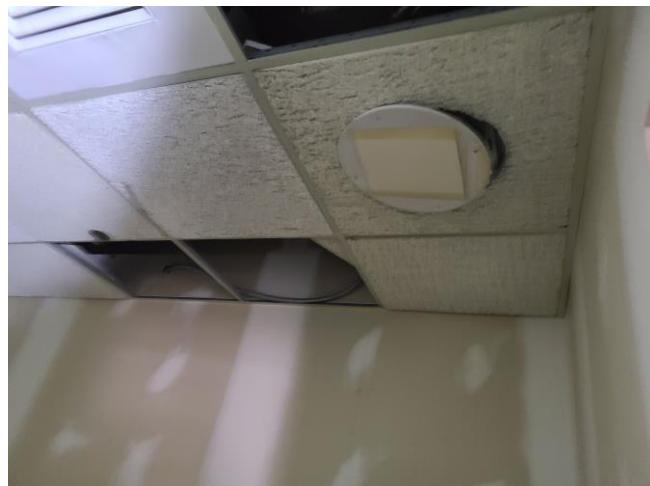
- In the main store area near the registers the wall and lower false ceiling are partially demoed
Refer to General Repair Recommendations #9

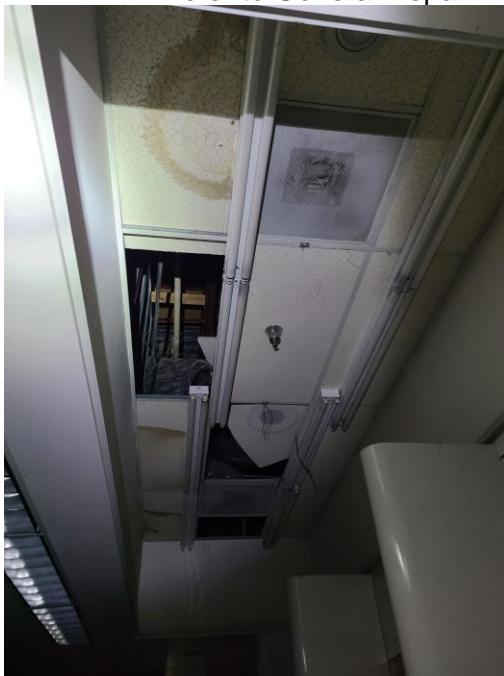
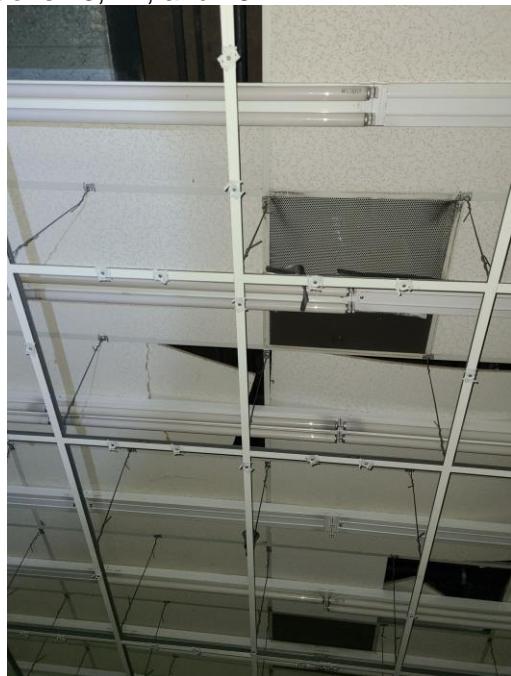
- Incinerator/ Furnace rooms are in bad condition demo and new construction
Refer to General Repair Recommendations #17

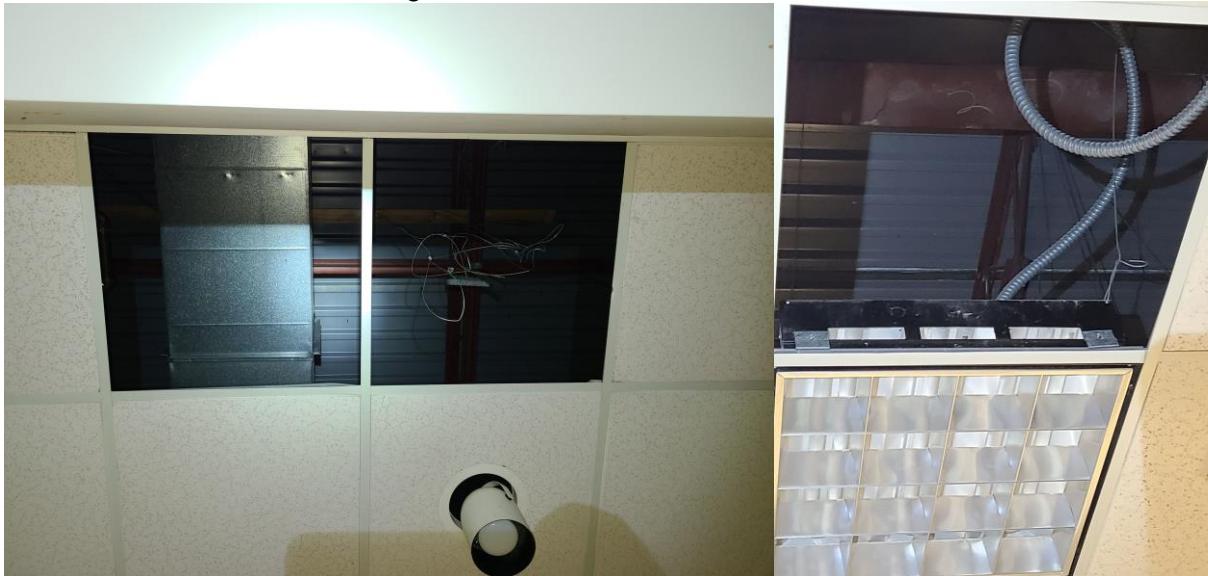
42.0 4594 COMMUNITY CHURCH MINISTRIES

- New metal decking

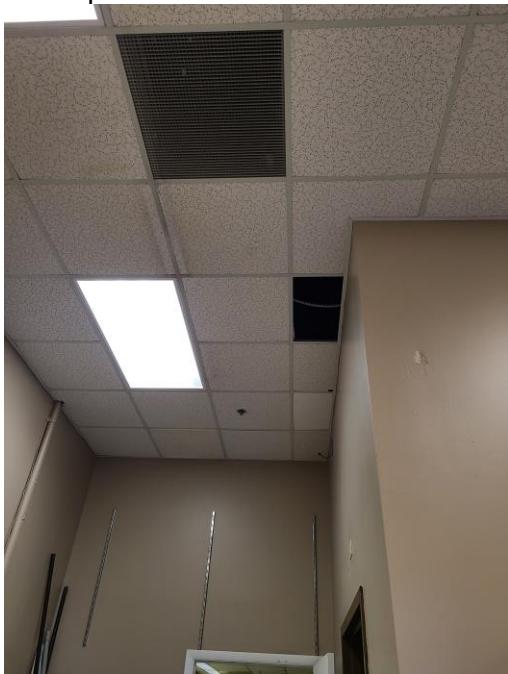
- Random damaged tiles that are man made
Refer to General Repair Recommendations # 8

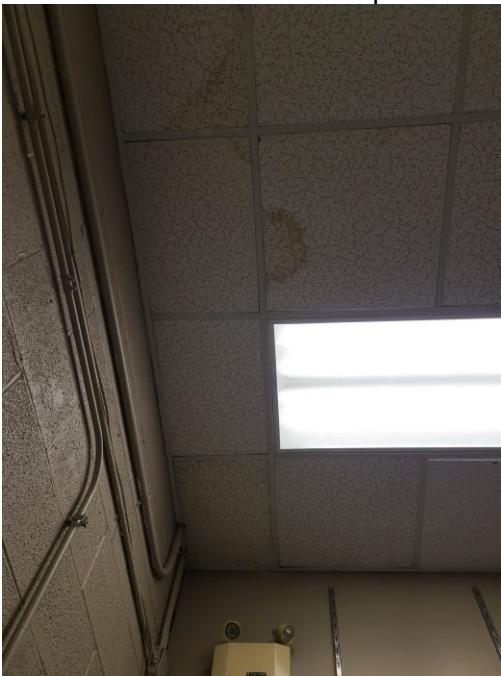
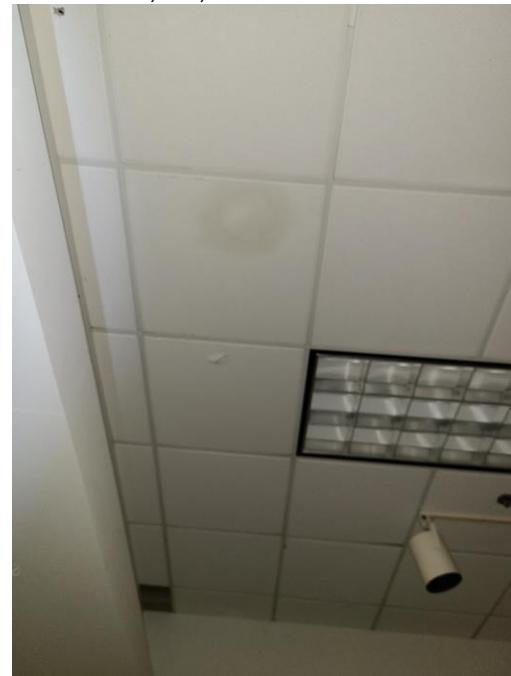
- Random stained tiles in the main room
Refer to General Repair Recommendations #3, #4, and #8

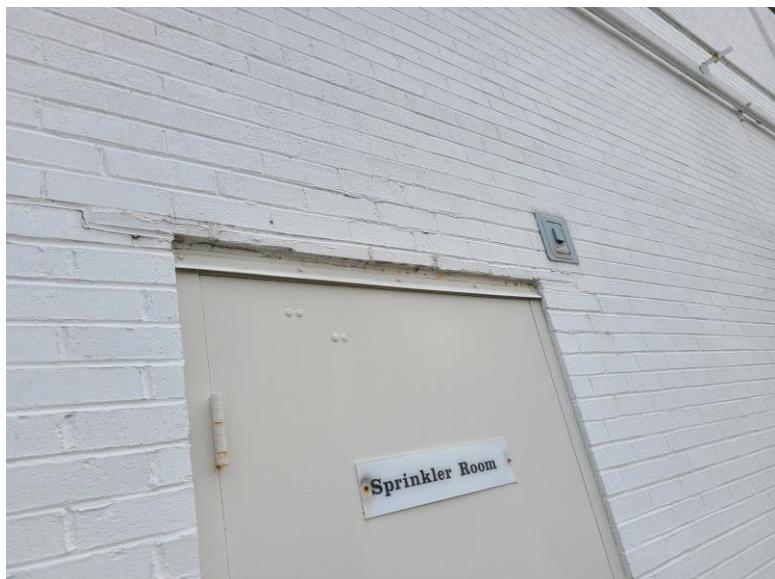
44.0 SPRINKLER ROOM

- Sprinkler Room is OK
- Threshold sweep rusted outside of the door
Refer to General Repair Recommendations #5 and #7

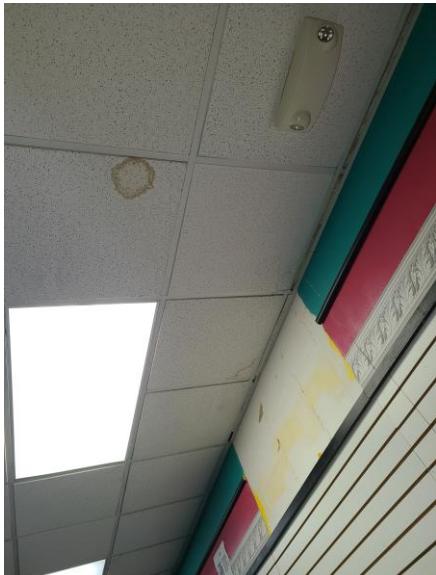
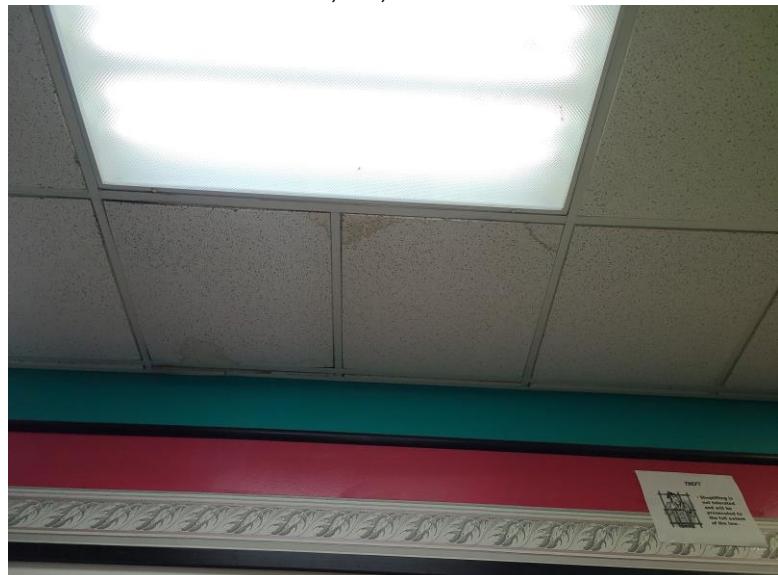
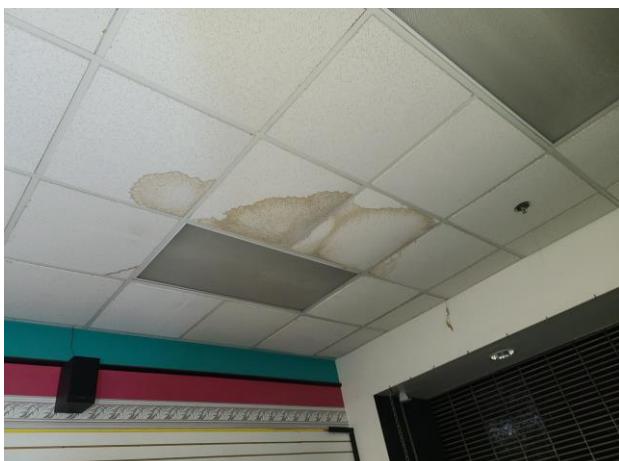
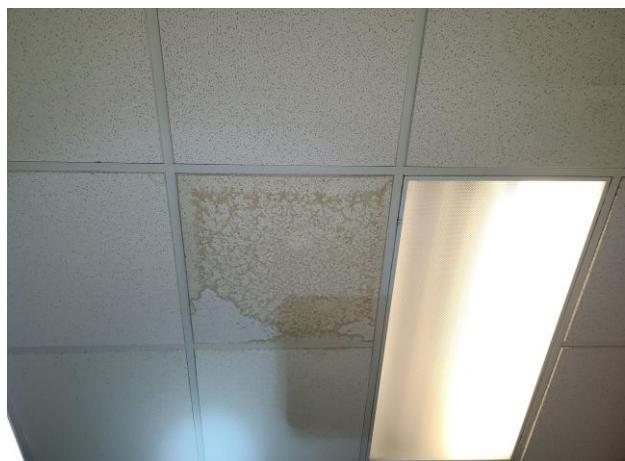
45.0 4670 FAMILY DOLLAR

- At the back of the store, the metal decking is ok
- Inside the store area there are damaged, stained ceiling tiles
Refer to General Repair Recommendations #3, #4, and #8

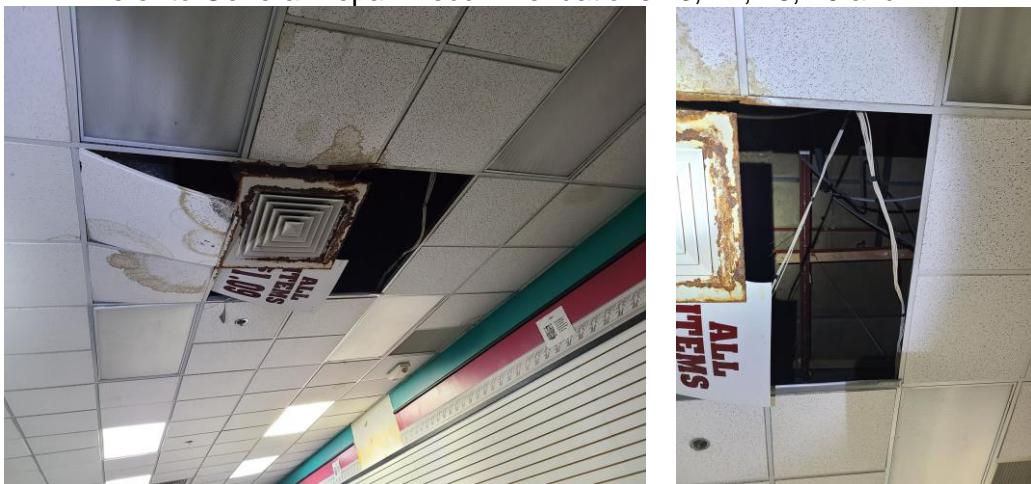
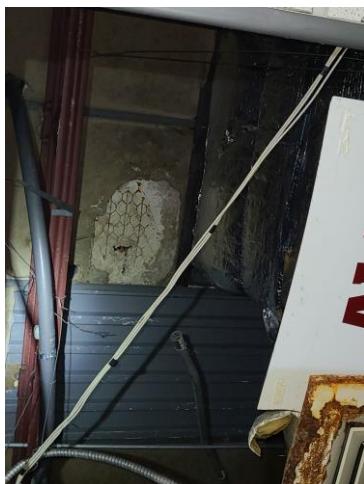
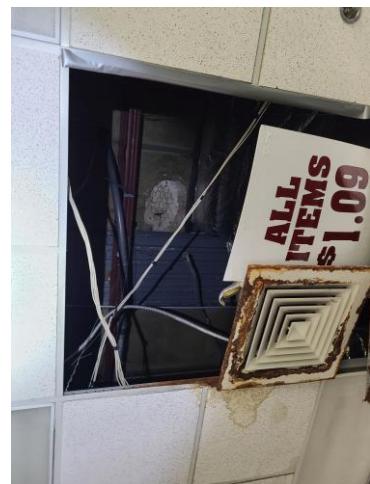
- Above the vent, the upper roof panel is corroded with exposed rebar
Refer to General Repair Recommendations #3, #4, #8, #9 and #12

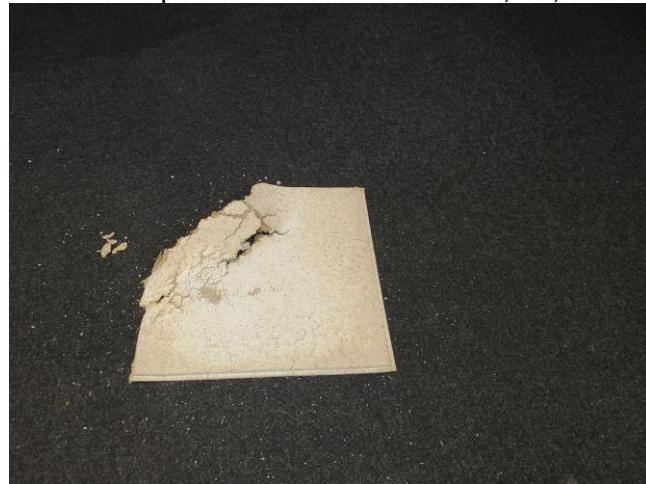
- Falling ceiling tiles

Refer to General Repair Recommendations #3, #4, and #8

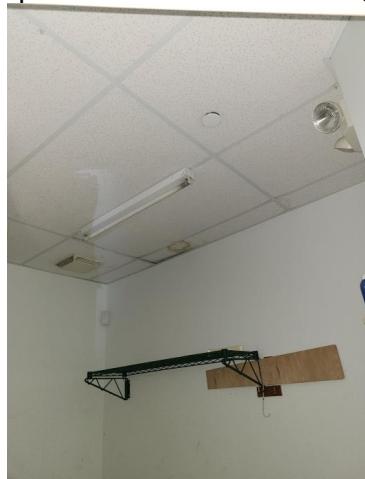
- By the vent there is a hole in the ceiling tile outside the restroom door.
Refer to General Repair Recommendations #3, #4, and #8

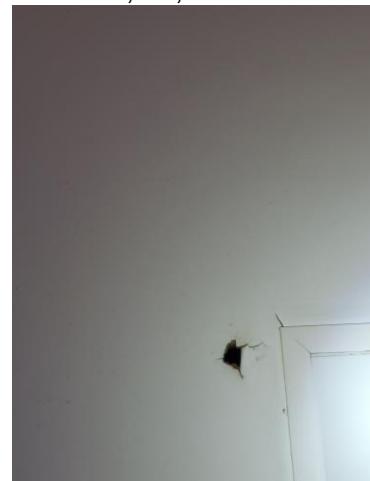
48.0 3330

- Rear office area has cracked and damaged ceiling tiles by the restroom
