Subject: Elyria Midway Mall Inspection
Store by Store Envelope Inspections
R.E. Warner Project 37422

LORAIN COUNTY PORT AUTHORITY
ELYRIA MIDWAY MALL

R.E. Warner Project No. 37422

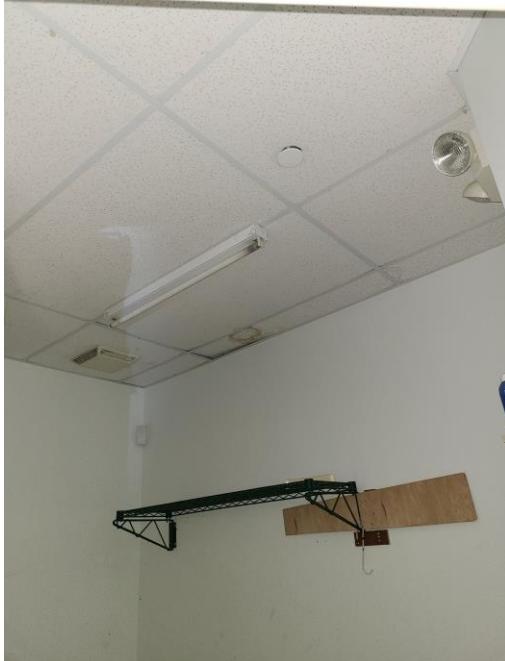
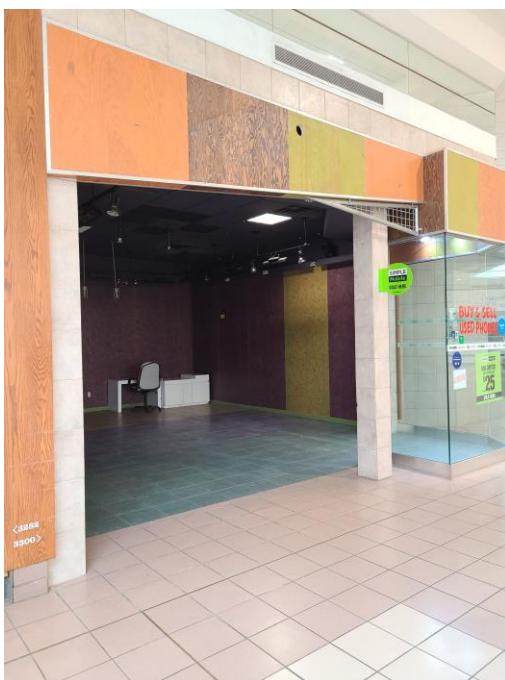
**49.0 3300 SIMPLE MOBILE**

- At (4) vents, minor to moderate surface corrosion with possible mold/mildew in the HVAC
Refer to General Repair Recommendations #2

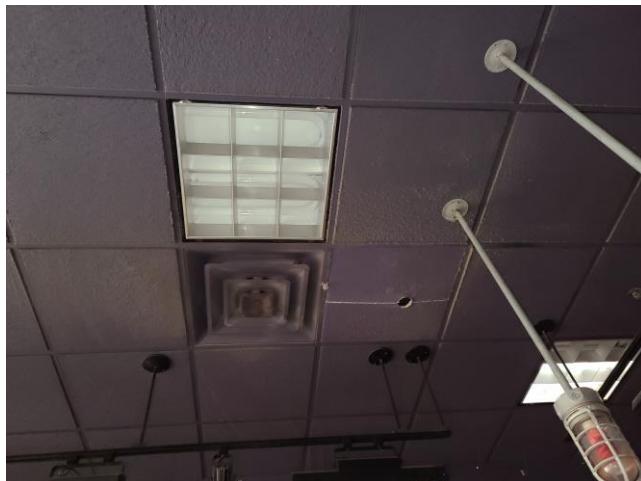
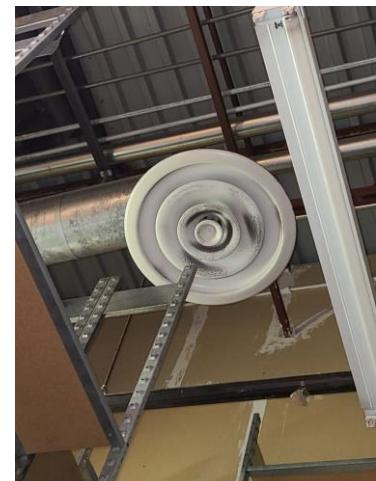
- Back-room area there are holes in dry wall
Refer to General Repair Recommendations #15 and #16

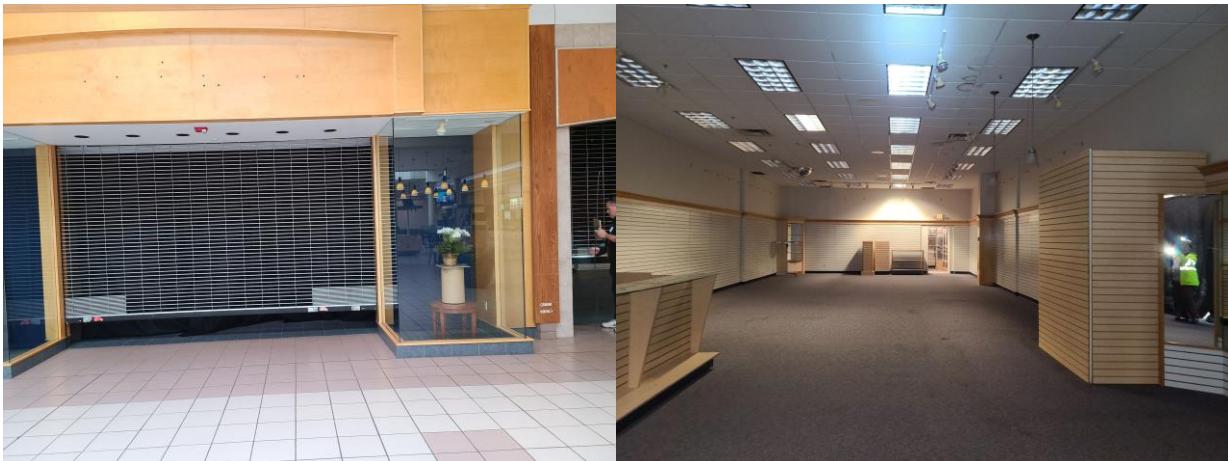
- At the front of the store random there are areas of stained ceiling tiles
Refer to General Repair Recommendations #3, #4, and #8

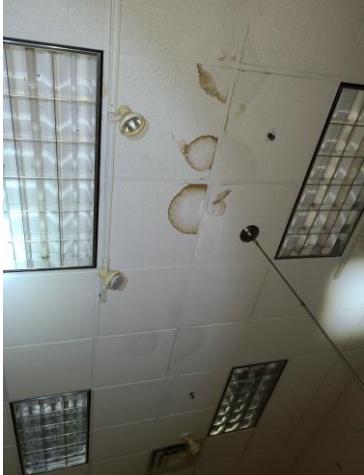
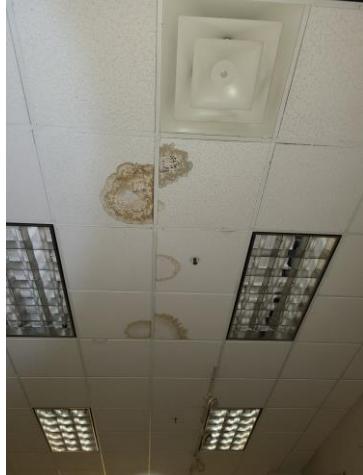
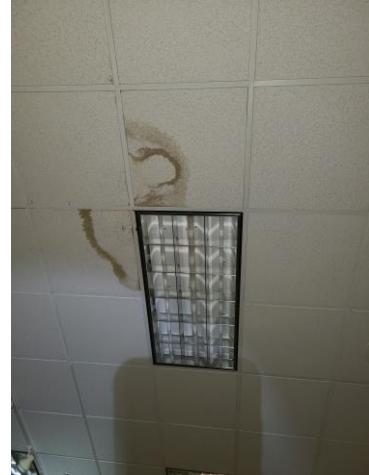
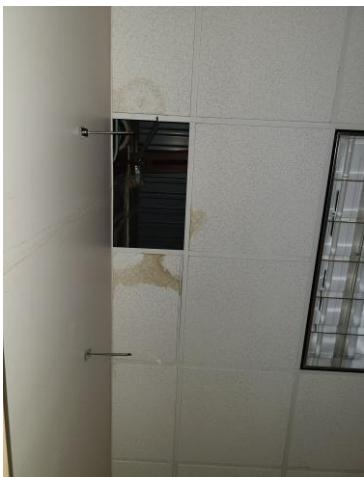
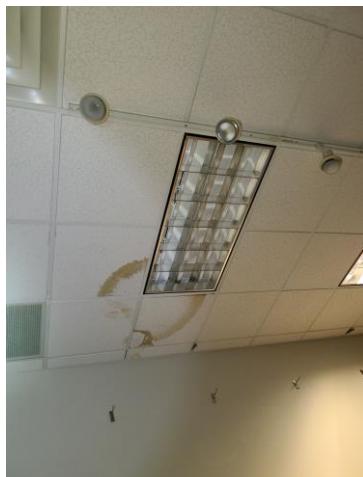
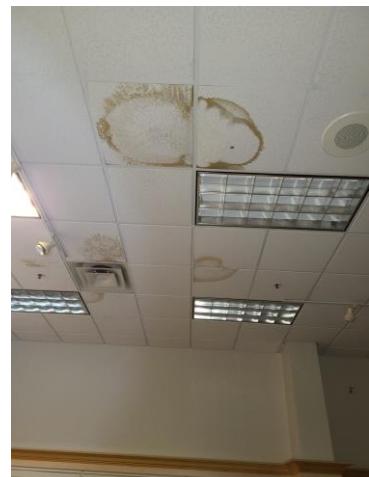
- Metal roof decking above the drop ceiling is in good condition
- Back area the ceiling tiles sagging due to leaks
Refer to General Repair Recommendations #3, #4, and #8

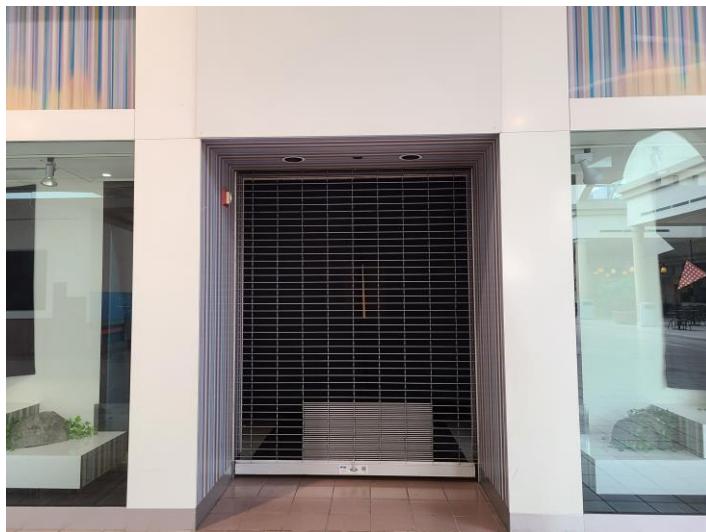
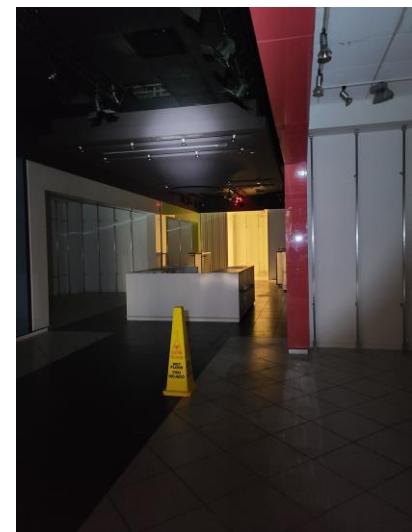
- There are numerous stains and cracking on the ceiling tiles near the front of the store
Refer to General Repair Recommendations #3, #4, and #8

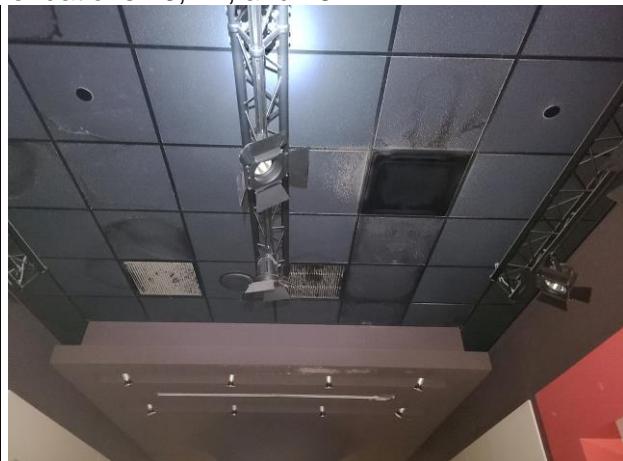
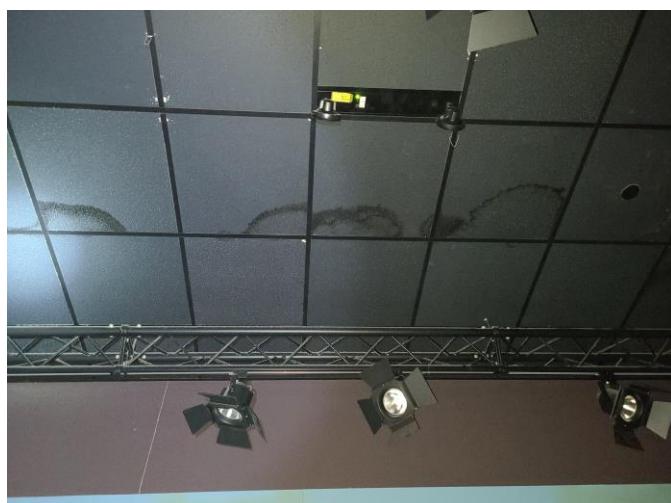
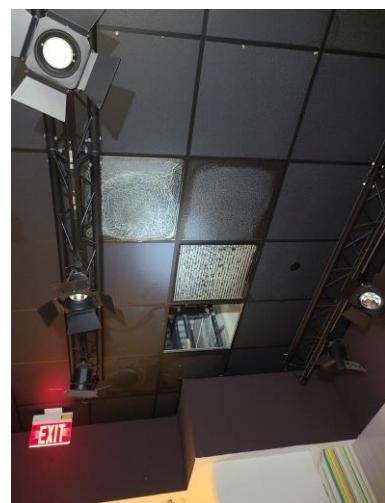
- Near the back of the store there are wet and damaged ceiling tiles are falling.
- Refer to General Repair Recommendations #3, #4, and #8

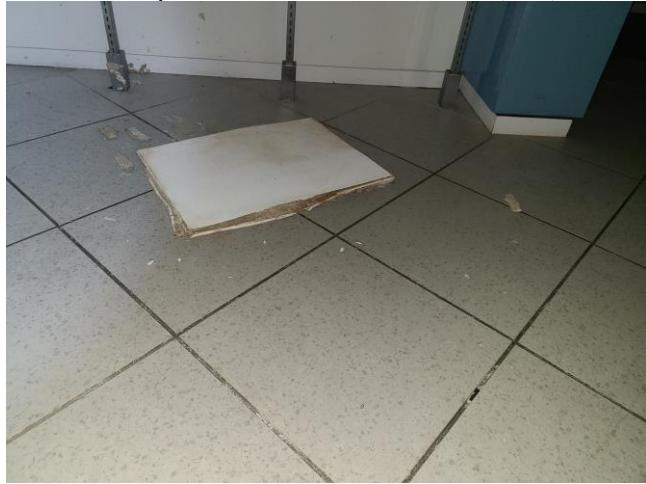
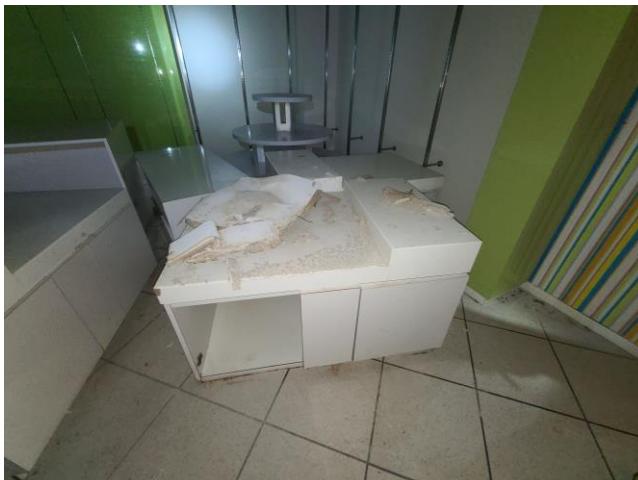
- Mold and Mildew on the back wall (Interior wall)
Refer to General Repair Recommendations #2

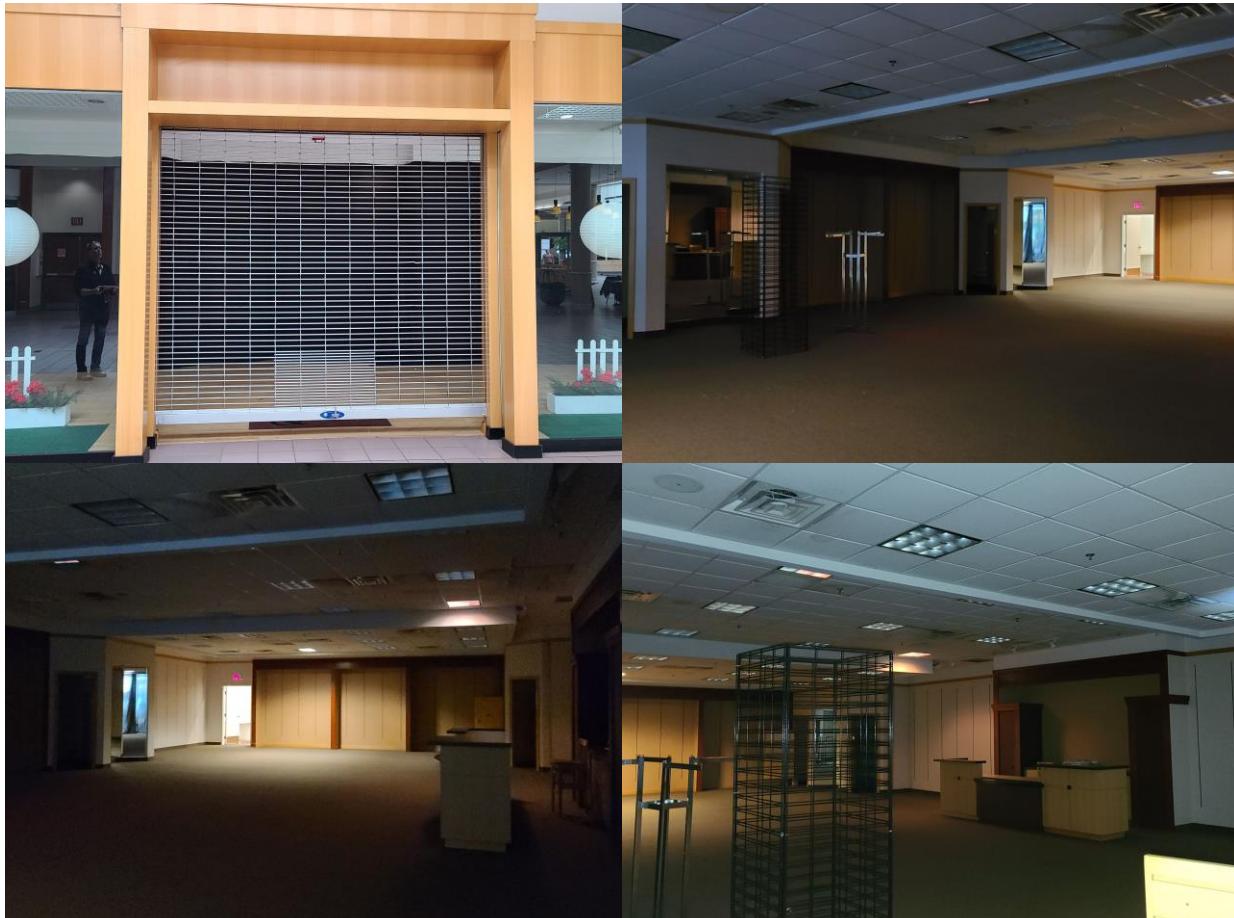
- Near the front of the store, damaged and stained ceiling tiles (Some are sagging and about ready to fall in)
Refer to General Repair Recommendations #3, #4, and #8

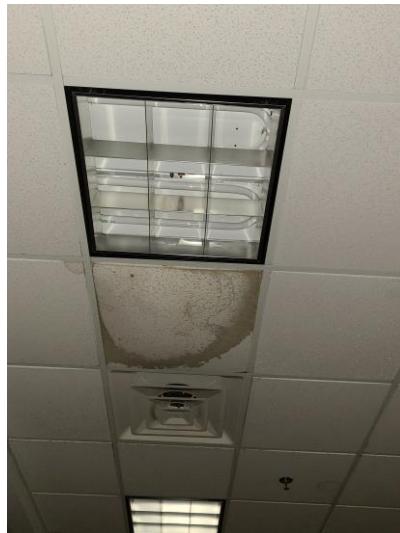
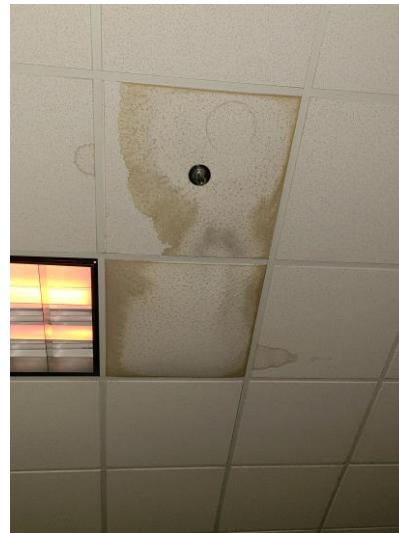
- Middle store by the counter ceiling tiles bad (Stained and ready to fall in)
Refer to General Repair Recommendations #3, #4, and #8

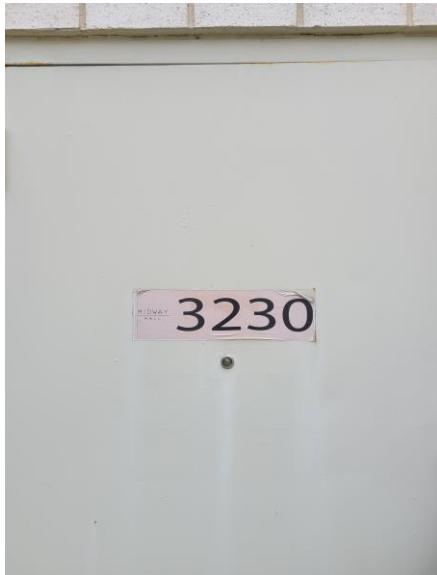
- Back door jamb is corroded
Refer to General Repair Recommendations #5

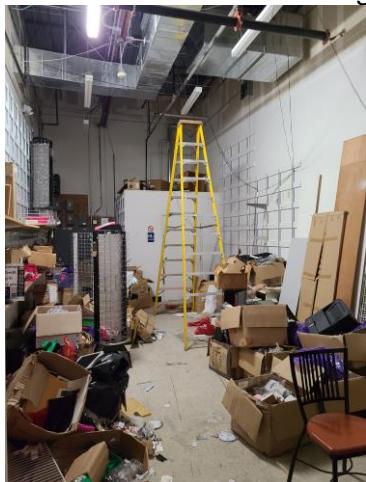
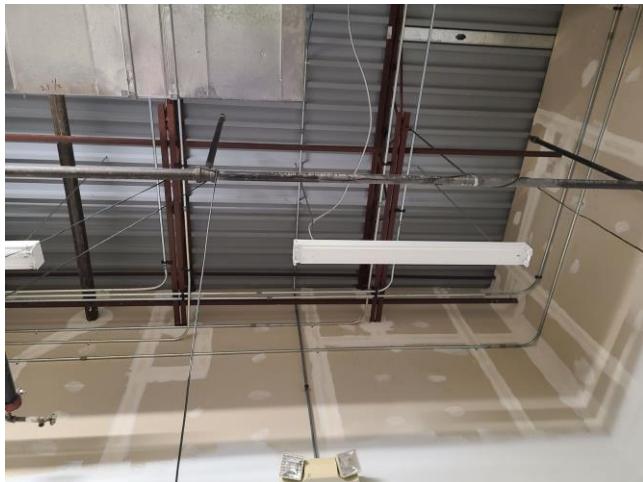
- Metal roof deck is in good condition

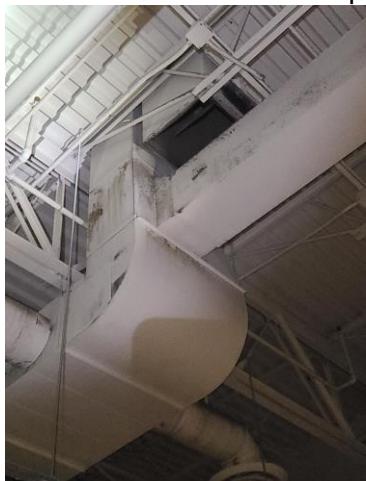
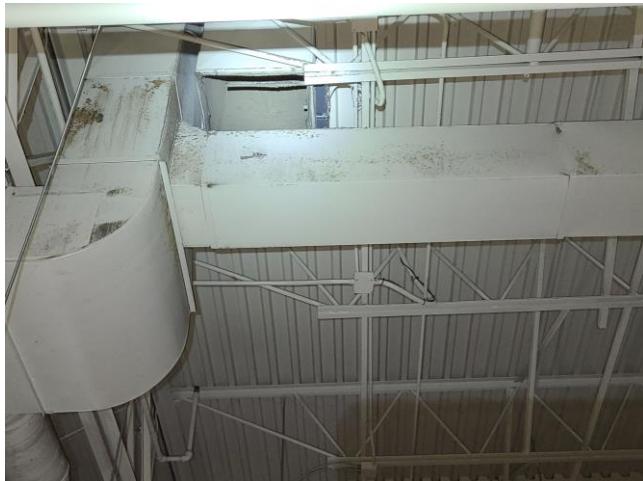
- In the middle of the building on the duct work, there is possible mold and mildew
Refer to General Repair Recommendations #2

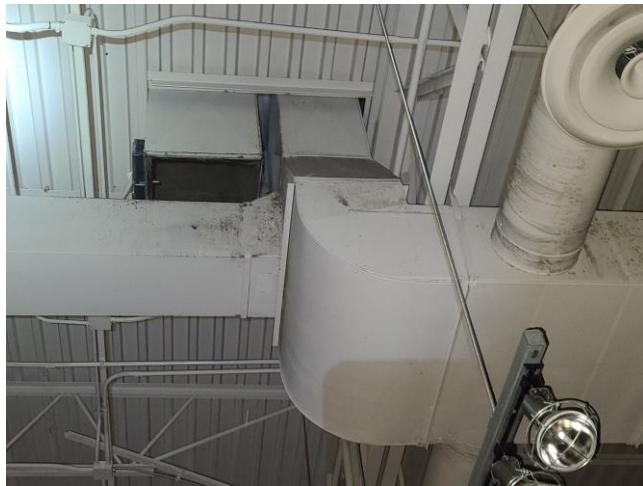
- All through the store the metal roof decking is in good condition

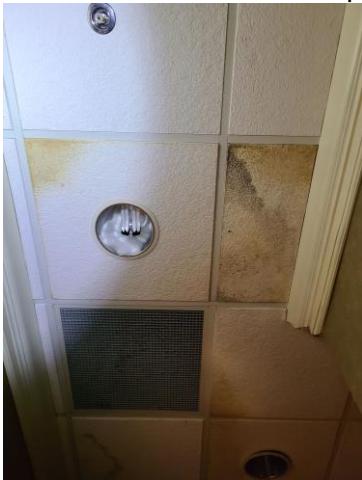
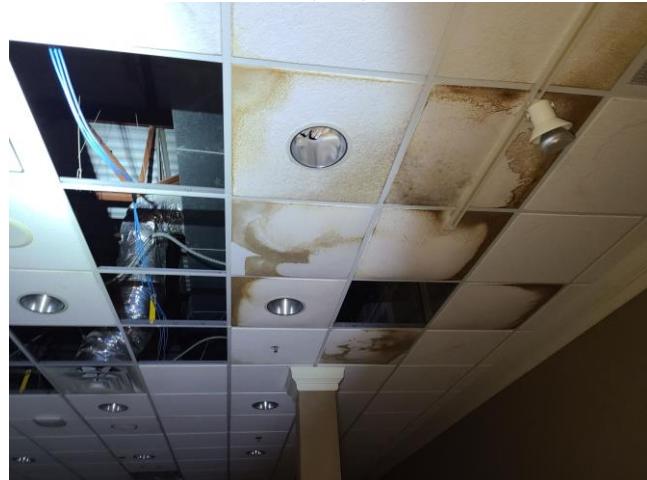
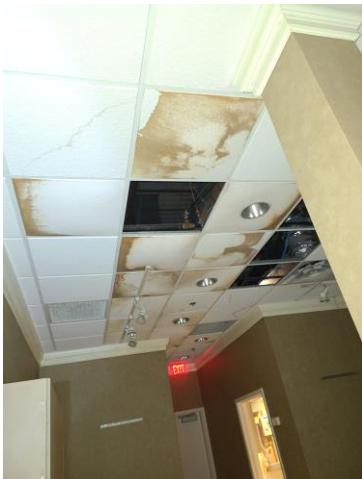
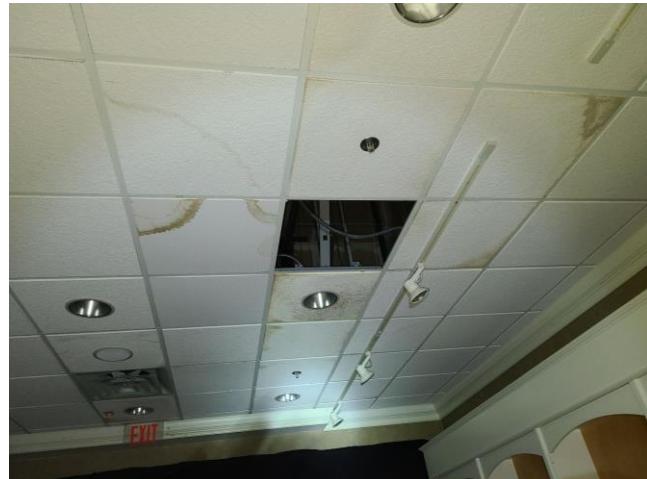
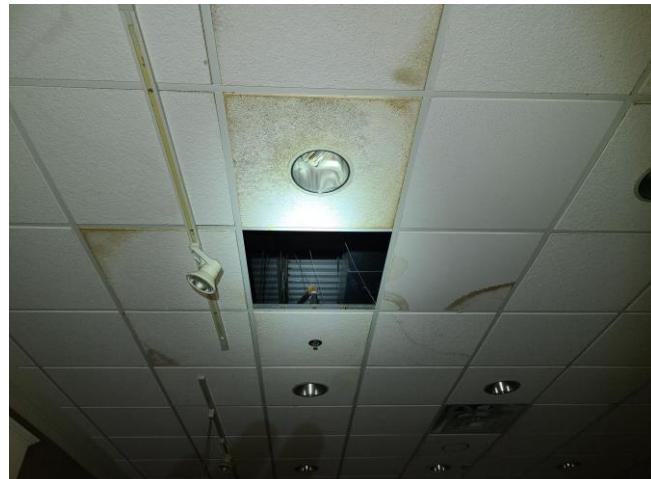
55.0 3166- MASTER CUTS

- Possible Black Mold
Refer to General Repair Recommendations #2
- There are random missing and dark stained ceiling tiles with heavy staining
Refer to General Repair Recommendations #3, #4, and #8

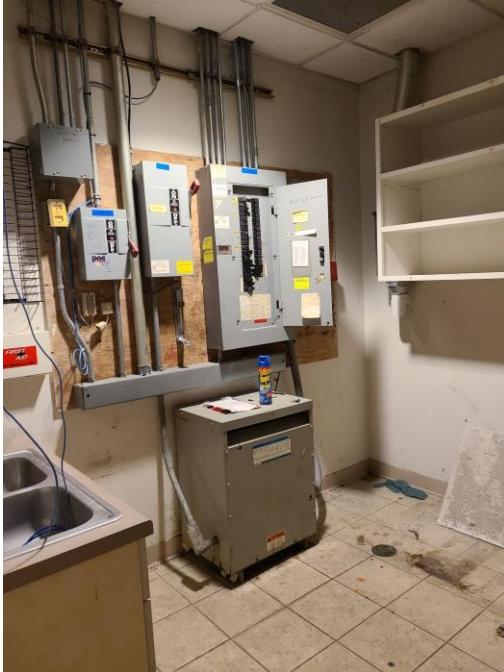
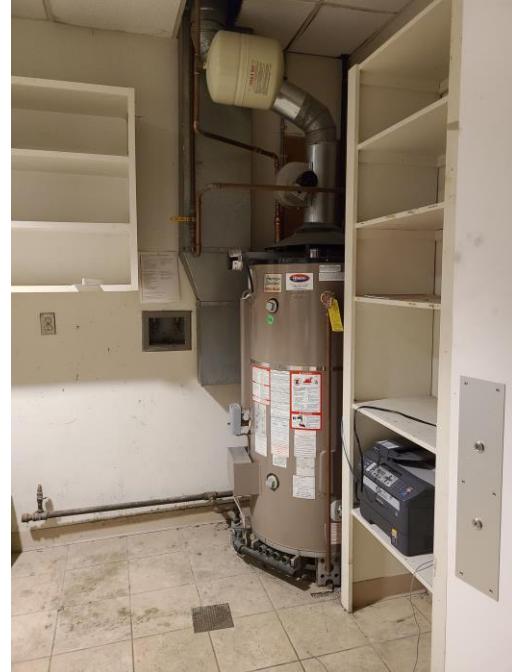
- Minor staining in the Utility room
Refer to General Repair Recommendations #3, #4, #8, #10 and #18

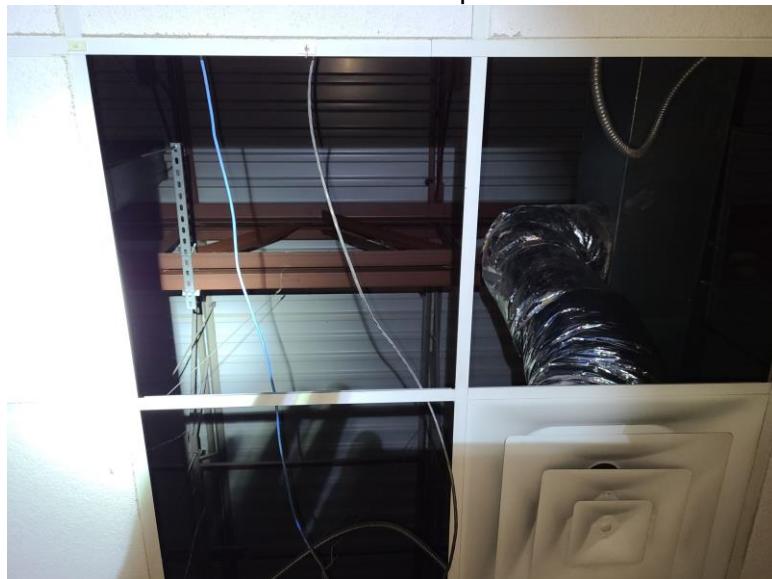
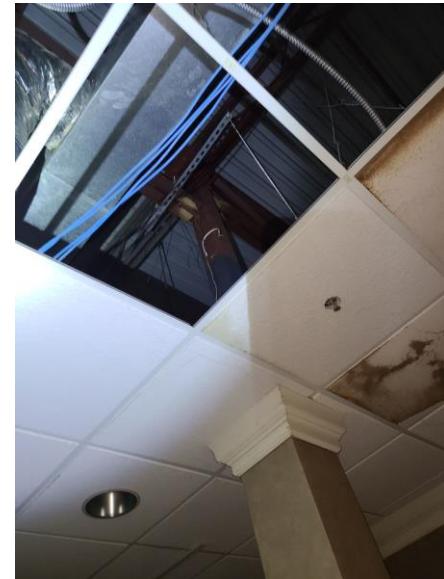
- Minor surface corrosion on the ribs of the metal roof deck and the support steel
Refer to General Repair Recommendations #9

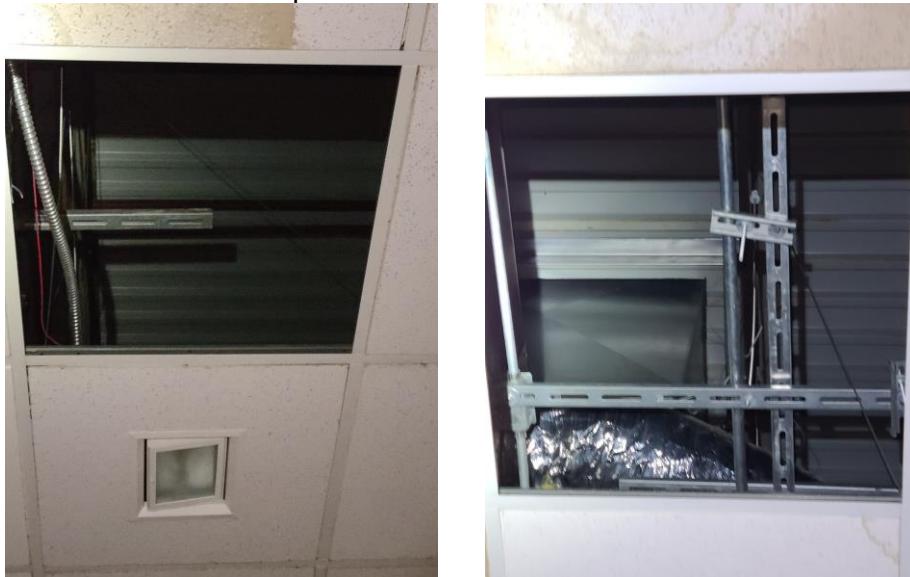
- Metal decking is experiencing minor corrosion
Refer to General Repair Recommendations #9

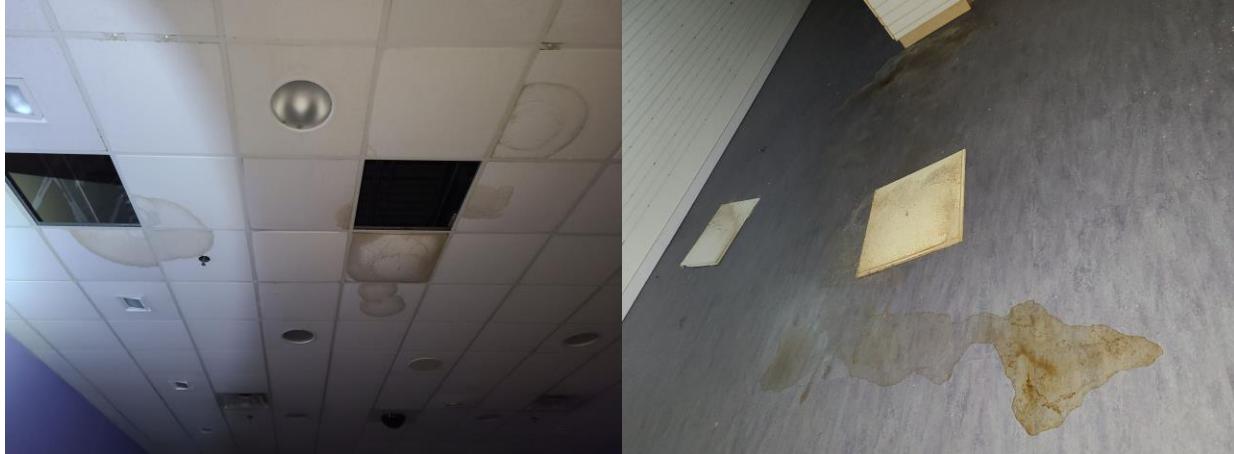
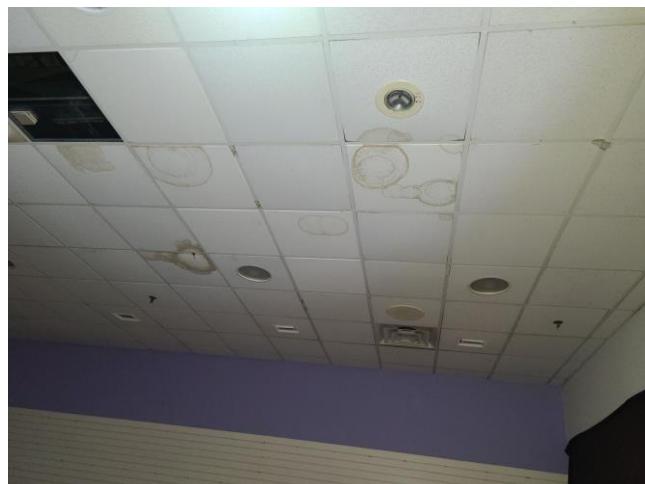
- At the front of the store, badly stained ceiling tiles. Several couple ceiling tiles have fallen. Moderate to heavy staining on many of the ceiling tiles. Refer to General Repair Recommendations #3, #4, #8, and #10

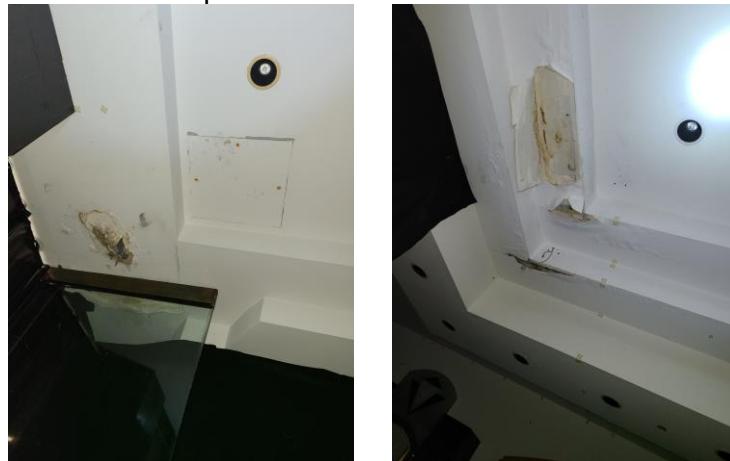
- Towards the center of the store, above the counter peeling and cracked paint
- Discoloring of the ceiling material

Refer to General Repair Recommendations #3, #4, #8 and #9

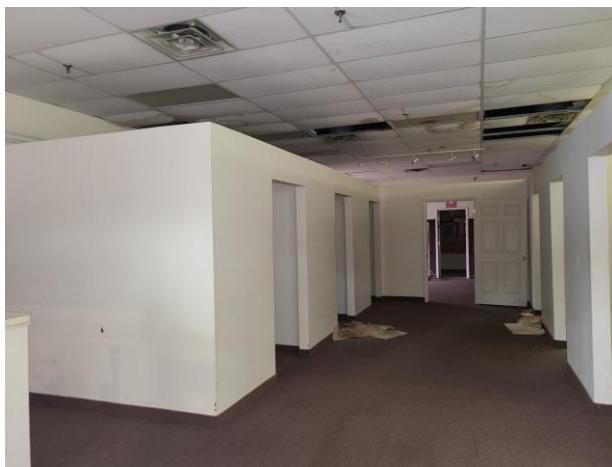
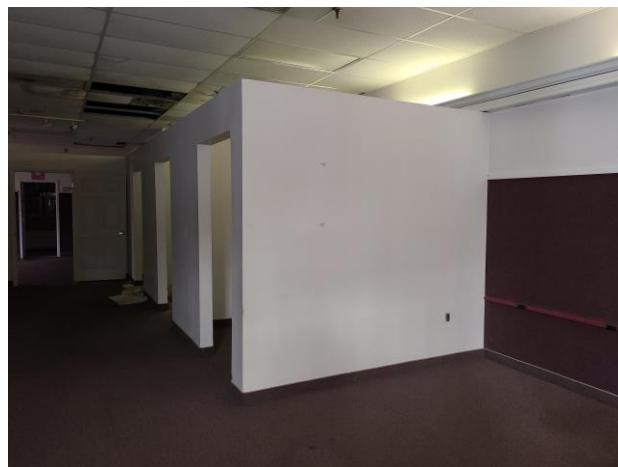
- In the front left corner and All through the middle of the store the ceiling tiles are damaged and missing from water damage
Refer to General Repair Recommendations #2, #3, #4, and #8

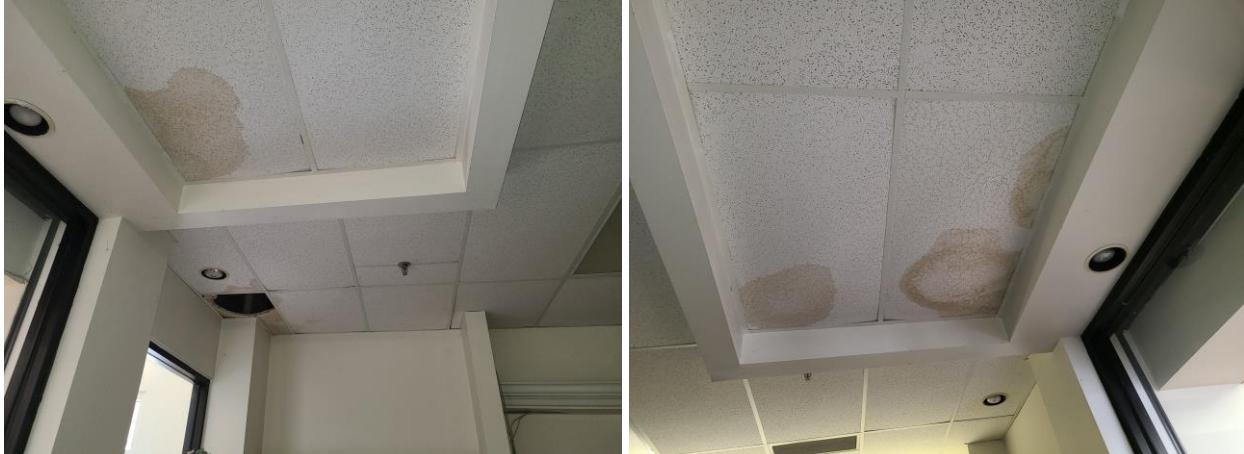
- Lots of ceiling tiles fallen due to water damage causing Mold and mildew panels on the floor.
Refer to General Repair Recommendations #2, #3, #4, and #8

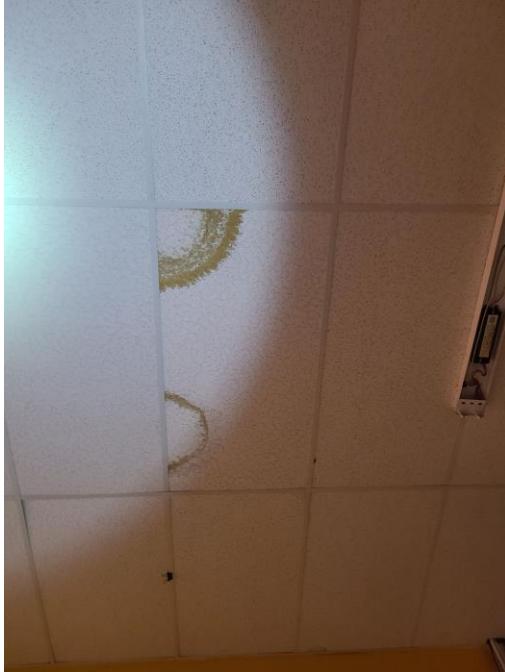
- Some are moderate to heavy staining and the ceiling tile is missing due to water damage
Refer to General Repair Recommendations #2, #3, #4, and #8

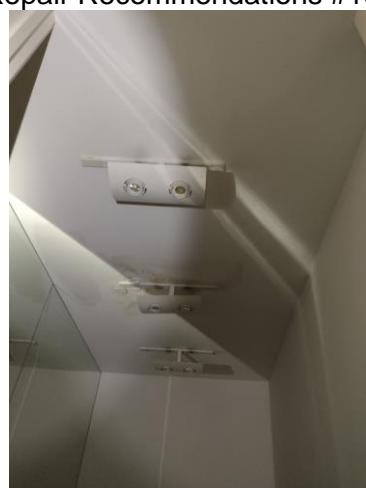
- In the main area there is an area of peeling and blistering paint and an area that was repaired
Refer to General Repair Recommendations #16

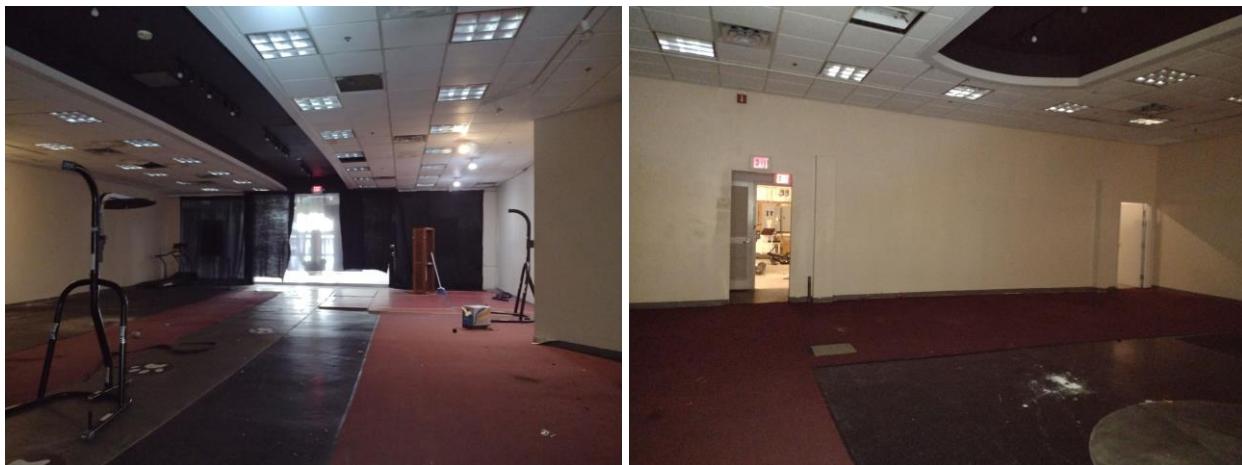
- In the front left and right corners, dark stains, and holes in the ceiling tiles from water damage
Refer to General Repair Recommendations #3, #4, and #8

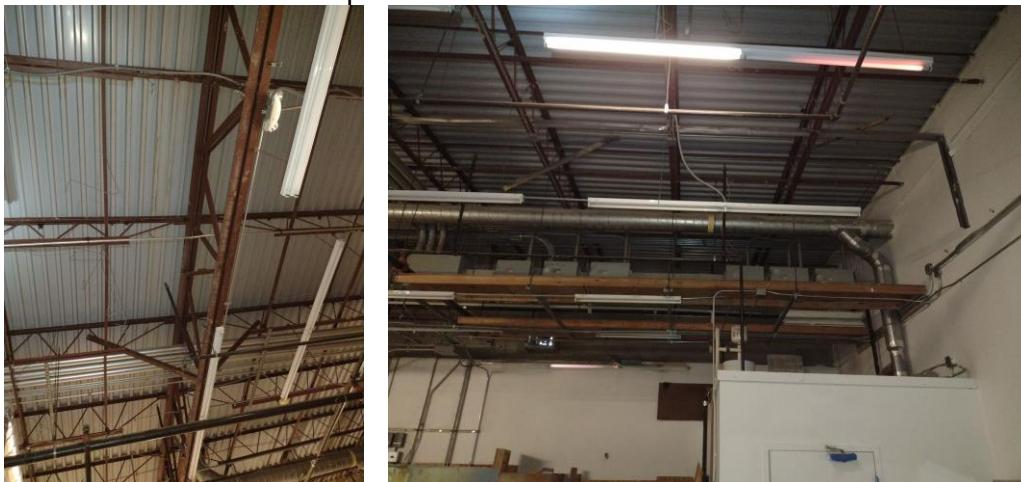
- In the right front corner of the store there are damaged ceiling tiles
- Refer to General Repair Recommendations #2, #3, #4, and #8

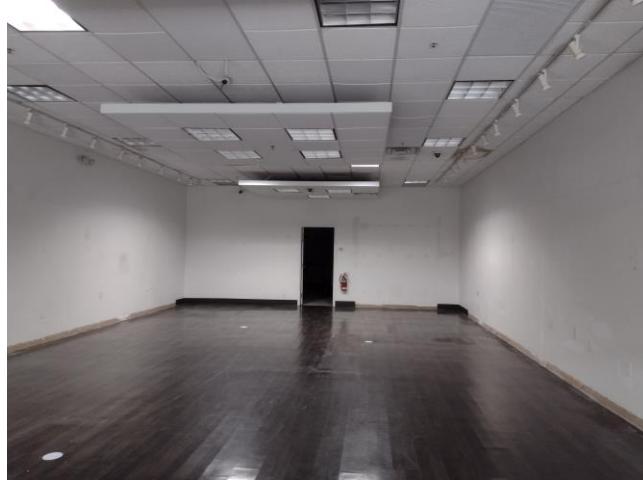
- In the center and back of the room there are badly stained, damaged, and sagging ceiling tiles that are about ready to fall.
Refer to General Repair Recommendations #3, #4, and #8

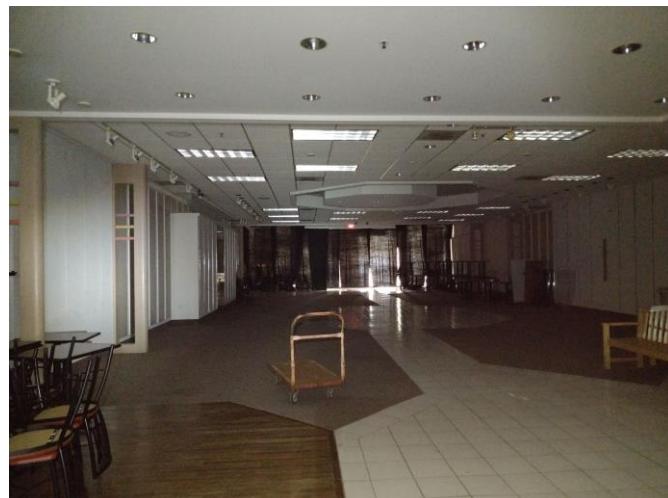
- In the back of the store random areas of cracked and damaged ceiling tiles
Refer to General Repair Recommendations #3, #4, and #8

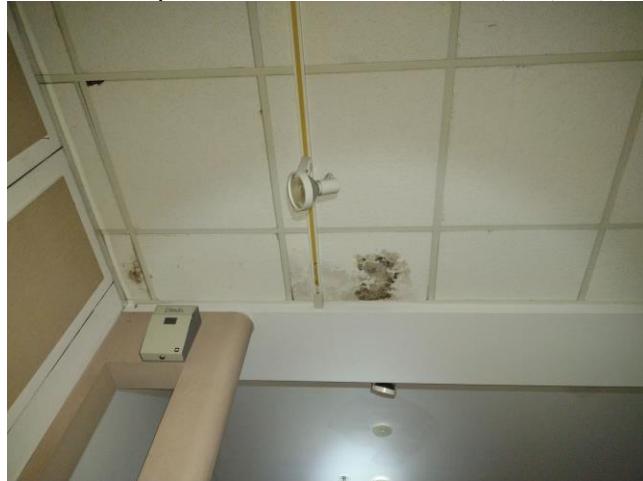
- Near the front of the store, by the 1st column to the right side of the ceiling tile is discolored and damaged
Refer to General Repair Recommendations #2, #3, #4, and #8

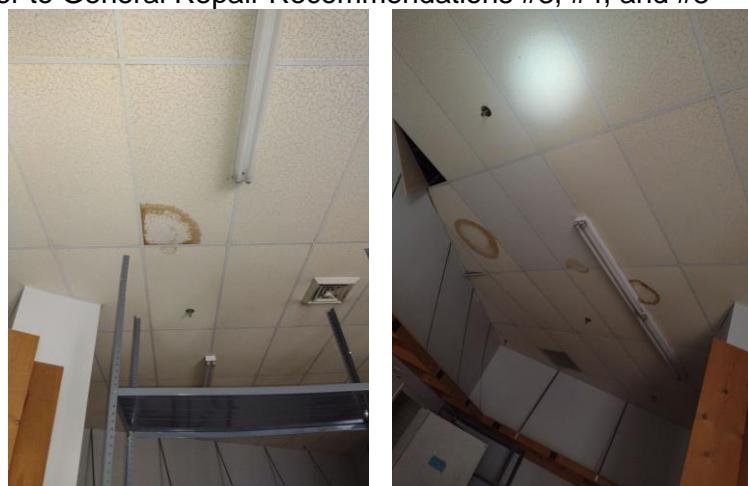
- By the back entrance door, the ceiling tiles are loose, sagging, and missing at random places.
Refer to General Repair Recommendations #3, #4, and #8

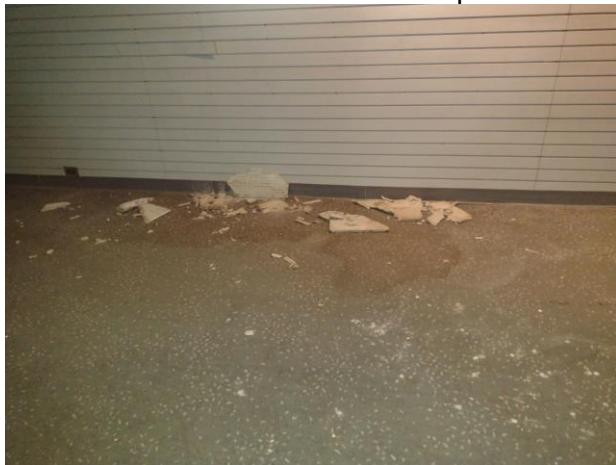
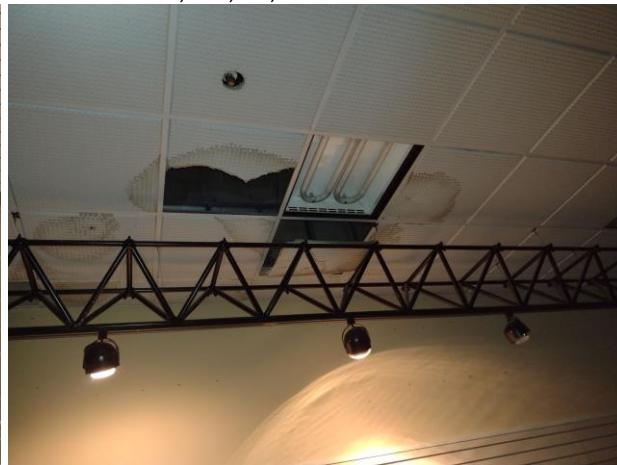
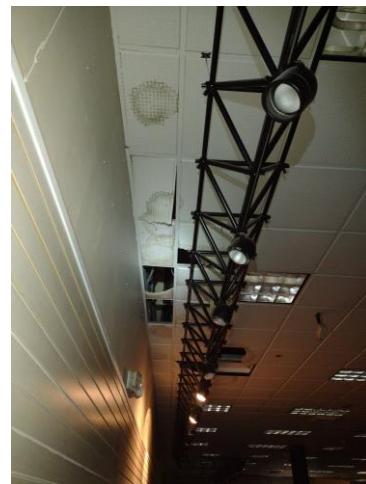
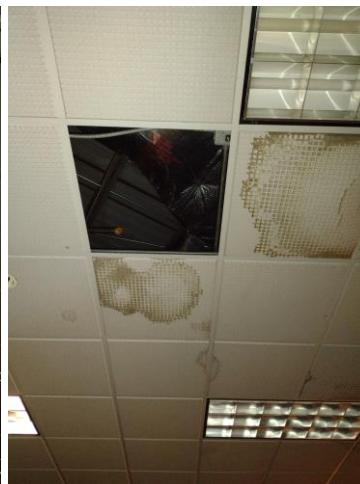
- (2) Store ceiling areas near the office
Refer to General Repair Recommendations #2, #3, #4, and #8

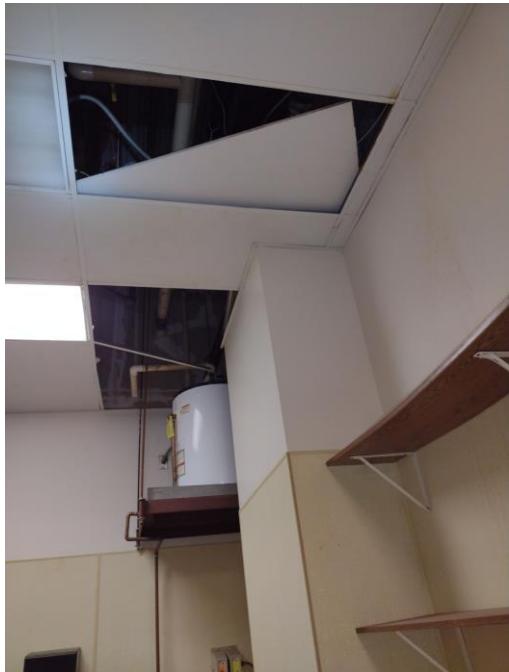
- At the metal roof decking there is minor/ moderate surface corrosion
Refer to General Repair Recommendations #9

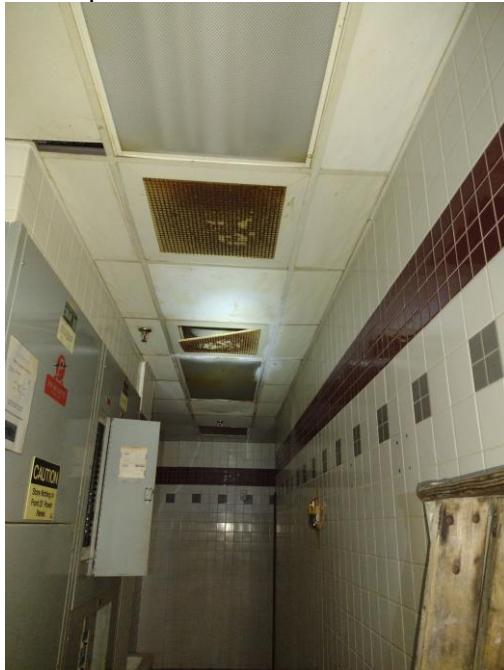
- At the metal roof decking there is moderate surface corrosion
Refer to General Repair Recommendations #9

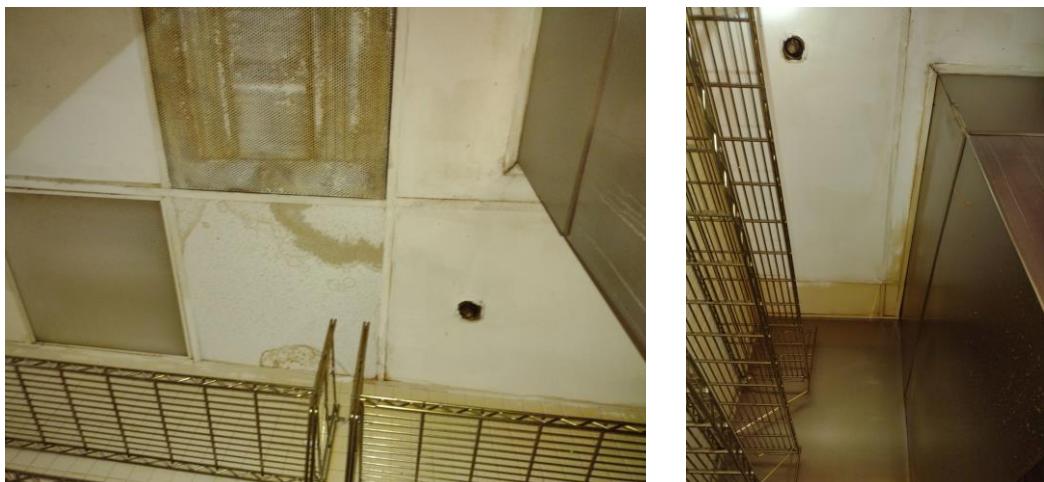
- At the ceiling above the front counter, the plaster is peeling and falling off.
Refer to General Repair Recommendations #15
